Remedy available for
 2021 - 2023 (WL) Jeep Grand Cherokee L
 2022 - 2023 (WL) Jeep Grand Cherokee

SAFETY RECALL

Intermediate Shaft

Reference: 58A / NHTSA 23V-352

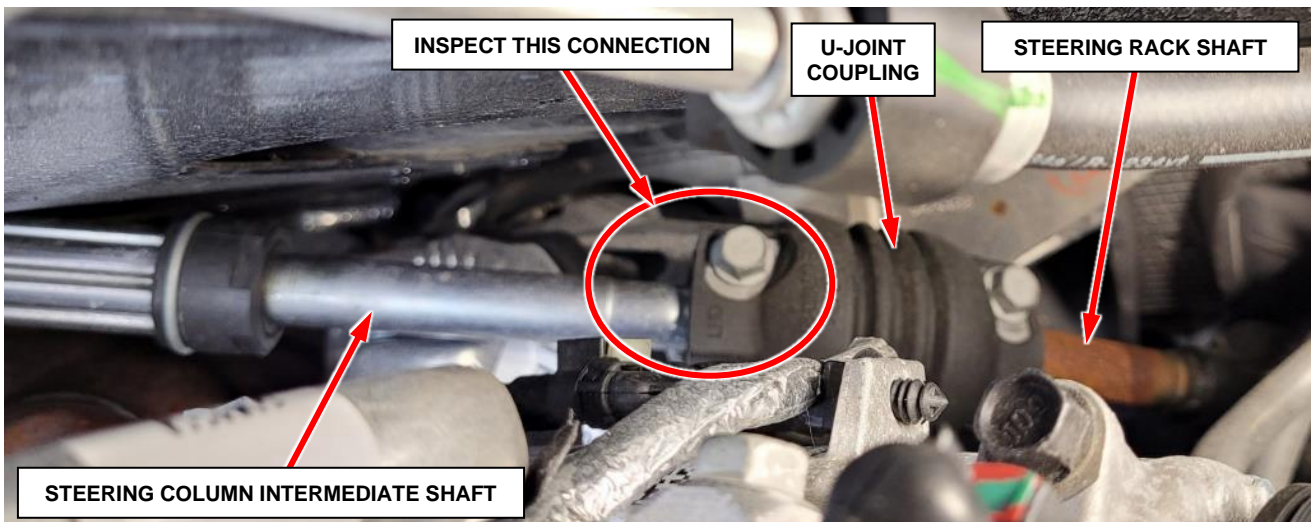
Figure 3 – Locate Suspect Steering Connection

4. Visually locate the steering column intermediate shaft to U-joint interface connection for inspection (Figure 3).

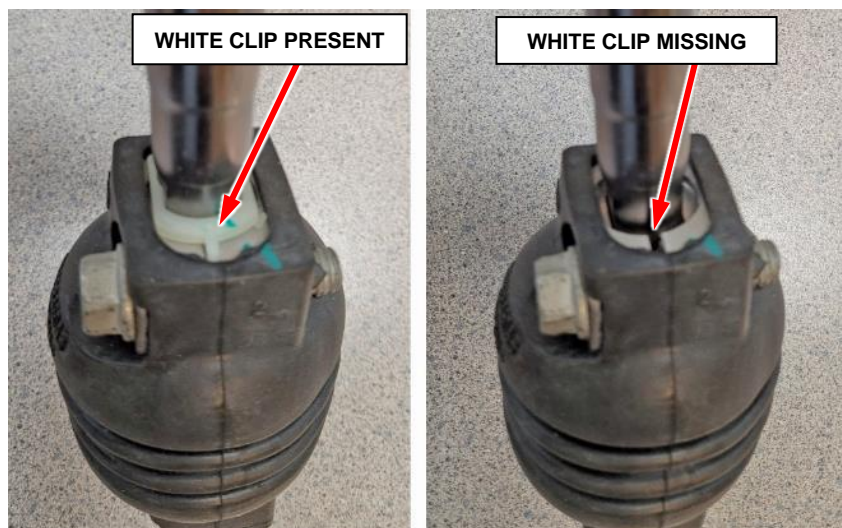
Figure 5 – Inspect for White Clip at U-Joint Connection

- b) Is the white spacer clip present or missing? (Figure 5).

White Clip Present **White Clip MISSING**

- **White Plastic Clip Present:** Continue to next step of repair procedure.
- **White Plastic Clip Missing:** Obtain a **NEW** white plastic clip and follow these instructions.

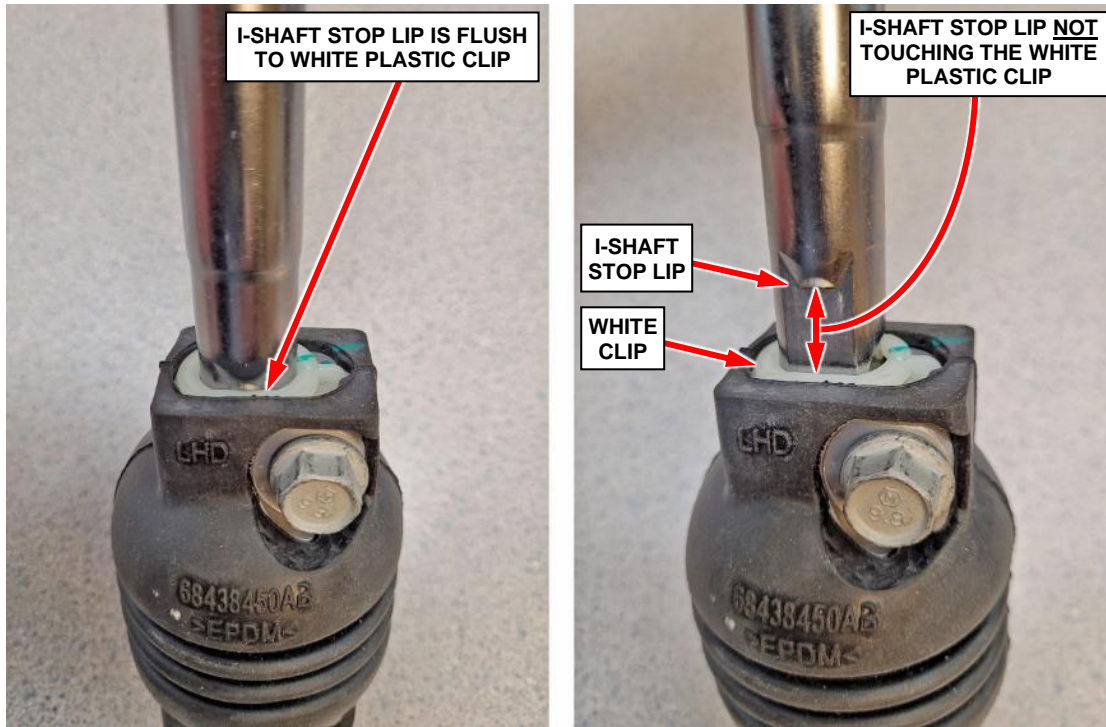
- c) Is the intermediate shaft fully inserted into the U-joint coupler with I-shaft stop lip touching the white plastic clip or not fully inserted? (Figure 6).

Shaft Inserted to Clip

Shaft NOT Fully Inserted to Clip

6. Do **ANY** of the identified conditions (a-c) exist:
- a) Bolt is NOT fully tightened flush to U-joint coupling.
 - b) White plastic clip is MISSING.
 - c) Intermediate shaft is NOT fully inserted into the U-joint coupling.

YES >>> One or more of the above conditions (a-c) exist, proceed to the **Repair Procedure**.

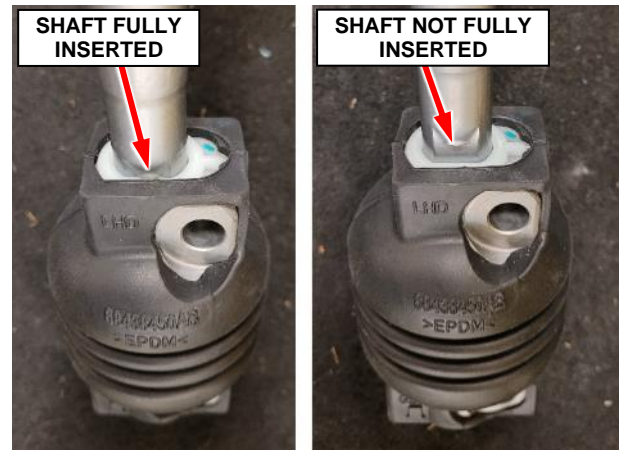
Figure 25 – Intermediate Shaft Insertion Into U-Joint Coupling

- **I-Shaft Stop Lip Contacts White Plastic Clip:**
Continue to **Step 10** of repair procedure.
- **I-Shaft Stop Lip NOT Contacting White Plastic Clip and CANNOT Be Inserted Further:**
Intermediate shaft is oversize. Obtain a **NEW** intermediate shaft then follow these instructions.

Fully Inserted

Not Fully Inserted
