RECALL 23V359 REMEDY INSTRUCTIONS

Make(s): SALEM / WILDWOOD
Model(s): MANY, SEE BELOW
Model Year(s): 2023

Concern:
The manufacturing plant may have failed to apply thread sealant on the brass 90° fitting that is used to connect to the furnaces' LPG steel pipe. Without thread sealant, LP may leak. This condition may lead to a fire causing personal injury.

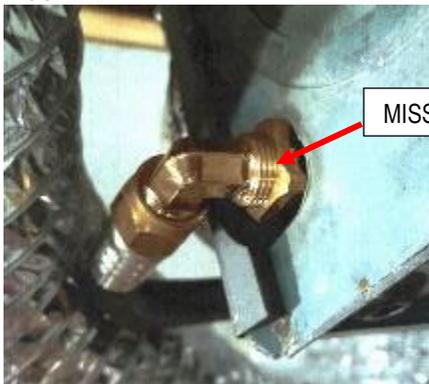
FIGURE 1

- IF IT DOES NOT HAVE ANY THREAD SEALANT ON THE FURNACE SIDE AS DEPICTED IN FIGURE 1, MOVE ON TO REMEDY;
- IF IT DOES HAVE TREAD SEALANT ON THE FURNACE SIDE AS DEPICTED IN FIGURE 2, CLAIM THE INSPECTION CODE. NO FURTHER ACTION IS NEEDED.

STEP 1: DISCONNECT LPG LINE AT THE BRASS 90° FITTING;

STEP 2: DISCONNECT BRASS 90° FITTING AT FURNACE;

STEP 3: APPLY THREAD SEALANT TO THE SIDE OF THE 90° FITTING THAT GOES INTO THE STEEL TUBE ON THE FURNACE;

STEP 4: TIGHTEN UNTIL FITTING IS SEATED;

STEP 5: CONNECT THE LPG LINE BACK TO THE BRASS 90° FITTING;

STEP 6: PERFORM LPG DROP TEST, ENSURE LPG SYSTEM PASSES;
