SERVICE PROCEDURE

23515
JULY, 2023

SUBJECT: NONCOMPLIANCE RECALL
Anti-Lock Brake (ABS) Light on certain 2021 thru 2024 International® eMV™, HV™, HX®, LT®, MV™, RH™, and LoneStar® Series trucks built 10/05/2020 thru 05/09/2023, certain International® ProStar® model trucks built 10/15/2020 thru 10/14/2021, certain 2021 thru 2024 IC Bus® CE commercial buses built 10/06/2020 thru 03/16/2023, certain 2021 thru 2023 IC Bus® RE integrated commercial buses built 01/06/2021 thru 12/21/2022, and certain 2022 and 2023 IC Bus® TC commercial buses built 03/30/2021 through 06/10/2022 with feature code 04AZS or 04AZY (Air Brake, Anti-Lock Brake system [ABS] with Electronic Stability Program [ESP] and Automatic Traction Control [ATC])

Subject: **Bendix® EC-80™ Antilock Braking System (ABS) Electronic Control Unit (ECU) Standalone Update Tool - ID 13351**

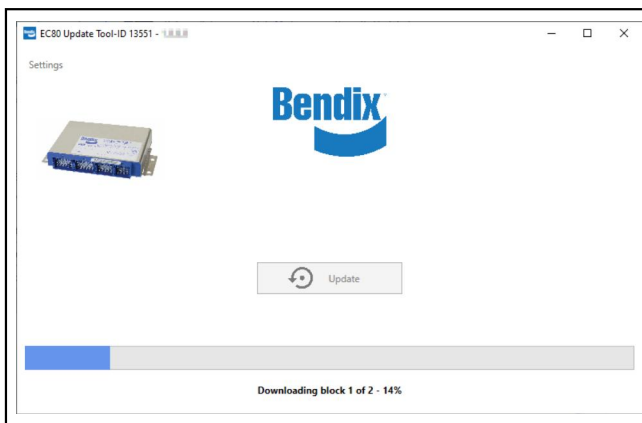
Figure 3 – Update in Process

4. *Figure 3* shows the update is in process. The update time is approximately two (2) minutes.

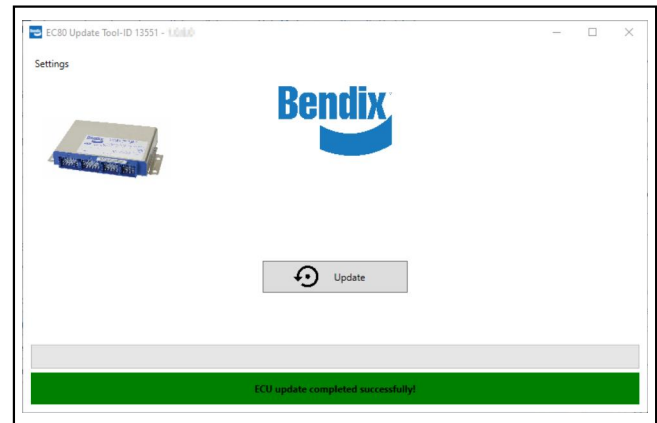
Figure 4 – Update Completed Successfully

5. *Figure 4* shows the update completed successfully.

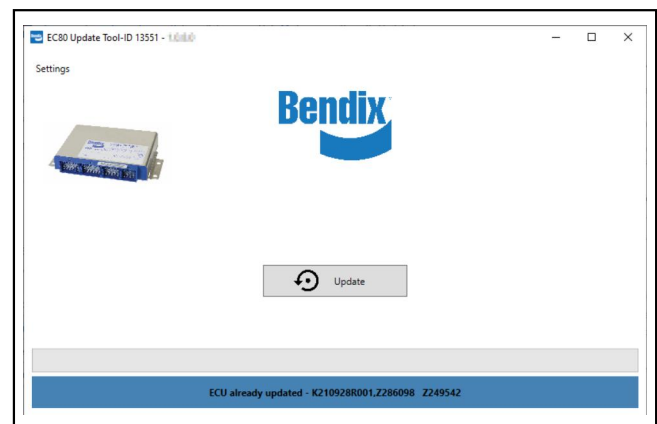
Figure 6 – Update Already Performed

7. *Figure 6* shows the update has already been performed. No further action is required.

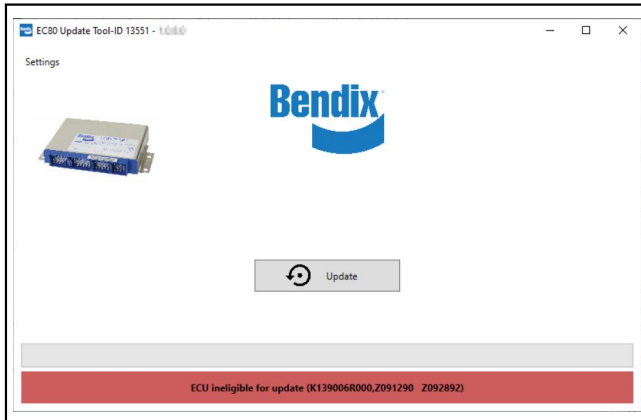
Figure 7 – ECU Ineligible for Update

8. *Figure 7* shows the Electronic Control Unit (ECU) is not eligible for the update. No further action is required.
