PRODUCT CAMPAIGN BULLETIN

APPLICABILITY: 2023 Ascent

NUMBER: WRJ-23

SUBJECT: Lower Control Arm Castle Nut / Improper Torque

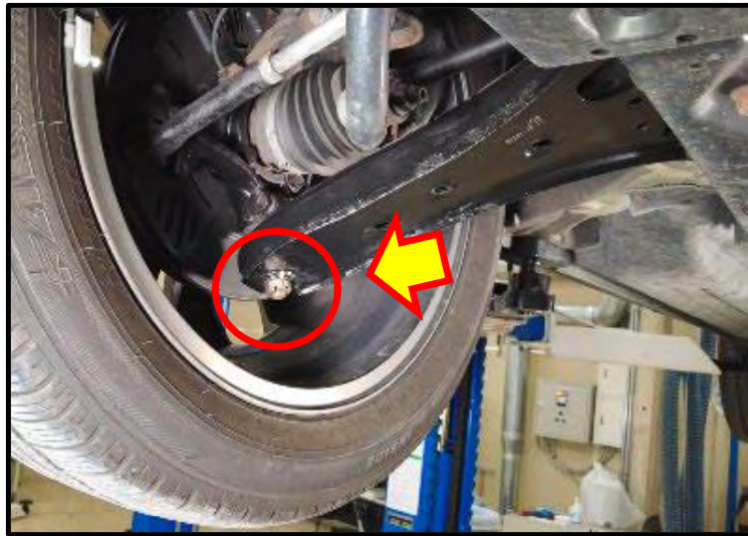
The affected vehicles may be equipped with either a left or right front lower control arm with an insufficiently tightened ball joint castle nut. Over time, the rotational movement of a loose castle nut could result in the sheering of the retention pin. Without a functional retention pin, the castle nut could eventually fall off completely, allowing the ball joint to separate from the lower control arm.

If the ball joint separates from the lower control arm while driving, the vehicle may experience a loss of control, increasing the risk of a crash.

Subaru dealers will inspect the five (5) affected vehicles and, if the castle nut is determined to be loose, replace the lower control arm assembly at no cost to the customer.

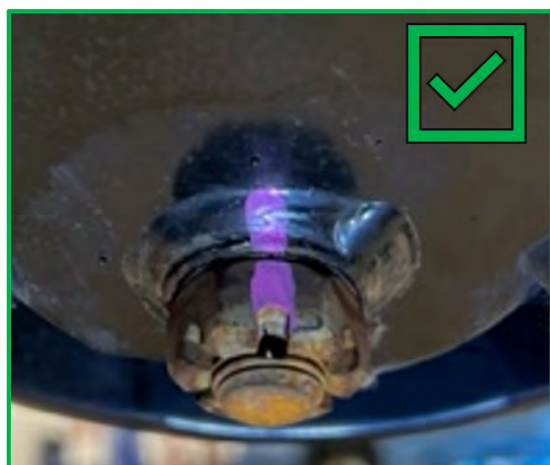
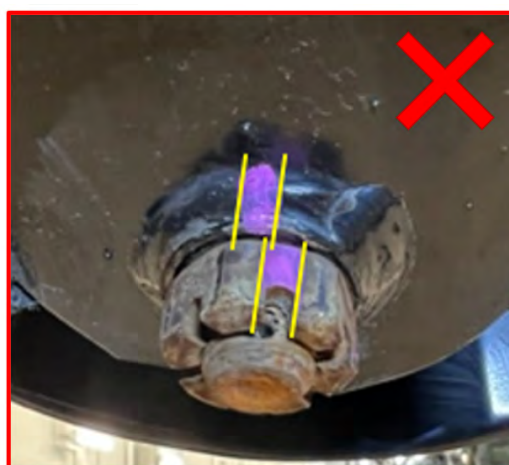
STEP 6: Perform a visual inspection of the markings made to the castle nut and lower control arm. If the markings indicate the castle nut has moved during the torque procedure, the lower control arm assembly will require replacement. If the markings indicate no movement, only the cotter pin will require replacement. See the images below.

NO: Replace the one-time use cotter pin. No further action is required.

STEP 7: Replace the affected front lower control arm assembly as per the applicable Service Manual. Refer to STIS [Suspension > FRONT SUSPENSION > Front Arm](#)
