SAFETY RELATED RECALL

Global Recall Action Number: N798

Subject: Rear Door Latch Water Ingress	Publication No.: N798
	Model: Discovery (LR)
	Model Year: 2017 - 2020
	Date of Issue: 07 September 2023

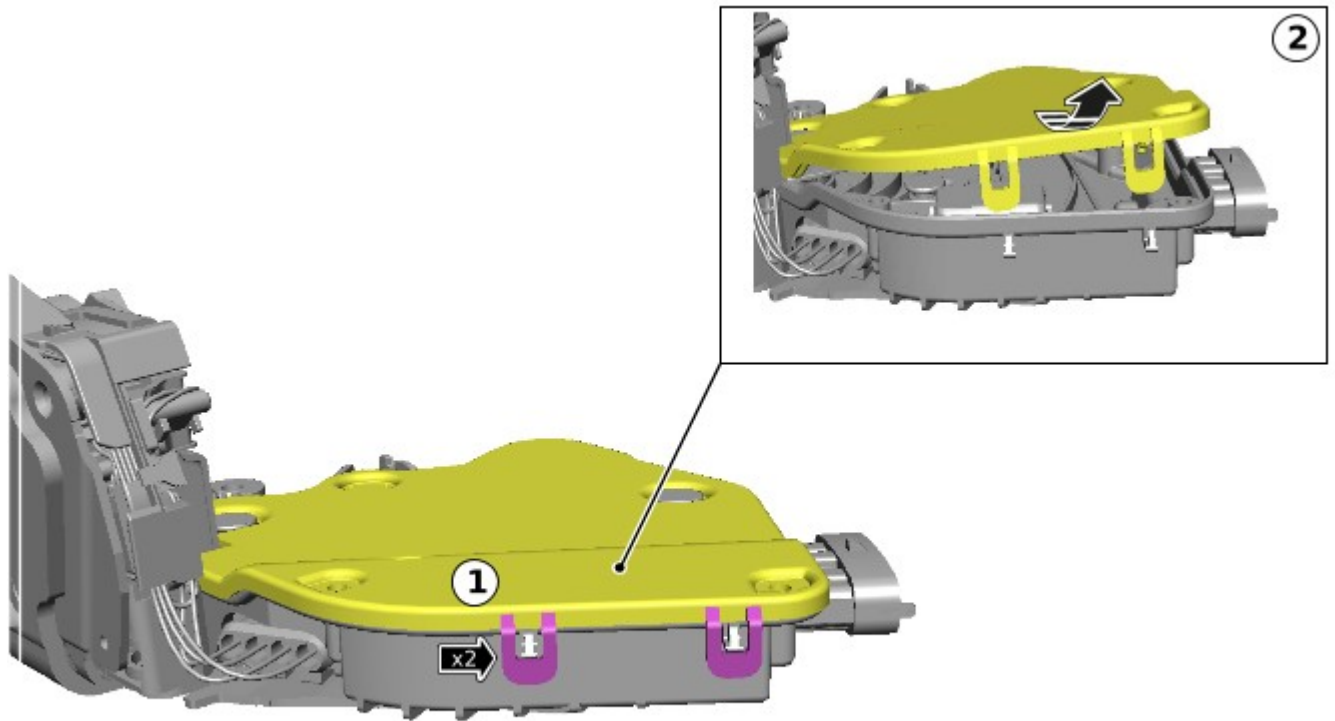
E249345

Only reposition the door latch cover, removal of the cover will cause damage to the door latch.

Access the inside of the door latch.

1. Release the 2 door latch cover retaining clips.
2. Reposition the door latch cover, as shown in the illustration.

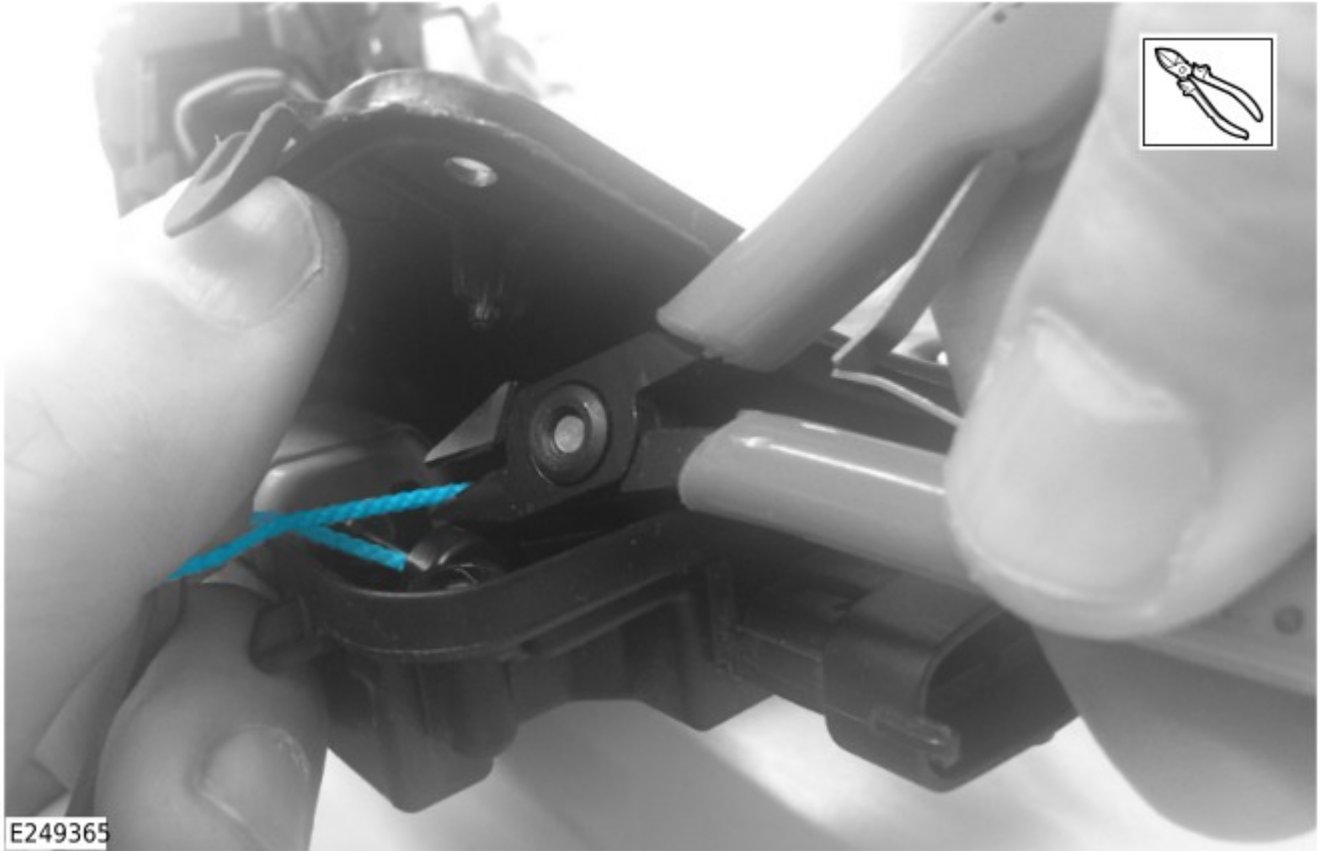
- Allow 40-60 mm of cord from the motor spindle before cutting.
- After cutting the keyless vehicle motor cord, make sure the lever returns back the original position.

Use a suitable tool to cut the keyless vehicle motor cord.

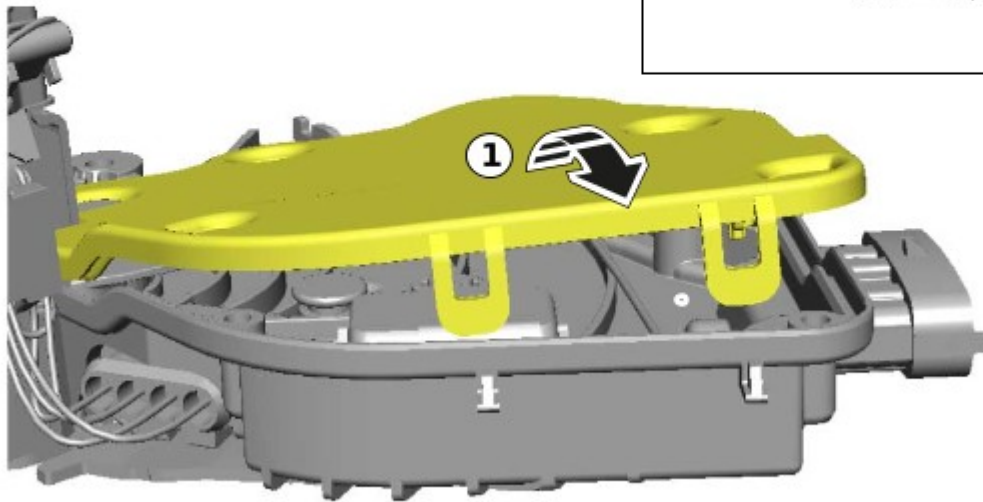
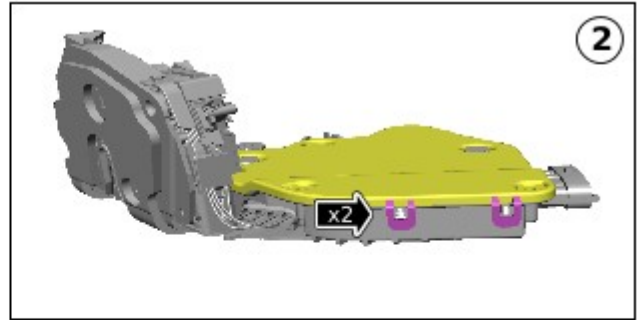
E249348

Make sure the excess keyless vehicle motor cord remains inside the door latch housing before installing the door latch cover.

Install the door latch cover.

1. Reposition the door latch cover.
2. Secure the 2 door latch cover retaining clips.

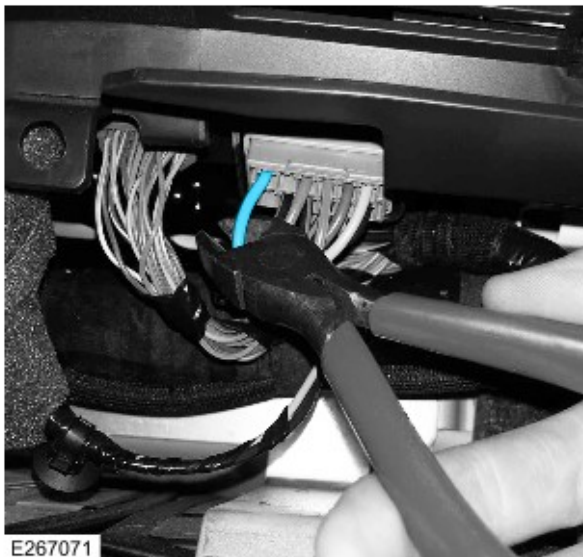
The cut ends must be free from sharp edges. Any strands of wire must be taped over, to prevent damaging adjacent wires or cables or any personal injury.

Remove the harness protection and locate the GY-RD wire in cavity 12 of connector C4PK28C at the [RFA](#).

- Use a suitable tool to cut the GY-RD wire.
- Isolate both ends of the GY-RD wire using a suitable insulating tape.
- Secure both ends of the GY-RD wire to the wiring harness, using a suitable insulating tape.
- The wiring harness must be wrapped in insulating tape and returned as close as possible to new vehicle condition.

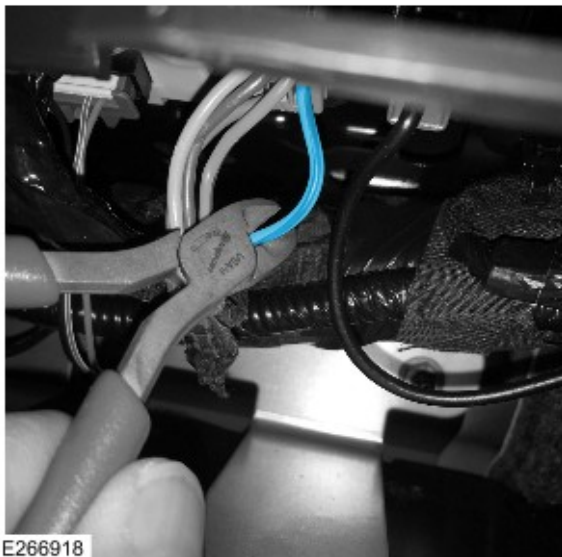
The cut ends must be free from sharp edges. Any strands of wire must be taped over, to prevent damaging adjacent wires or cables or any personal injury.

Remove the harness protection and locate the GY-RD wire in cavity 6 of connector C4PK28B at the [RFA](#).

- Use a suitable tool to cut the GY-RD wire.
- Isolate both ends of the GY-RD wire using a suitable insulating tape.
- Secure both ends of the GY-RD wire to the wiring harness, using a suitable insulating tape.
- The wiring harness must be wrapped in insulating tape and returned as close as possible to new vehicle condition.
