SAFETY RELATED RECALL

Global Recall Action
Number: N784

Subject: Inoperative Rear Lamps	Publication No.: N784
	Model: Range Rover (LK)
	Model Year: 2022 - 2023
	Date of Issue: 13 July 2023

SERVICE INSTRUCTION - N784

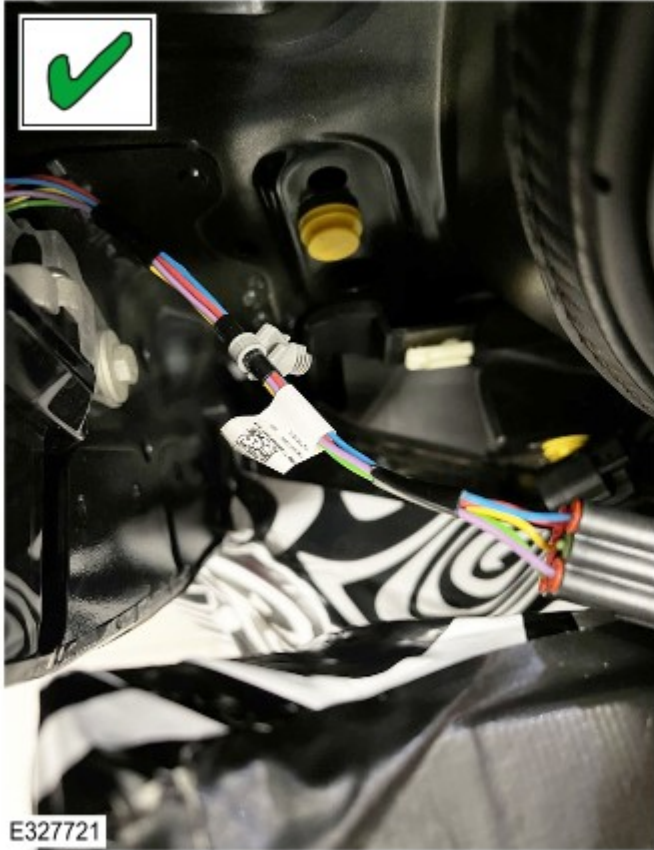
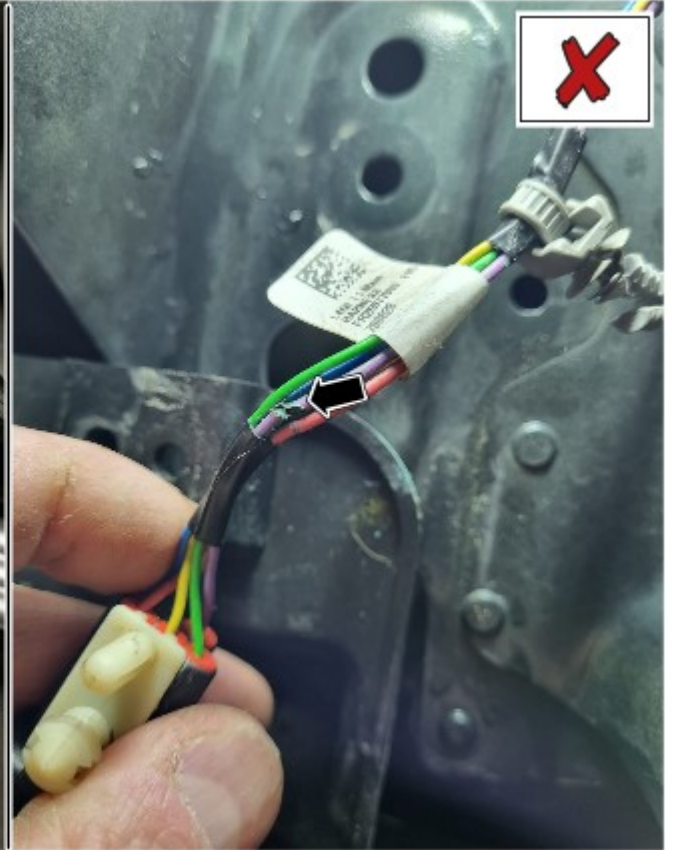
E327721

6. Inspect both rear lamp assembly wiring harnesses for damage.

- If neither of the rear lamp assembly wiring harnesses are damaged, as shown in the illustration with a green '✓', continue to **step 8**.
- If 1 or both of the rear lamp assembly wiring harnesses are damaged, as shown in the illustrations with a red 'X', continue to **step 7**.

7. Renew the rear lamp assemblies that have failed the inspection and have damaged wiring harnesses.
