SAFETY RELATED RECALL

Global Recall Action
Number: N784v2

Inoperative Rear Lamps	Publication No.: N784v2
	Model: Range Rover (LK)
	Model Year: 2022 - 2023
	Date of Issue: 07 February 2024

SERVICE INSTRUCTION - N784V2

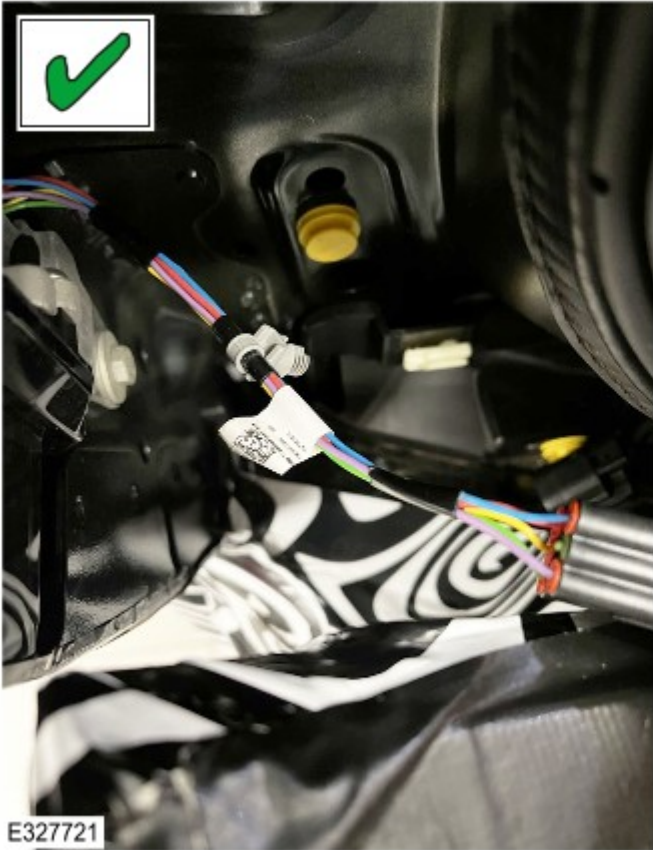
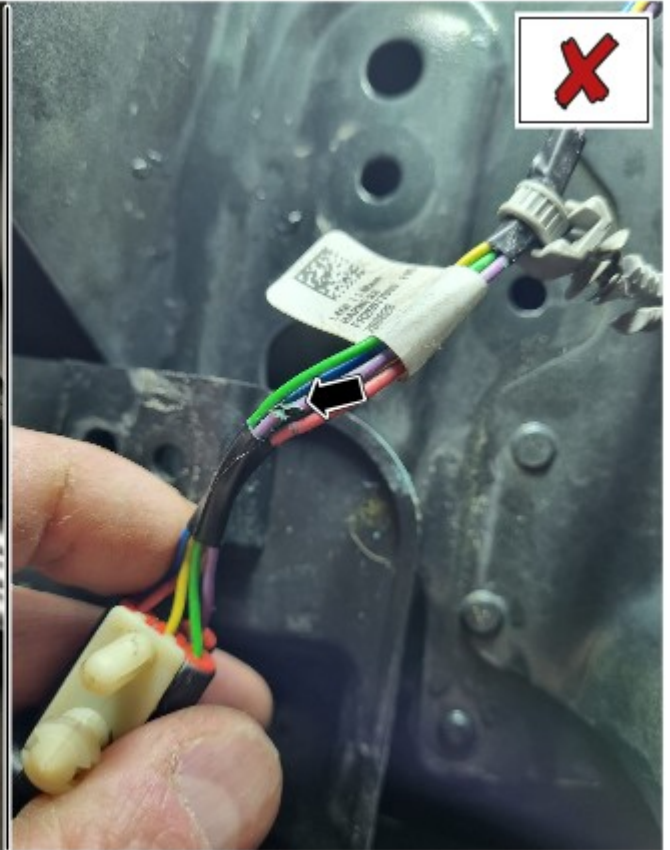
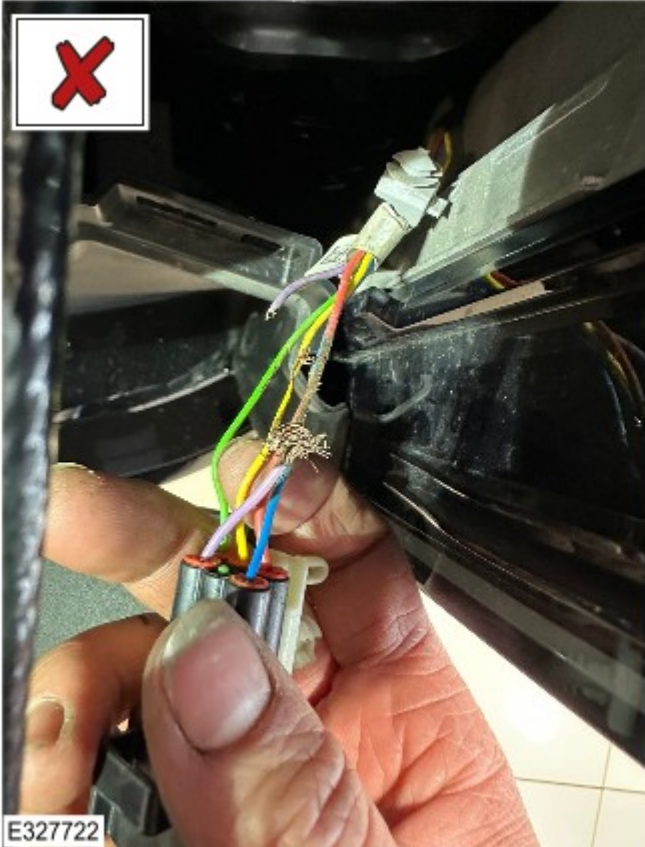
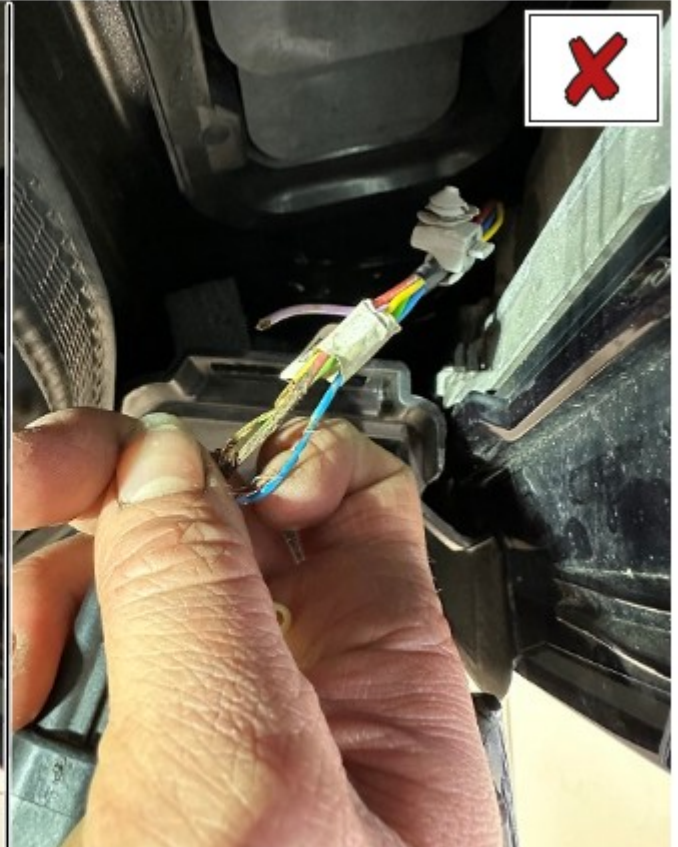
A concern has been identified on 2022 and certain 2023 model year Range Rover vehicles where the rear lamp assembly mounted in the body could partially or permanently fail to operate as a result of damage to the rear lamp link lead wiring caused by a foam block located adjacent to the lamp on the interior of the body shell.

6. Inspect both rear lamp assembly wiring harnesses for damage.

- If neither of the rear lamp assembly wiring harnesses are damaged, as shown in the illustration with a green '✓', continue to **step 8**.
- If 1 or both of the rear lamp assembly wiring harnesses are damaged, as shown in the illustrations with a red 'X', continue to **step 7**.

7. Renew the rear lamp assemblies that have failed the inspection and have damaged wiring harnesses.
