Safety Recall

Volvo Trucks North America

Release Date	Number	Release	Page
06.2023	RVXX2306	01	1(3)

VNRE Electric Heater Relay Torque

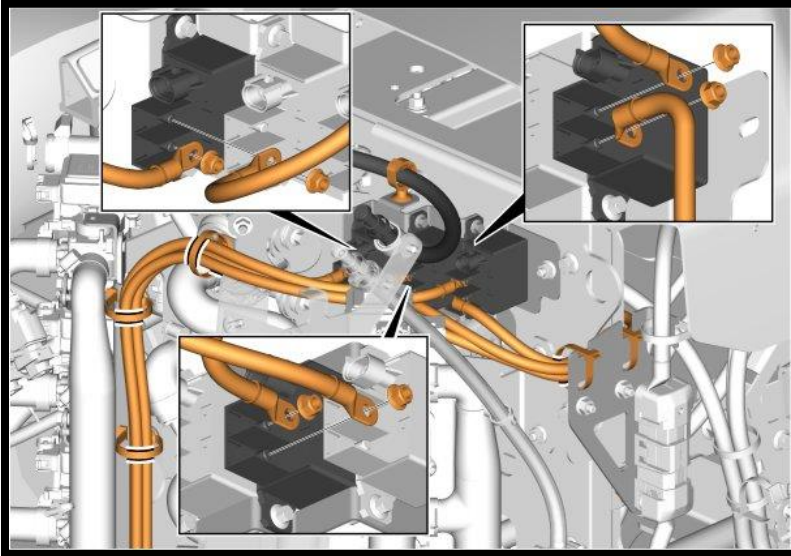
17. Remove relay nuts and remove power cables.

18. Inspect cable and mating surface to ensure and clean connection.

19. Reinstall relay power cables and nuts.
