SAFETY RECALL

Mack Trucks Inc.

Release Date	Number	Release	Page
06.2023	SC0444	01	1(3)

LRBE Electric Heater Relay Torque

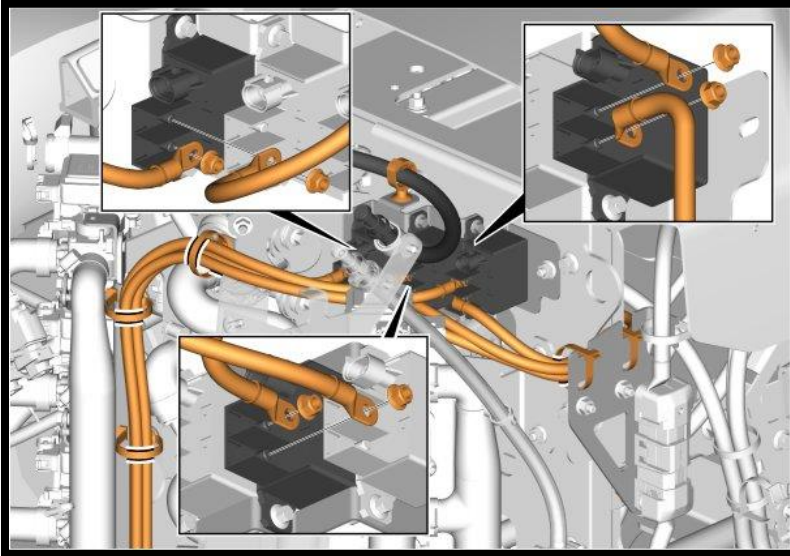
Mack Trucks has determined that certain 2019-2023 model year LRBE vehicles have the risk of the Energy Storage System (ESS), Electric Heater Relays power cables having insufficient torque. Insufficient torque on the power cables to relays may result in a relay failure which could continue to power the cabin heater. Relay failure and overheating could result in a vehicle fire.

22. Remove relay nuts and remove power cables.

23. Inspect cable and mating surface to ensure and clean connection.

24. Reinstall relay power cables and nuts.

25. Torque relay power cable nuts to specification below.

Tightening torque	
Cable terminal, relay, nut	7.5 \pm 0.5 Nm (6 \pm 0.4 lb _r -ft)

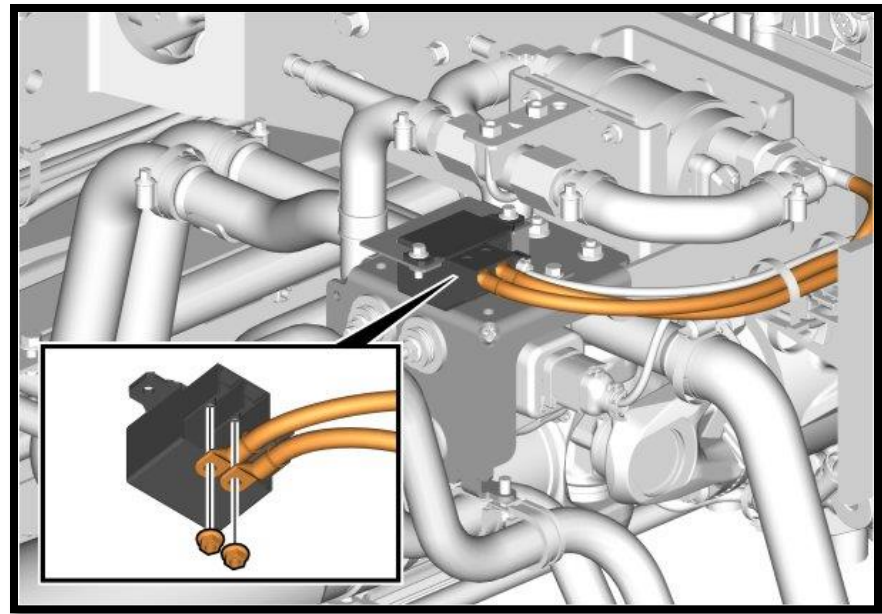
26. Remove relay power cable nuts and remove cables.

27. Inspect cable and mating surface to ensure and clean connection.

28. Reinstall relay power cables and nuts.
