GROUP	MODEL
Safety Recall Campaign	2023MY Sportage (NQ5a)
NUMBER	DATE
SC272	June 2023

SUBJECT: **BRAKE BOOSTER INSPECTION & REPLACEMENT (SC272)**

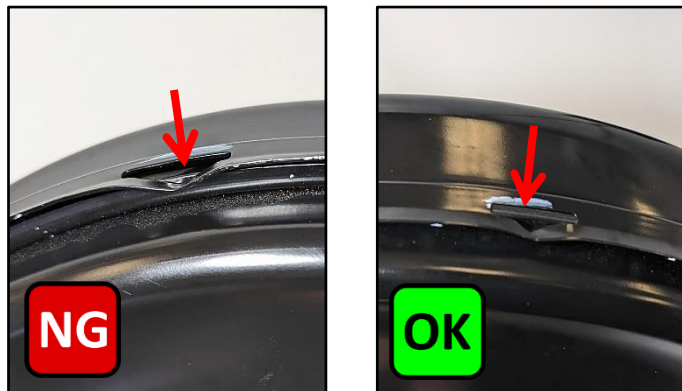
This bulletin provides information to inspect and, if necessary, replace the brake booster assembly on certain 2023MY Sportage (NQ5a) vehicles, produced from January 12, 2022 through February 15, 2023. The brake booster diaphragm in the subject vehicles may become misaligned, resulting in an internal vacuum leak. An internal vacuum leak can cause loss of brake assist. A loss of brake assist can result in hard pedal feel and increased effort during pedal application, thereby increasing stopping distances and the risk of a crash. Follow the procedure outlined in this publication to inspect for an excess gap seal between the inner and outer shell and, if necessary, replace the brake booster assembly on the applicable vehicle. Before conducting the procedure, verify the vehicle is included in the list of affected VINs.

Reference images of a No Good (NG) and (OK) diaphragm seal.

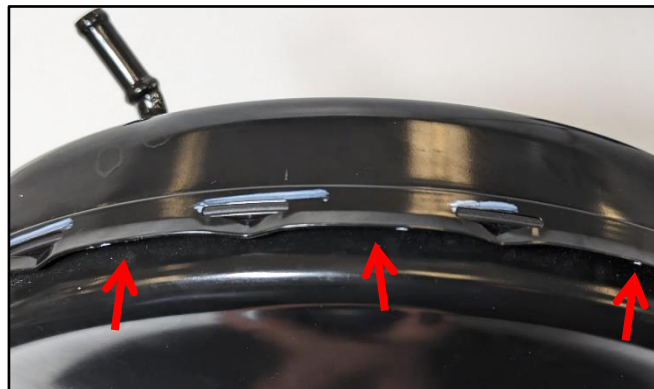
7. Inspect the outer and inner shell gap between ALL gasket tab points (16 total), around the outer circumference area of the brake booster.

Note: The feeler gauge should not be able to be inserted between any check point of the inner and outer shell outlined area shown.

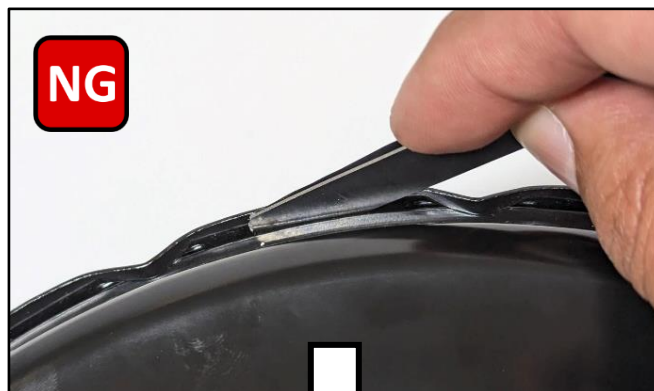
- 8a.
 - If the feeler gauge is able to be inserted between both of the shells with an excess gap of 0.75mm or more (**NG**), replace the brake booster assembly with a new part in the reverse order of removal.

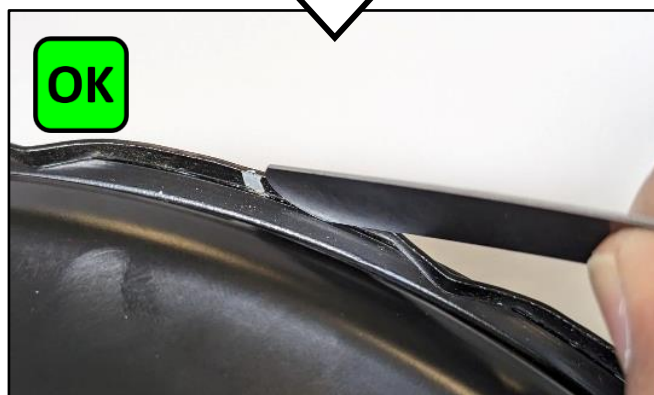
- 8b.
 - If the feeler gauge is not able to be inserted between both of the shells using the 0.75mm setting (**OK**), then reinstall the removed brake booster assembly in the reverse order of removal.
