Remedy available for
 2021 – 2023 Grand Cherokee / Grand
 Cherokee L

SAFETY RECALL

Rear Coil Spring

Reference: 64A / NHTSA 23V-413

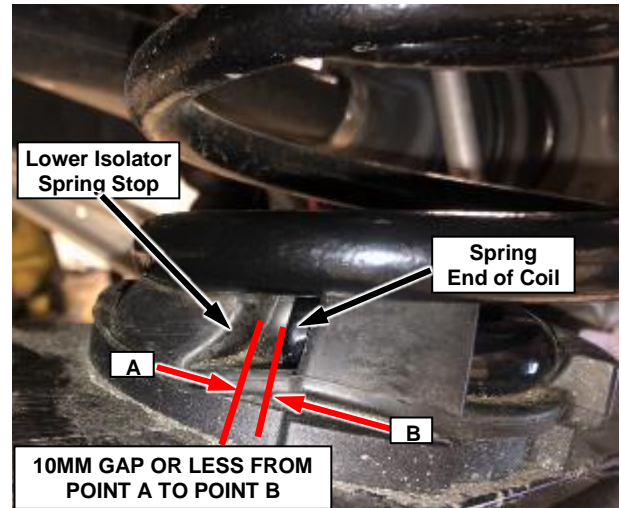
Figure 1 – Check Coil Spring to Isolator Gap at Smallest Point

1. Raise and support the vehicle (Refer to 04 - Vehicle Quick Reference/Hoisting/Standard Procedure).
2. Inspect for the following two conditions:
 - Gap from the end of coil to isolator spring stop (Figures 1 and 2)
 - Pass: 10mm or less gap
 - Fail: greater than 10mm

NOTE: If the spring stop is slightly deformed, measure the area of the smallest gap. See A-B measurement in Figure 1.

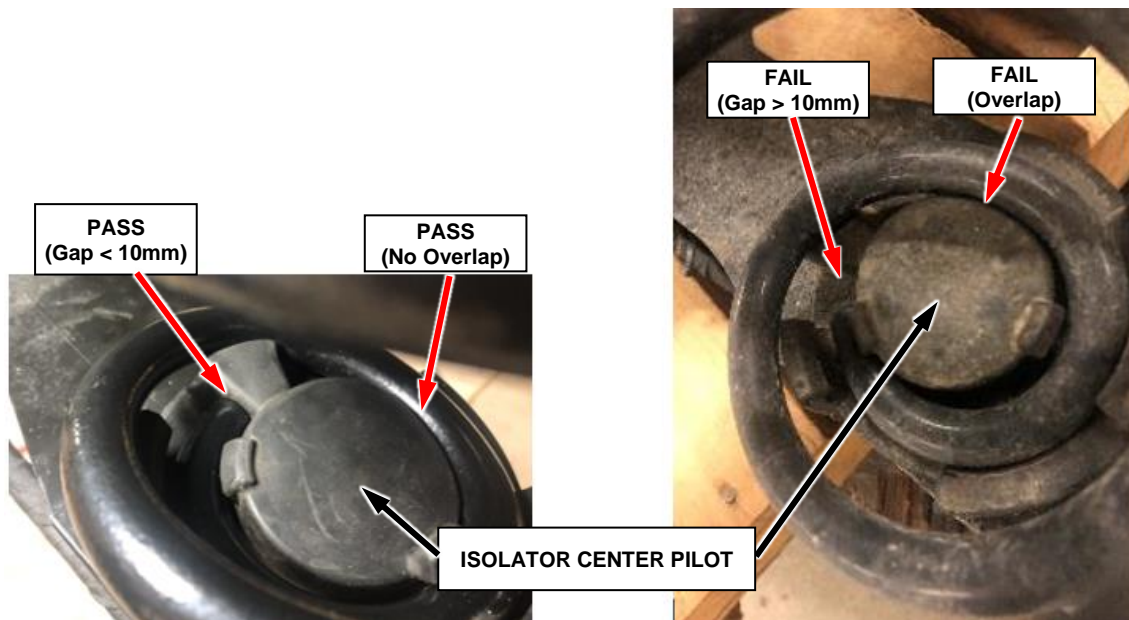
Figure 2 – Inspect Isolator Spring Pilot and Gap

- Coil not sitting on top of the center pilot of the isolator (Figure 2)

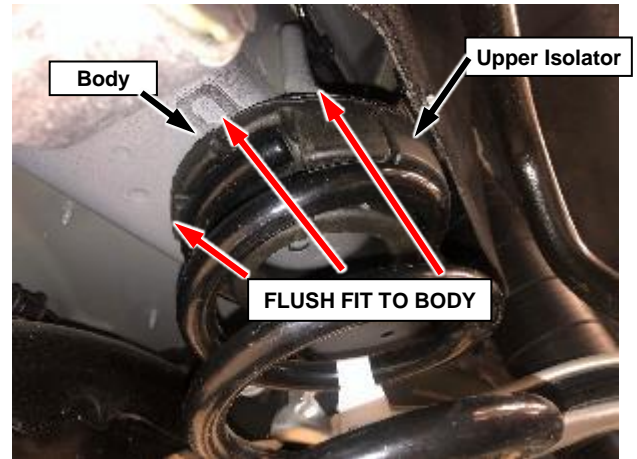
Figure 3 – Upper Spring Isolator to Body

- 3. Verify that the upper spring isolator is seated flush to the body on the welded body pilot feature (Figures 3 and 4).

NOTE: Upper Isolator is replaced only if this inspection step fails. Otherwise it can be reused.
