Remedy available for
 2021 – 2023 Grand Cherokee / Grand
 Cherokee L

SAFETY RECALL

Rear Coil Spring

Reference: 64A / NHTSA 23V-413

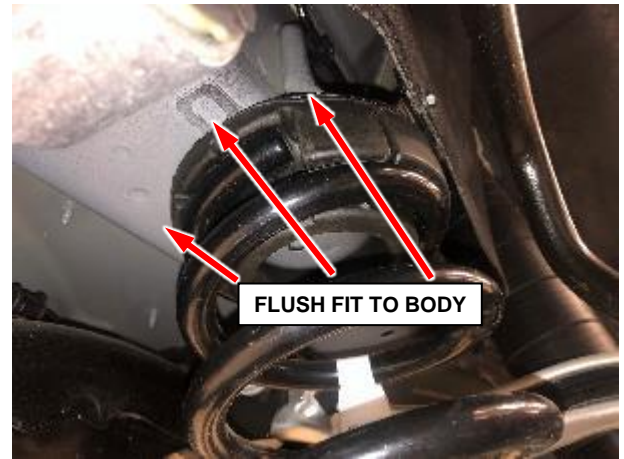
Figure 3 – Upper Spring Isolator to Body

- 3. Verify that the upper spring isolator is seated flush to the body on the welded pilot on the body (Figures 3 and 4).
