Remedy available for
 2021 – 2023 Grand Cherokee / Grand
 Cherokee L

SAFETY RECALL

Rear Coil Spring

Reference: 64A / NHTSA 23V-413

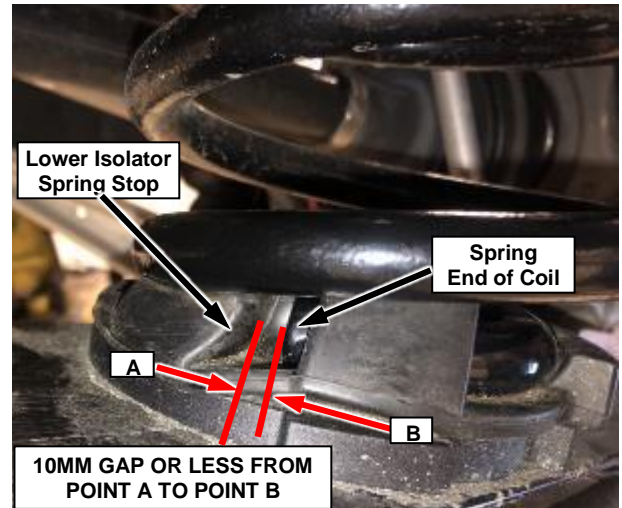
Figure 1 – Check Coil Spring to Isolator Gap at Smallest Point

1. Raise and support the vehicle (Refer to 04 - Vehicle Quick Reference/Hoisting/Standard Procedure).
2. Inspect for the following **two conditions**:
 - Gap from the end of coil to isolator spring stop (Figures 1 and 2)
 - Pass: 10mm or less gap
 - Fail: greater than 10mm

NOTE: If the spring stop is slightly deformed, measure the area of the smallest gap. See A-B measurement in Figure 1.

If either end of either spring fails the inspection, lower the rear suspension on that side of the vehicle (one side at a time if both sides need repair), remove and replace the lower isolator(s), and reinstall the spring(s) and its isolators in the proper orientation.

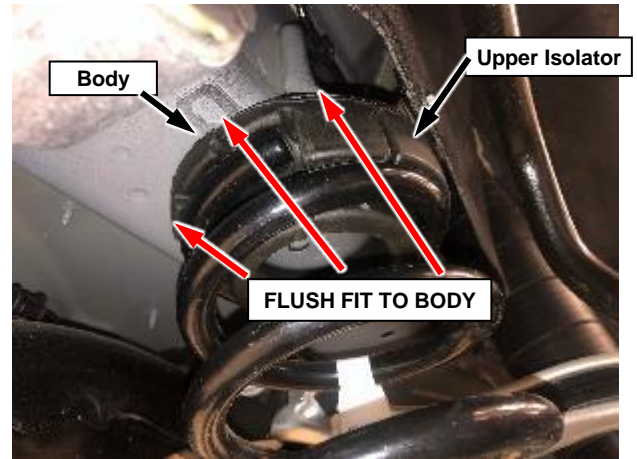
Figure 3 – Upper Spring Isolator to Body

- 3. Verify that the upper spring isolator is seated flush to the body on the welded **body pilot feature** (Figures 3 and 4).

NOTE: Upper Isolator is replaced only if this inspection step fails. Otherwise it can be reused.
