Remedy available for  
 2021 – 2023 Grand Cherokee / Grand  
 Cherokee L

# SAFETY RECALL

## Rear Coil Spring

Reference: 64A / NHTSA 23V-413

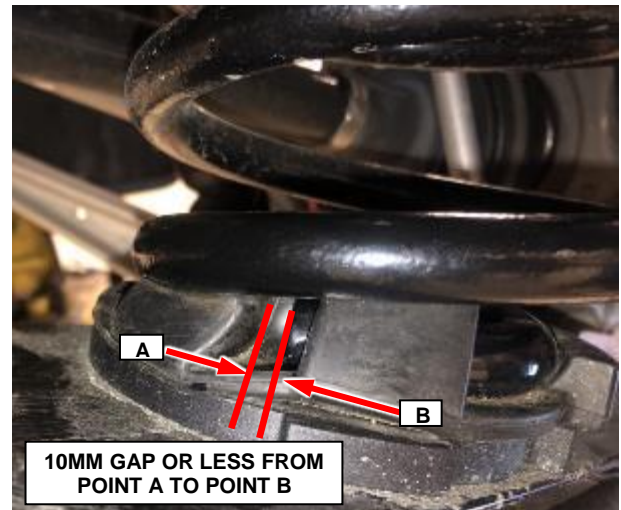
Figure 1 – Check Coil Spring to Isolator Gap at **Smallest** Point

**NOTE:** Neither the coil spring end nor the isolator spring stop are machined surfaces. If the ends of these surfaces are not parallel to each other, measure the area of the smallest gap. See A-B measurement in Figure 1.

2. Inspect for the following:
  - Gap from the end of coil to isolator spring stop (Figure 1)
    - Pass: 10mm or less gap
    - Fail: greater than 10mm
  - Coil not sitting on top of the center pilot of the isolator (Figure 2)

If either end of either spring fails the inspection, lower the rear suspension on that side of the vehicle (one side at a time if both sides need repair), remove and replace the lower isolator(s), and reinstall the spring(s) and its isolators in the proper orientation.

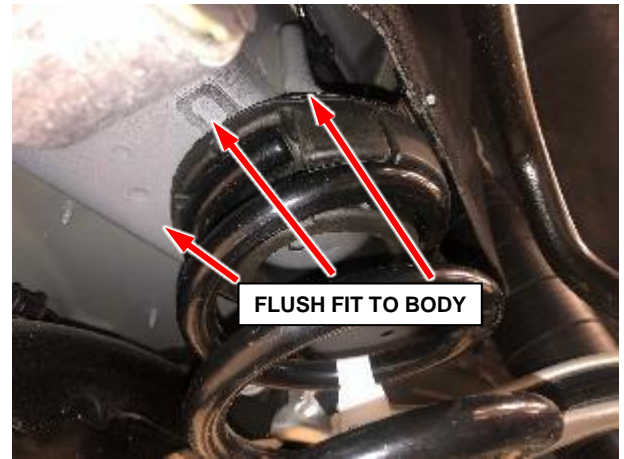
**Figure 3 – Upper Spring Isolator to Body**

- 3. Verify that the upper spring isolator is seated flush to the body on the welded pilot on the body (Figures 3 and 4).

16. Lower the rear suspension crossmember enough to remove the rear coil spring.
17. Remove the lower isolator by prying it from the compression link. Clean the compression link surface under the lower isolator. Install a new lower spring isolator to the compression link. If the upper isolator was not positioned to the body correctly, it should also be replaced. Otherwise, reuse the upper isolator.
