# VOLUNTARY RECALL CAMPAIGN

Classification: EL23-015	Reference: NTB23-050	Date: June 14, 2023
-----------------------------	-------------------------	------------------------

## VOLUNTARY SAFETY RECALL CAMPAIGN 2022 SENTRA; COWL SEAM SEAL

**CAMPAIGN ID #:** PMA21  
**APPLIED VEHICLES:** 2022 Sentra (B18)

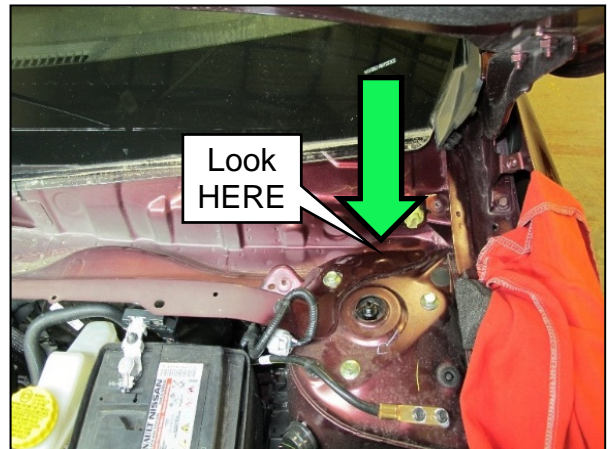
9. Locate the driver (LH) side cowl joint seams to be resealed, as shown in Figure 15 and Figure 16.
  - Figure 15 shows the general area of the driver (LH) side strut/cowl area.
  - Figure 16 is seen by looking down the windshield toward the engine bay under the open hood.

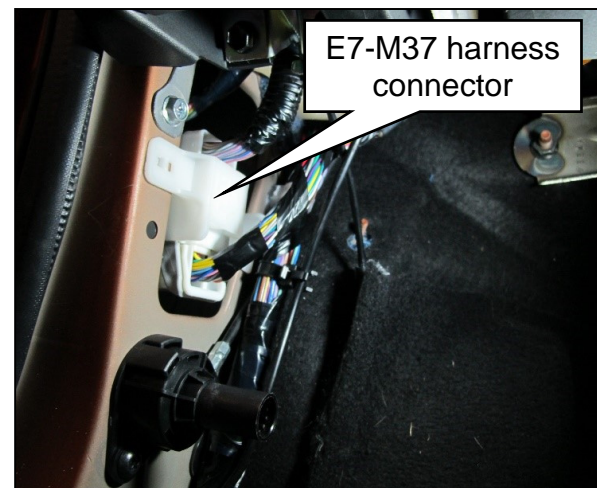
Figure 35

27. Locate the E7-M37 harness connector in the driver (LH) side lower A pillar area.

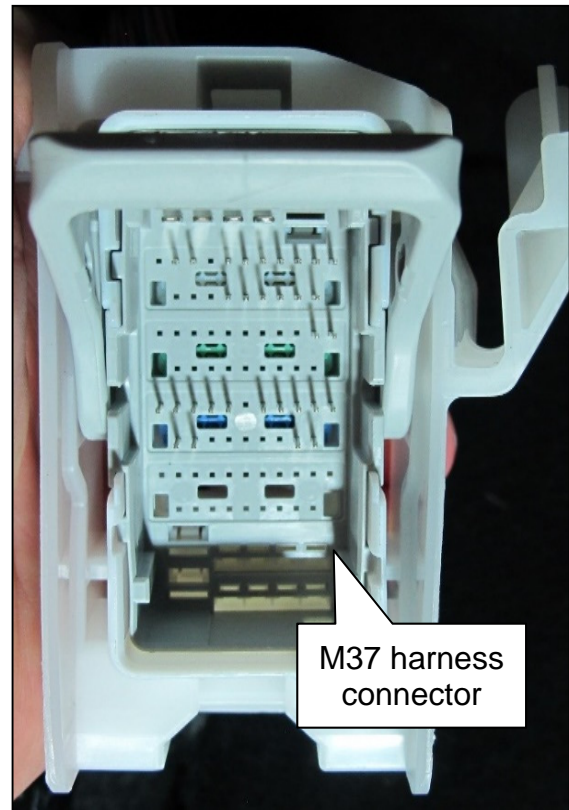
Figure 42

33. Visually inspect BOTH sides of the E7-M37 harness connector for water intrusion or corrosion (Figure 42 and Figure 43).

- If no water intrusion or corrosion was found, continue to step 35 on page 20.
- If water intrusion or corrosion WAS found, replace the engine room harness and the main harness. Contact FQA with the required information in step 34.
