RECALL

R23CH: INOPERATIVE AIR PRESSURE GAUGES

Production Models Affected: Certain 2021 through 2024 Model Year T3RE, T3FE and BBCV (EV only) Blue Bird buses equipped with pneumatic brakes.

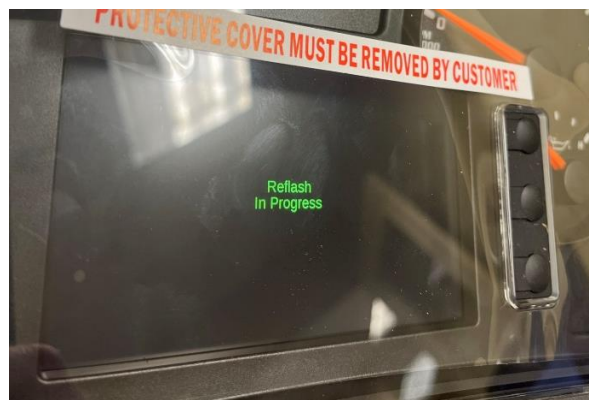
Figure 1

- This cluster flash is unique from any other update Blue Bird Field Service has published. The calibration process will transpire as follows:
 - Once flash is started, the status bar on the AmeFlash tool will progress from 0-100%, left to right. During this process, the cluster will display “REFLASH IN PROGRESS”. See Figure 1.
 - Once that completes, the cluster display will be black and will not auto-initialize.
 - The red low air visual indicators SHOULD begin to flash rapidly. See Figure 2.
 - If they do not, remove the cluster battery fuse within the PDU, count to 3, and re-install it. The low air warning LED’s should begin to flash rapidly for ~30 seconds. After which the cluster will re-start and the bus can be restored to service.
