December 18, 2024

## Safety Recall: 2018–23 Odyssey Install FAKRA Service Cables at MOST Bus Network

Supersedes 23-046, dated July 21, 2023, to the revise the information highlighted in **yellow**.

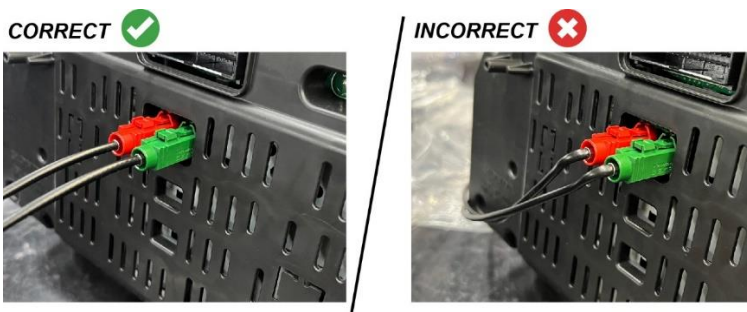
NOTE: Make sure the FAKRA splice repair service cables are not bent at connector(s) as shown below.

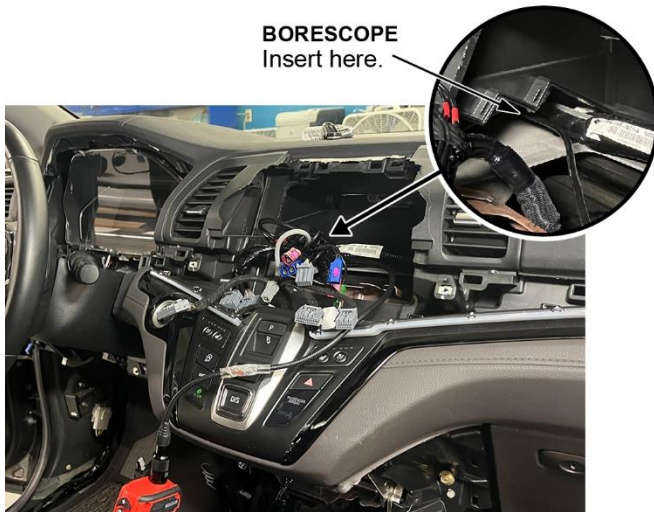
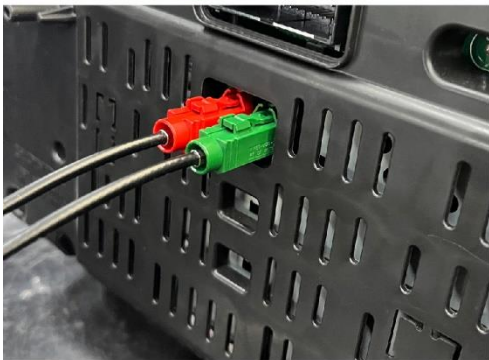
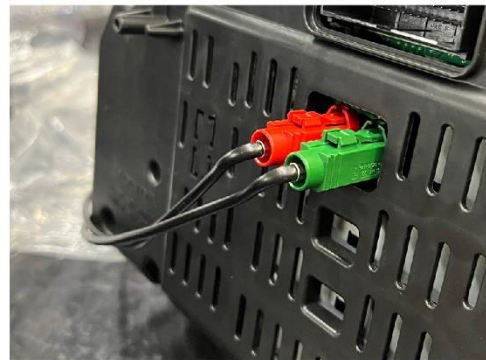
NOTE: Make sure the FAKRA splice repair service cables are not bent at the connector(s) as shown below:

**CORRECT** ✓

**INCORRECT** ✗

- Using the digital borescope (T/N BK5600DUAL55) or a commercially available borescope with multiple view angles, inspect the cable routing at the back of the gauge control module as shown below to make sure the cables are routed straight and not bent at the connector(s). Adjust gauge control module harness as needed to achieve proper cable routing.

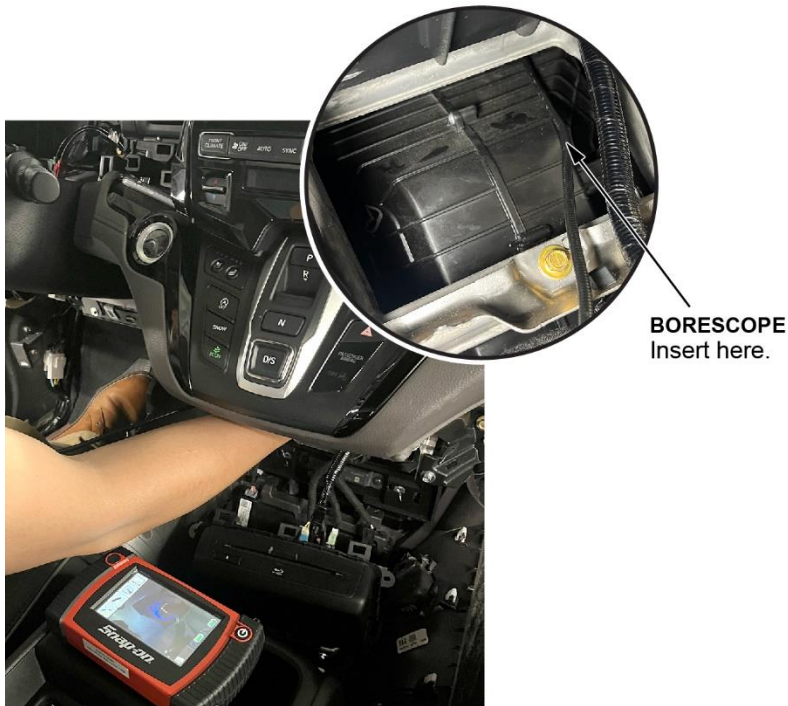
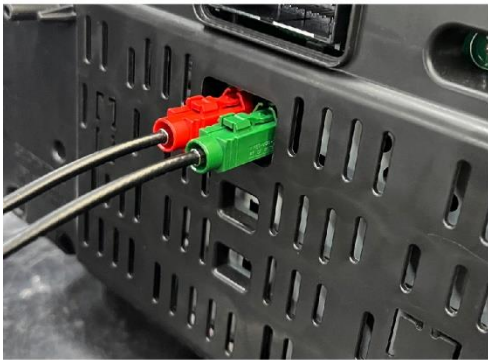
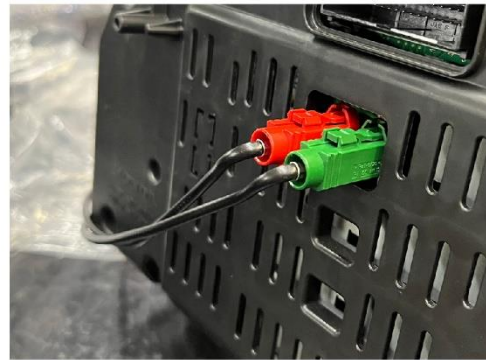
NOTE: Make sure the FAKRA splice repair service cables are not bent at the connector(s) as shown below.

**CORRECT** ✓

**INCORRECT** ✗

- Using the digital borescope (T/N BK5600DUAL55) or a commercially available borescope with multiple view angles, inspect the cable routing at the back of the gauge control module as shown below to make sure the cables are routed straight and not bent at the connector(s). Adjust infotainment control unit harness as needed to achieve proper cable routing.
