Safety Recall 23V-455

Claim Preparation & Repair Instructions

GREASE ZERK INSPECTION/CORRECTION PROCEDURE

Recall Number:	23E-046		
Product:	Grease Zerks		
Date:	July 10, 2023	Labor Rate:	Inspection - 0.3 hours per axle
			Repair - 0.3 hours per axle

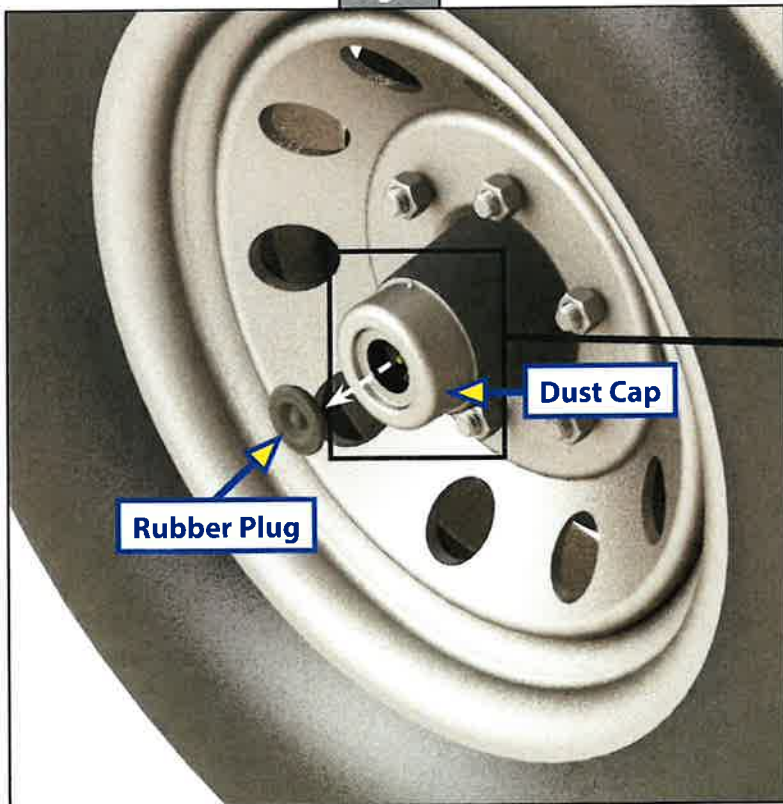
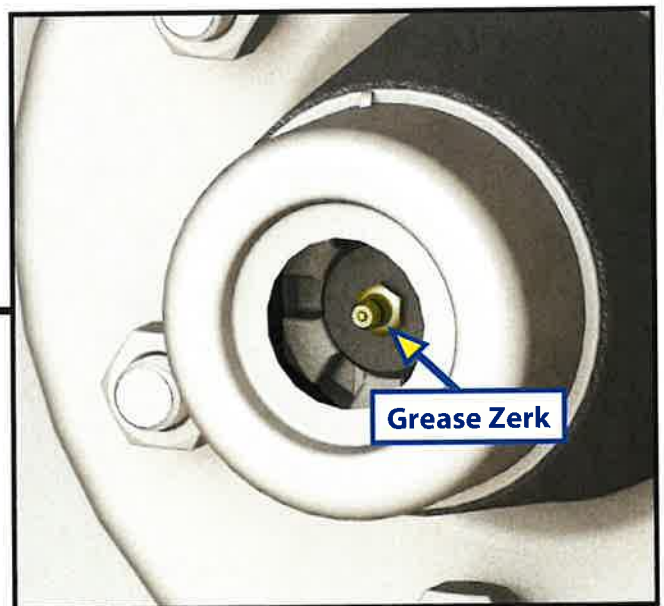
Fig. 1

This document provides instructions for completion of Lippert Recall 23E-046 on specific 5,200 lb and 6,000 lb CURT axles installed on Grand Design Recreational Vehicles which may not have had the grease zerks properly tightened during the assembly process. These instructions will explain how the grease zerks are to be inspected and, if necessary, corrected or replaced. The Lippert production dates are Feb. 7, 2023, to May 17, 2023.

1. Use a flat screwdriver to remove the rubber plug from the dust cap (Fig. 1).
2. Inspect the grease zerk located behind the dust cap (Fig. 1).
 - A. Make sure the grease zerk is installed straight and no more than one thread is showing at the base of the zerk.
 - B. If more than one thread is showing or there is a gap in front, tighten the zerk to 90 to 100 in-lbs.
 - C. If the zerk is damaged, replace it.
3. Replace rubber plug on dust cap.
