SAFETY RECALL

FRONT AXLE U-BOLT TORQUE

RECALL NO: AAUW0

REFERENCE: RCB-003-23

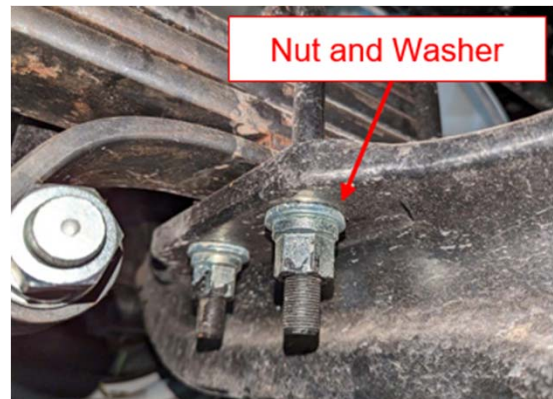
1. Inspect the condition of all eight front axle U-bolt nuts and washers. Determine if any of these can be rotated by hand. If any of these are found to be hand loose, take pictures and contact Tech Assist for further direction. Do not retighten.

If no fasteners are found loose, proceed to step 2.
