TO: Mercedes-Benz Dealer Principals, General Managers, Sales Managers, Service Managers, Parts Managers	FROM: Gregory Gunther, Senior Manager, Vehicle Compliance and Analysis, Engineering Services
RE: Recall Campaign Launch Notification Inspect Transmission Wiring Harness Routing MY22-23 C-Class (206 platform)	DATE: August 4, 2023

Campaign No. 2023070015, August 2023
Revision B 10/13/2023

SUBJECT: **Model C-Class (206 platform)**
Model Year 2022-2023

Inspect Transmission Wiring Harness Routing

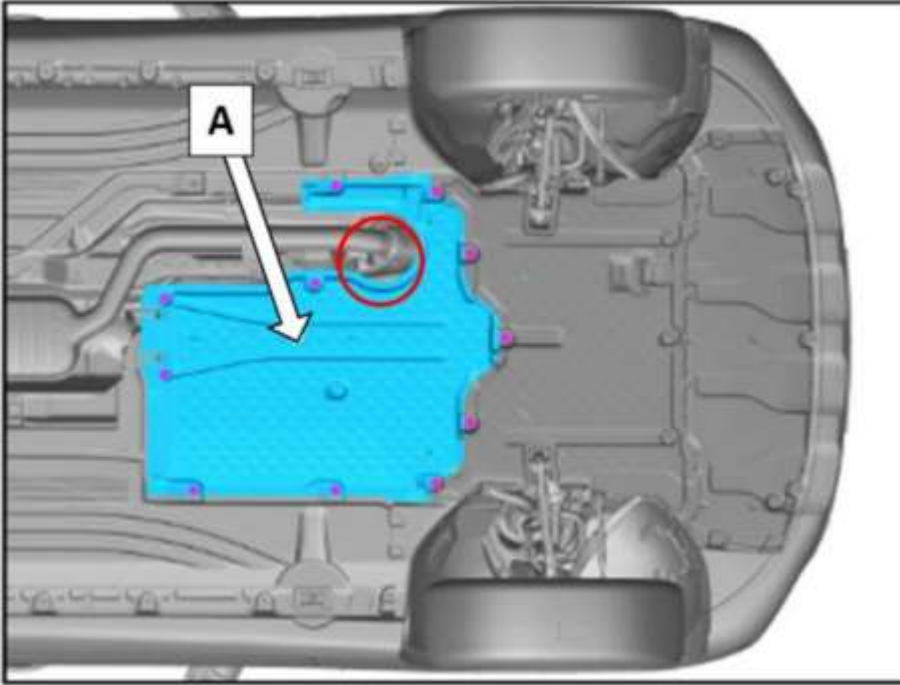
Figure 1

1. Remove rear engine compartment lining (A, Figure 1).

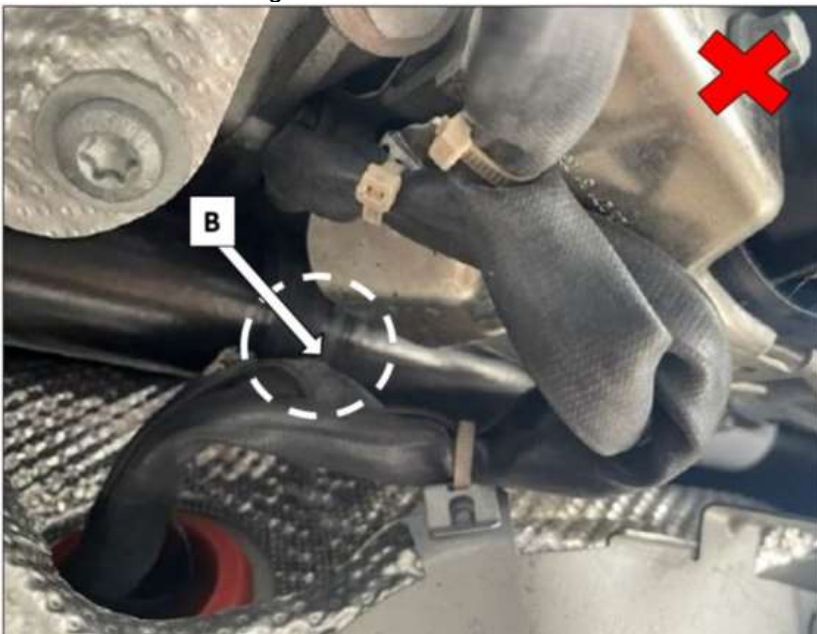
Figure 2, condition not OK

2. Check routing and clearance (B, Figure 2) between the electrical wiring harnesses and the transmission tunnel/drive shaft, and the transfer case for the front axle differential.

i The electrical wiring harnesses **must not** contact the drive shaft or the transfer case for the front axle differential!

- a. If the electrical wiring harness is in contact but **not damaged**:
Carry out **Work Procedure 1**.
- b. If the electrical wiring harness is in contact and **is damaged**:
Carry out **Work Procedure 2**.
- c. If the electrical **power supply line (3, Figure 3)**
(Cable cross section 10 mm²) is damaged:
Carry out **Work Procedure 3**.
- d. If the electrical wiring harness is **routed correctly**:
End measure.

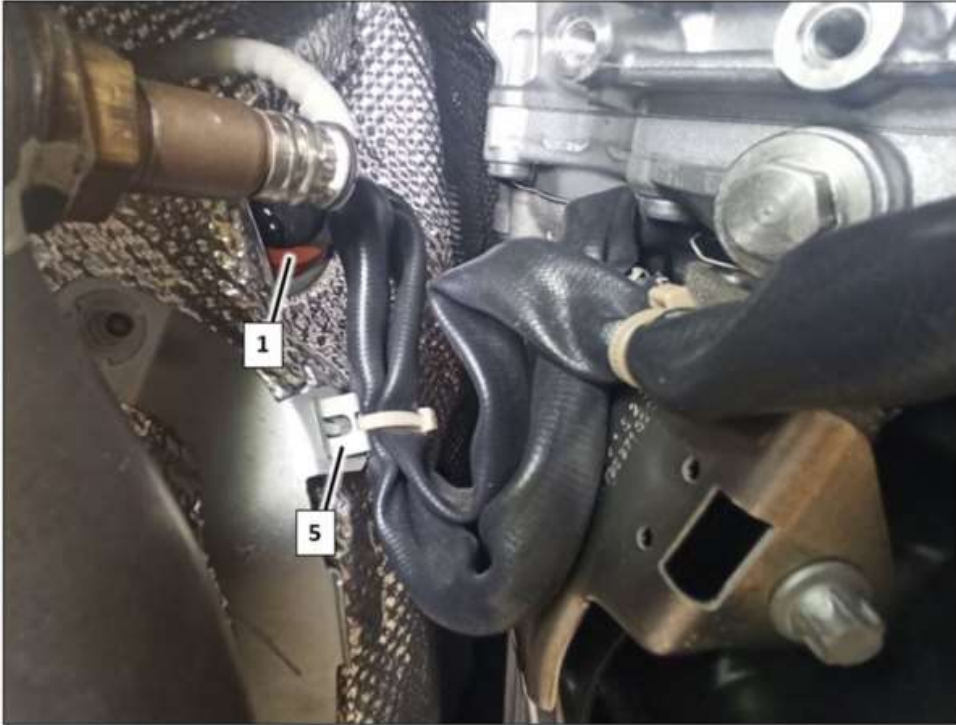
Figure 4

i The electrical wiring harness is in contact but **not damaged!**

1. Cut cable tie at first clip (5, Figure 4).

1. Adjust length of electrical wiring harnesses between red grommet (1, Figure 4) to first clip (5, Figure 4) as shown.
 - i** The length must be between **90 mm and max. 100 mm**. The electrical wiring harnesses **may not be** in contact!
2. Fasten both electrical wiring harnesses to the first clip with a new cable tie (5, Figure 4).
 - i** Check whether both electrical wiring harnesses are in contact at a different location. If so, carry out further corrective measures.
 - i** The electrical wiring harness may not be in contact at **any point!**
3. Assemble in reverse order.

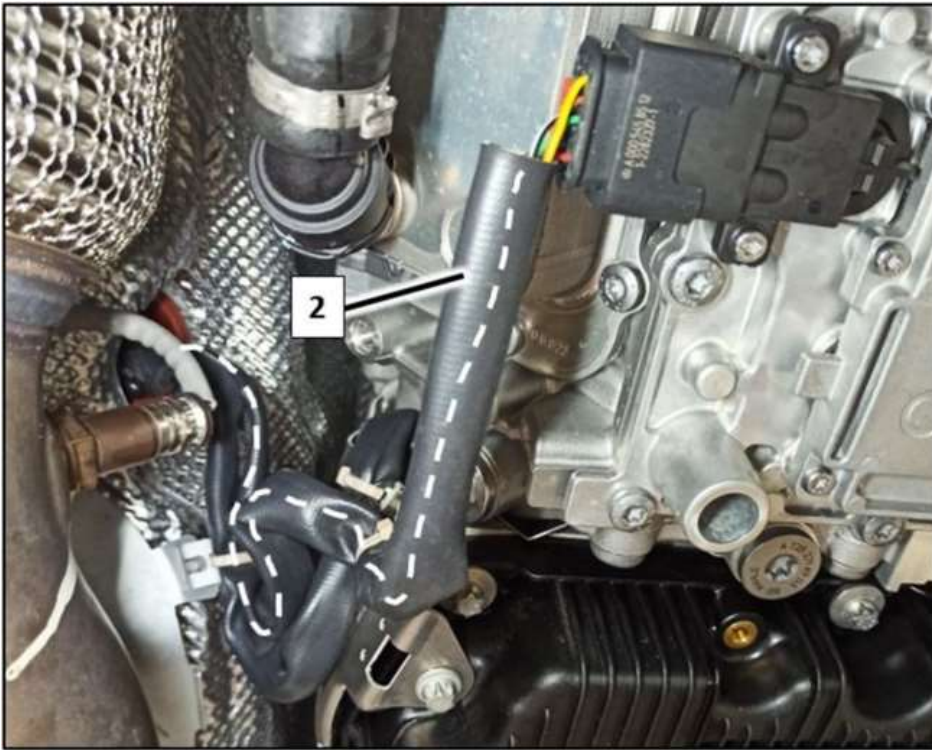
Figure 5

i If the electrical wiring harness is in contact and **is damaged**.

i **If only the protective hose is slightly damaged:**

i If one or more of the electrical signal lines (**cable cross section 0.35 mm² or 0.75 mm²**) in the electrical wiring harness (**2, Figure 5**) are damaged:

1. Wrap fabric tape around affected area.
2. Route the electrical wiring harness (2, Figure 5) correctly as shown.
 - i** The electrical wiring harness (2, Figure 5) may not be in contact at **any point!**

1. Repair the affected electrical signal line (**cable cross section 0.35 mm² or 0.75 mm²**) in the electrical wiring harness (**2, Figure 5**) using a line connector.

2. Route electrical wiring harness (**2, Figure 5**) correctly as shown.

i The electrical wiring harness (**2, Figure 5**) may not be in contact at **any point!**

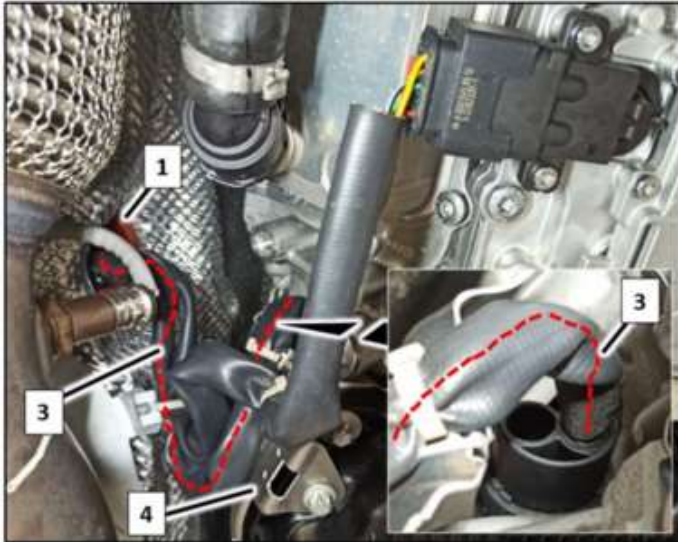
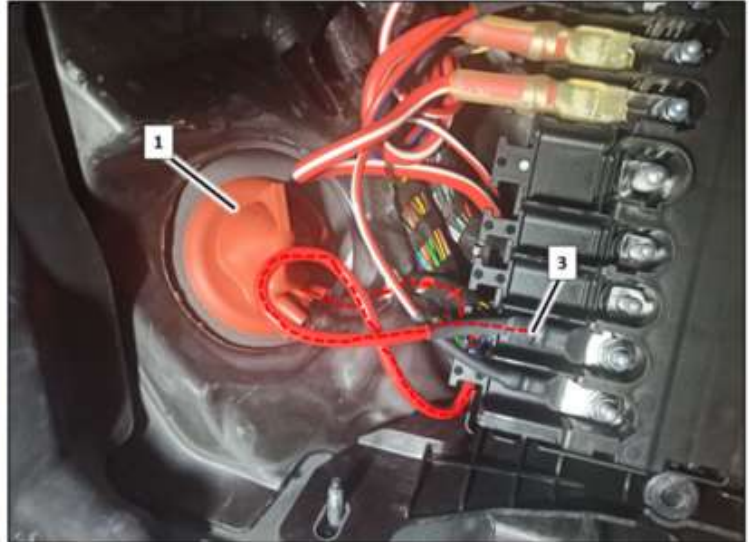
i If the electrical power supply line (3, Figures 6 and 7) (cable cross section 10 mm²) is damaged, replace electrical supply line (3, Figures 6 and 7):

1. Disconnect ground line of battery of 12 V on-board electrical system.
i For basic information, see AR54.10-P-0051WT.
2. Remove protective metal sheet (4, Figure 6).
3. Disconnect electrical power supply line (3, figure 6) from electrical connector.
4. Remove front floor covering on the passenger side.
i For basic information, see AR68.80-P-0008WT.
5. Remove electrical power supply line (3, Figures 6 and 7) with grommet (1, Figures 6 and 7).
6. Replace electrical power supply line (3, Figures 6 and 7).
i The electrical wiring harness may not be in contact at *any point!*
7. Assemble in reverse order.
