Recall Campaign Bulletin

Campaign No. 2023070017, August 2023

SUBJECT: **Model C-Class (206 platform)**
Model Year 2022-2023

Inspect 12V and 48V Ground Connections

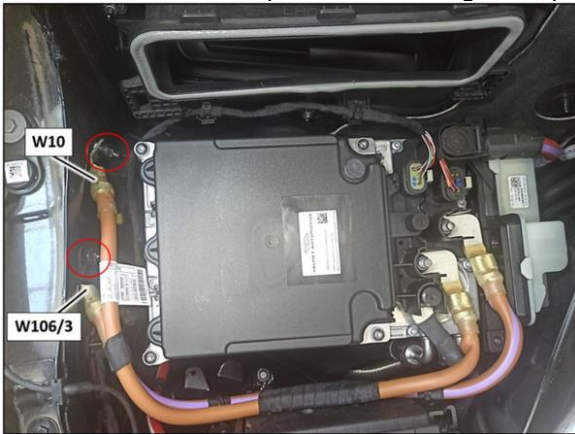
Figure 4, left-hand drive vehicle

2. Remove nut at respective affected ground point (W106/3, W10, Figure 4).

3. Remove respective affected cable lug from weld stud.
4. Check respective affected electric line, contact areas, and weld stud for damage.

- a. If there is **no** damage to the electric line, contact areas or weld stud: **Carry out Work Procedure 1.**
- b. If one or both electric line(s), contact areas or weld studs **are damaged**: **Carry out Work Procedure 2.**

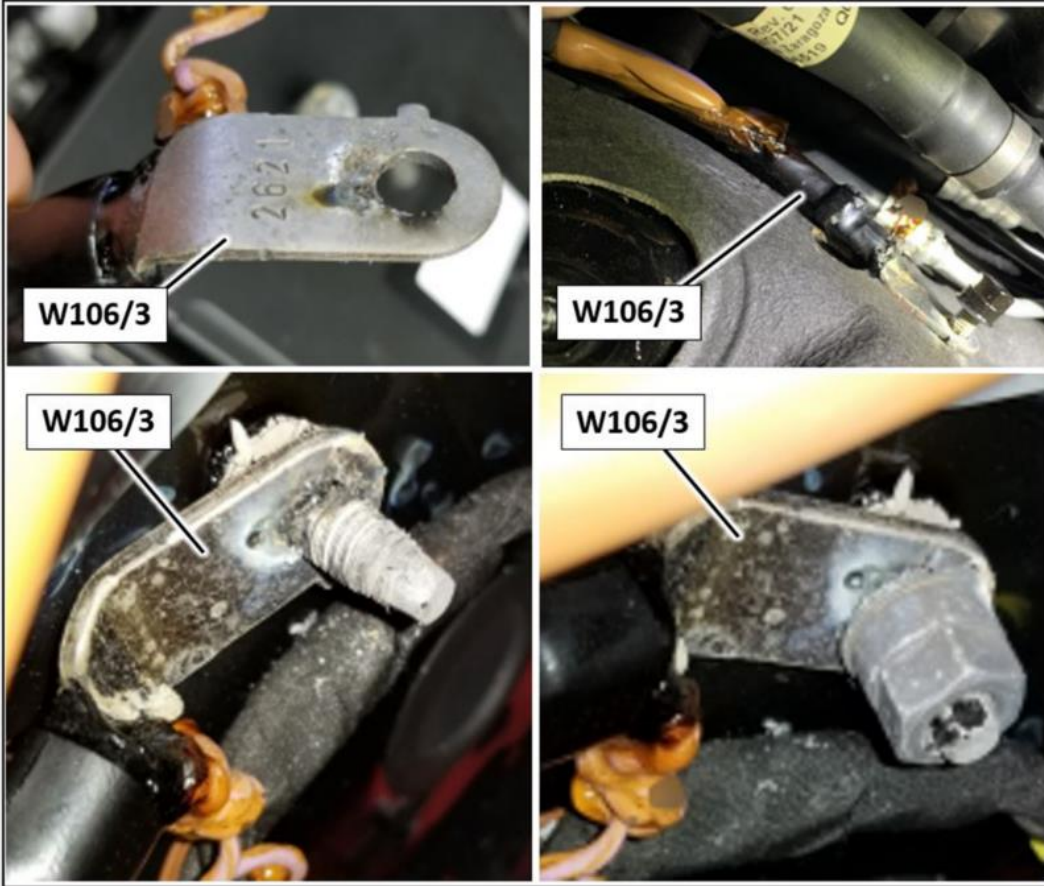
Figure 5, Example illustration of damage profiles for a 48 V battery ground point (W106/3)

i See examples of the damage profiles (Figures 5 and 6).

1. Remove battery of 48 V on-board electrical system.
i For basic information, see AR54.10-P-0022WT.
2. Replace damaged weld studs if necessary.
i For basic information, see AR60.00-P-0100A (The part number is listed in the WIS document).
3. Replace damaged electric line and nut if necessary and tighten with specified tightening torque.
 - 48 V battery ground point (W106/3) (see BA00.19-P-1039-01O) **16 Nm**
 - On-board electrical system battery ground point (W10) (see BA00.19-P-1012-01O) **16 Nm**
4. Assemble in reverse order.
5. Continue with **Test Procedure 3**.

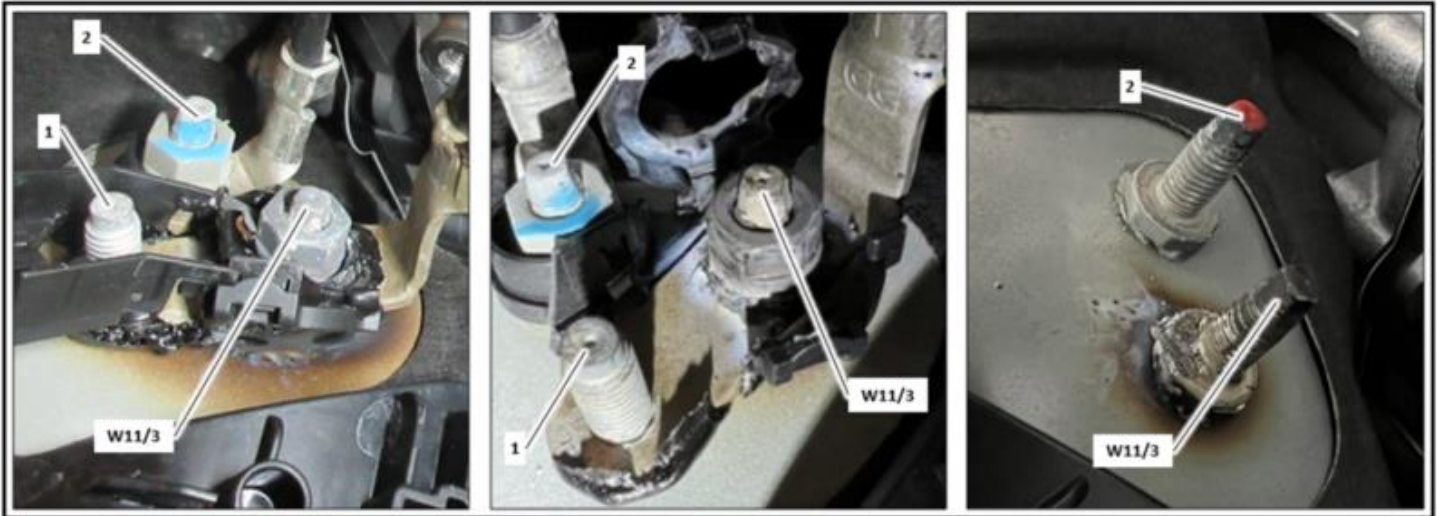
Figure 8, example illustration of damage profiles for ground point (1, 2, W11/3)

1. Remove respective affected nut from ground point (**1, 2 or W11/3, Figure 7**) and perform a visual check of the affected electric line, contact area, and weld stud.

i See examples of the damage profiles (**Figure 8**).

- a. If contact area, weld stud, and electric line are **not** damaged: Carry out **Work Procedure 3**.
- b. If contact area, weld stud, and/or electric line are **damaged**: Carry out **Work Procedure 4**.

i For basic information, see AR60.00-P-0100A (The part number of the weld stud can be found here).
2. Replace damaged electric line and nut if necessary and tighten with specified tightening torque.
 - Left combustion engine ground point (**W11/3, Figure 1**) **20 Nm**
 - Circuit 31 ground point with code B01 (**2, Figure 1**) **20 Nm**
 - Circuit 41 ground point, with engine 654 and with code B01 (**1, Figure 1**) **16 Nm**
3. Assemble in reverse order.
