Recall Campaign Bulletin

Campaign No. 2024070016, August 2024

SUBJECT: **Model C-Class (206 platform)**
Model Year 2022 – 2023

Inspect 12V and 48V Ground Connections

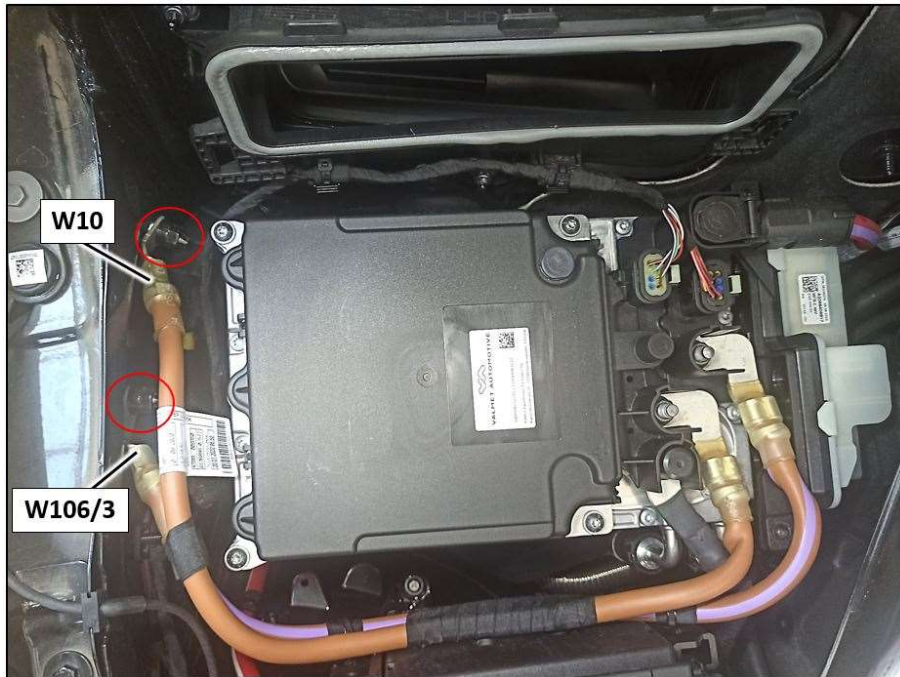
Figure 4

2. Remove nut at respective ground point (**Figure 4, W10 & W106/3**).

3. Remove respective affected cable lug from weld stud.
4. Check respective affected electric line, contact areas, and weld stud for **damage, such as arcing, scorch marks and/or melting**.

1. Replace respective nut and tighten with specified tightening torque.

Nm 48 V battery ground point (**W106/3**) (see BA00.19-P-1039-01O) = **16 Nm**

Nm On-board electrical system battery ground point (**W10**) (see BA00.19-P-1012-01O) = **16 Nm**

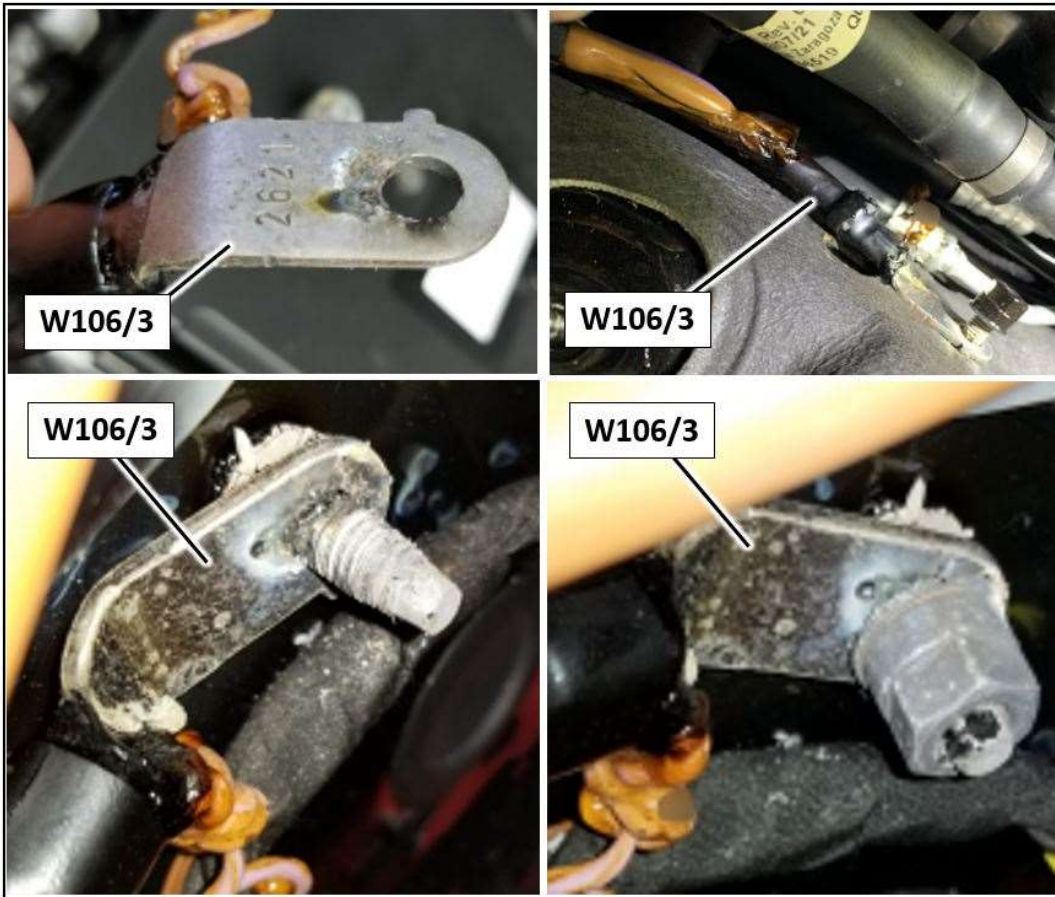
Figure 5, Examples of potential damage profiles of a 48 V battery ground point (W106/3)

i See examples of the damage profiles (**Figures 5 and 6**).

2. Replace damaged weld stud if necessary.

3. Replace damaged electric line and nut if necessary and tighten with specified tightening torque.

Nm 48 V battery ground point (**W106/3**) (see BA00.19-P-1039-01O) = **16 Nm**
