Recall Campaign Bulletin

Campaign No. 2023070017, August 2023
Revision A 11/06/2023

SUBJECT: **Model C-Class (206 platform)**
Model Year 2022-2023

Inspect 12V and 48V Ground Connections

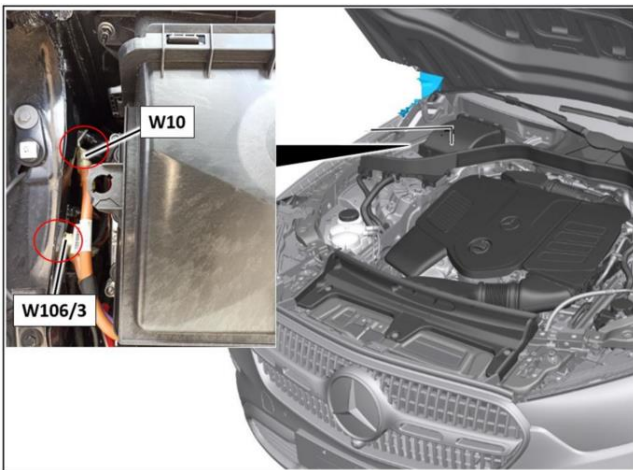
Figure 2, left-hand drive vehicle

3. Check threaded connections of ground points (**W106/3**, **W10**, **Figure 2**) for correct tightening torque.
 - 48 V battery ground point (W106/3) (see BA00.19-P-1039-01O) **16 Nm**
 - On-board electrical system battery ground point (W10) (see BA00.19-P-1012-01O) **16 Nm**

- a. If torque is **not correct**. Carry out **Test Procedure 2**.
- b. If torque is **correct**. Carry out **Test Procedure 3**.

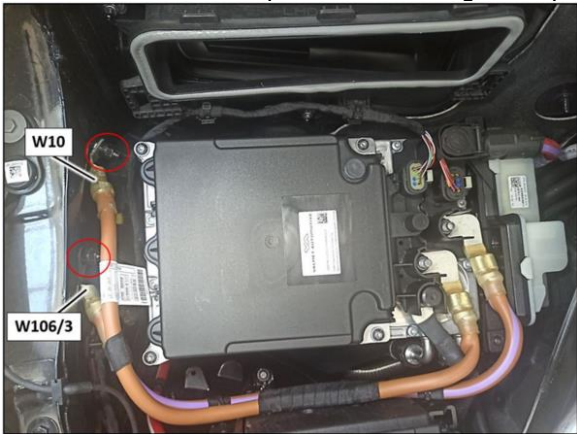
Figure 4, left-hand drive vehicle

3. Remove respective affected cable lug from weld stud.
4. Check respective affected electric line, contact areas, and weld stud for damage.

2. Remove nut at respective affected ground point (W106/3, W10, Figure 4).

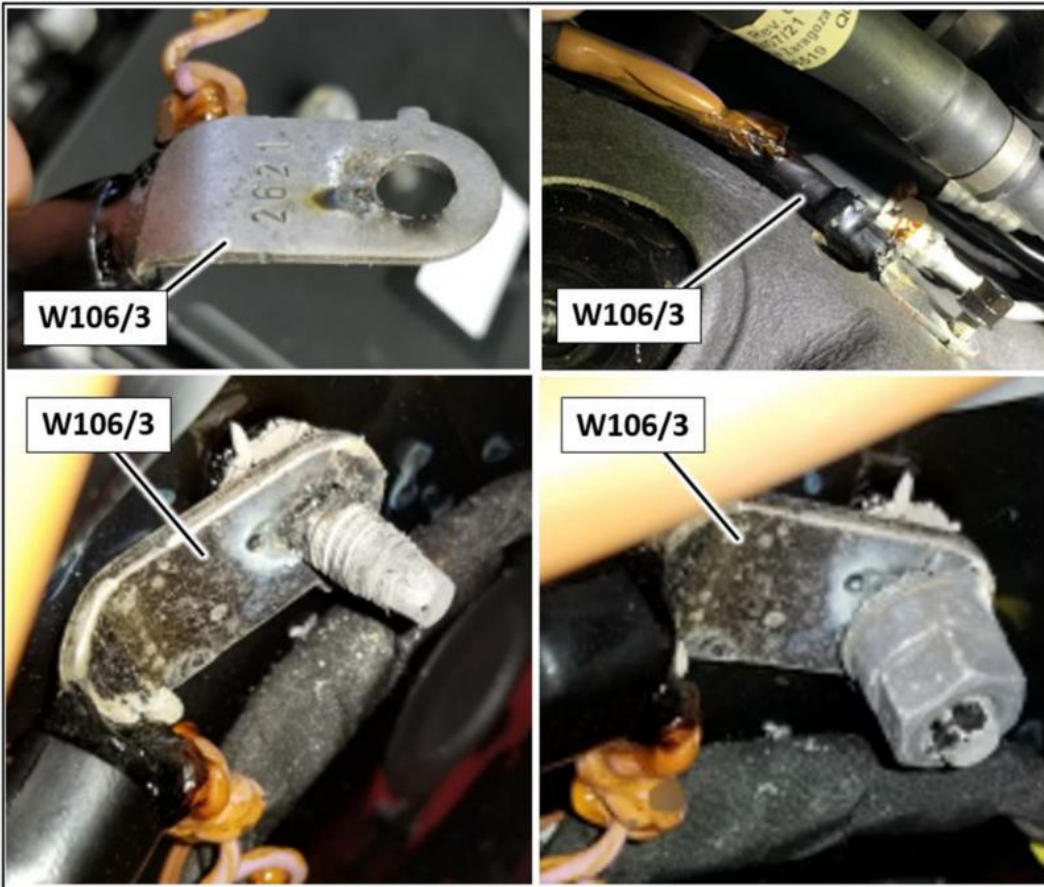
Figure 5, Example illustration of damage profiles for a 48 V battery ground point (W106/3)

i See examples of the damage profiles (Figures 5 and 6).

- a. If there is **no** damage to the electric line, contact areas or weld stud: **Carry out Work Procedure 1.**
- b. If one or both electric line(s), contact areas or weld studs **are damaged**: **Carry out Work Procedure 2.**

1. Replace respective nut and tighten with specified tightening torque.
 - 48 V battery ground point (W106/3) (see BA00.19-P-1039-01O) **16 Nm**
 - On-board electrical system battery ground point (W10) (see BA00.19-P-1012-01O) **16 Nm**
2. Assemble in reverse order.
3. Continue with **Test Procedure 3**.

1. Remove battery of 48 V on-board electrical system.
i For basic information, see AR54.10-P-0022WT.
2. Replace damaged weld studs if necessary.
i For basic information, see AR60.00-P-0100A (The part number is listed in the WIS document).
3. Replace damaged electric line and nut if necessary and tighten with specified tightening torque.
 - 48 V battery ground point (W106/3) (see BA00.19-P-1039-01O) **16 Nm**
 - On-board electrical system battery ground point (W10) (see BA00.19-P-1012-01O) **16 Nm**
4. Assemble in reverse order.
5. Continue with **Test Procedure 3**.

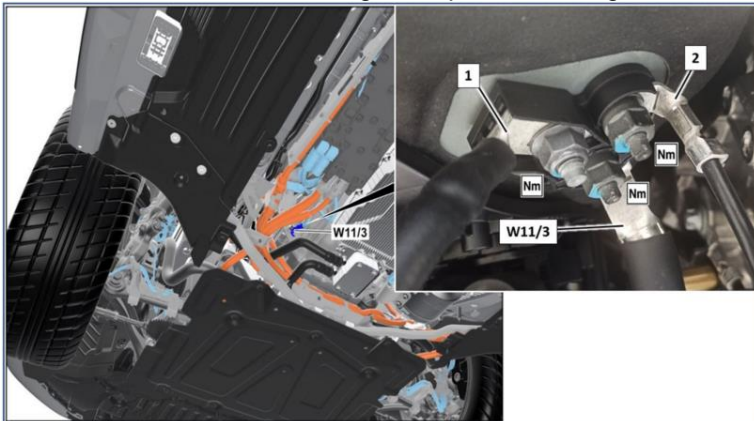
Figure 7

1. Remove rear engine compartment lining.
i For basic information, see AR61.20-P-1105WT.
2. Check threaded connections at ground points (**1, 2, W11/3, Figure 7**) for correct tightening torque.
 - Left combustion engine ground point (**W11/3, Figure 7**) **20 Nm**
 - Circuit 31 ground point with code B01 (**2, Figure 7**) **20 Nm**
 - Circuit 41 ground point, with engine 654 and with code B01 (**1, Figure 7**) **16 Nm**

- a. If the torque is **correct**: **End measure**.
- b. If the torque is **not** correct: Carry out **Test Procedure 4**.

1. Replace respective nut at ground point (**1, 2 or W11/3, Figure 7**) and tighten with specified tightening torque.
 - Left combustion engine ground point (**W11/3, Figure 7**) **20 Nm**
 - Circuit 31 ground point with code B01 (**2, Figure 7**) **20 Nm**
 - Circuit 41 ground point, with engine 654 and with code B01 (**1, Figure 7**) **16 Nm**
2. Assemble in reverse order.

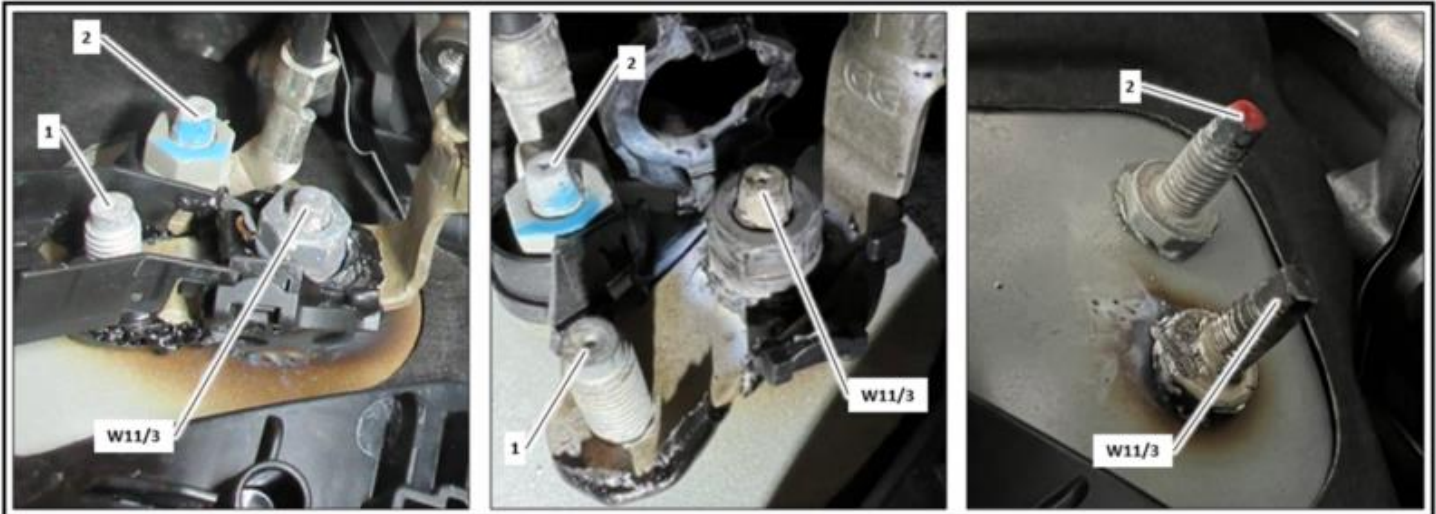
Figure 8, example illustration of damage profiles for ground point (1, 2, W11/3)

i See examples of the damage profiles (**Figure 8**).

- a. If contact area, weld stud, and electric line are **not** damaged: Carry out **Work Procedure 3**.
- b. If contact area, weld stud, and/or electric line are **damaged**: Carry out **Work Procedure 4**.

1. Replace damaged weld studs if necessary.

i For basic information, see AR60.00-P-0100A (The part number of the weld stud can be found here).
2. Replace damaged electric line and nut if necessary and tighten with specified tightening torque.
 - Left combustion engine ground point (**W11/3, Figure 1**) **20 Nm**
 - Circuit 31 ground point with code B01 (**2, Figure 1**) **20 Nm**
 - Circuit 41 ground point, with engine 654 and with code B01 (**1, Figure 1**) **16 Nm**
3. Assemble in reverse order.
