Recall Campaign Bulletin

Campaign No. 2023070016, August 2023

SUBJECT: **Model C-Class (206 platform)**
Model Year 2022-2023

Inspect 12V and 48V Ground Connections

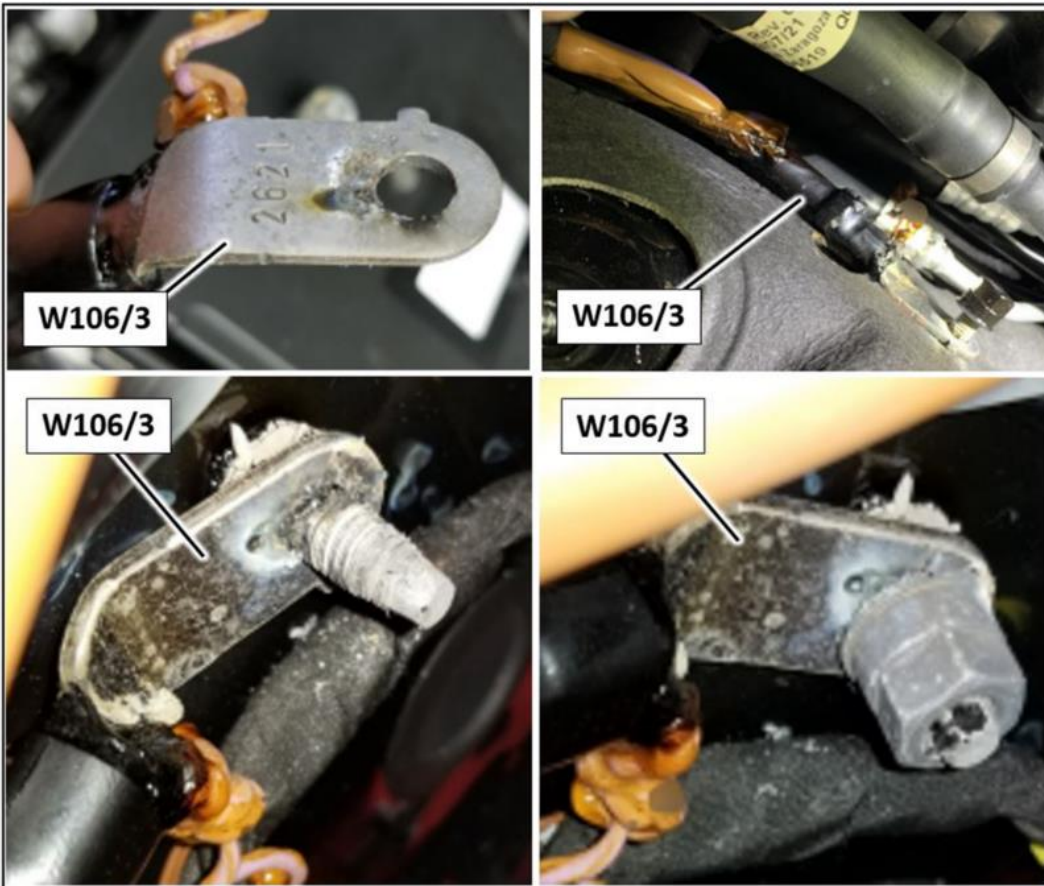
i For an examples of the damage profiles, (**Figures 5 and 6**).

Figure 5, Example illustration of damage profiles for a 48 V battery ground point (W106/3)

- a. **No** damage to the electric line, contact areas, and weld stud: Carry out **Work Procedure 1**.
- b. One or both electric line(s), contact areas, and weld stud **damaged**: Carry out **Work Procedure 2**.

1. Remove the battery of the 48 V on-board electrical system.
 - i** For basic information, see AR54.10-P-0022WT.
2. Replace damaged weld stud if necessary.
 - i** For basic information, see AR60.00-P-0100A (part number of weld stud can be found here).
3. If necessary, replace damaged electric line and nut and tighten to the specified tightening torque.
 - Ground point of 48 V battery (W106/3) (see BA00.19-P-1039-01O) **16 Nm**
 - Ground point of on-board electrical system battery (W10) (see BA00.19-P-1012-01O) **16 Nm**
4. Assemble in reverse order.

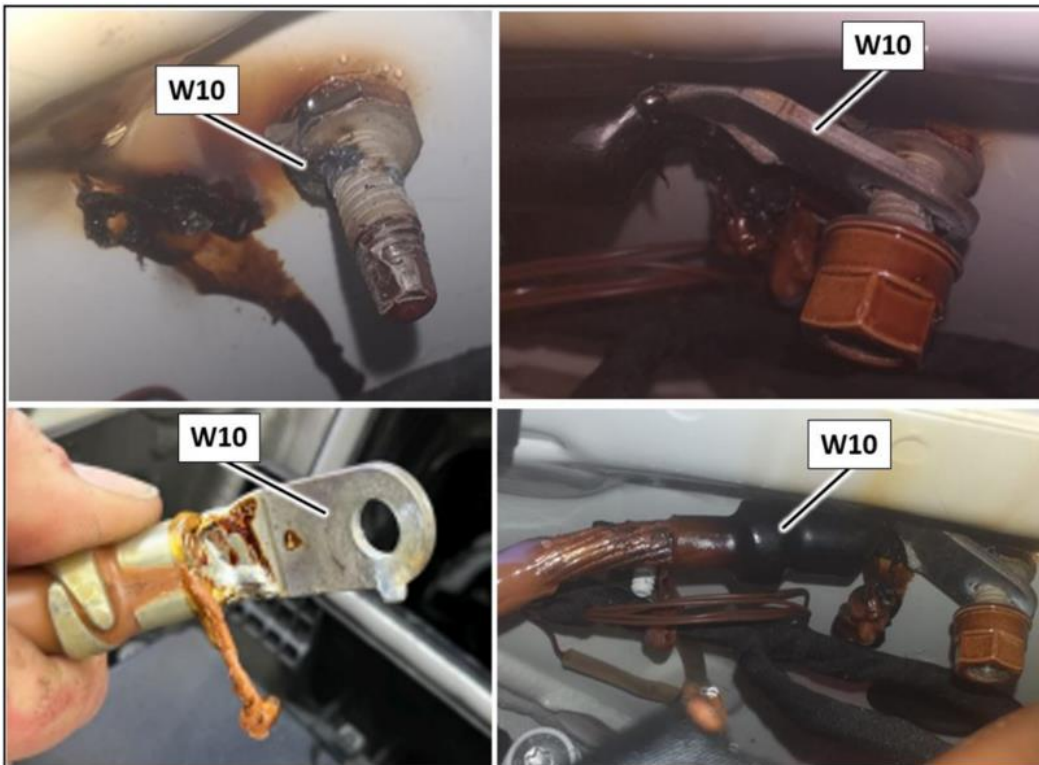
Figure 6, Example illustration of damage profiles for an on-board electrical system battery ground point (W10)
