Recall Campaign Bulletin

Campaign No. 2023070018, August 2023

SUBJECT: **Model C-Class (206 platform)**
Model Year 2022-2023

Inspect 12V and 48V Ground Connections

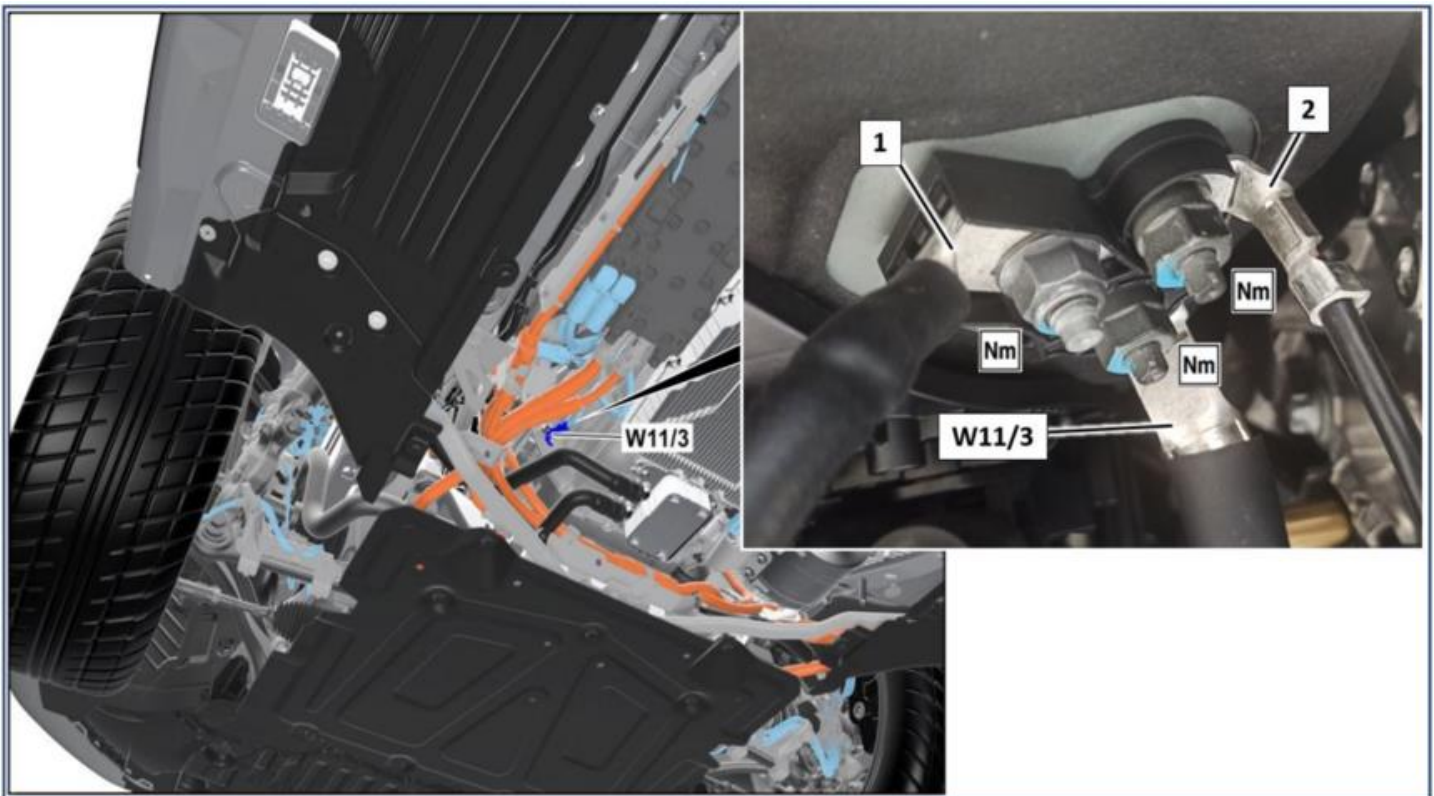
Figure 1

1. Remove rear engine compartment lining.
 - i** For basic information, see AR61.20-P-1105WT.
2. Check whether tightening torque of screw connections on ground points (1, 2, W11/3, Figure 1) is correct.
 - Ground point on left of combustion engine (W11/3, Figure 1) 20 Nm
 - Ground point of terminal 31, with code B01 (2, Figure 1) 20 Nm
 - Ground point of terminal 41, with engine 654 and with code B01 (1, Figure 1) 16 Nm

1. Replace respective nut at ground point (**1, 2, or W11/3, Figure 1**) and tighten to the specified tightening torque.
 - Ground point on left of combustion engine (**W11/3, Figure 1**) **20 Nm**
 - Ground point of terminal 31, with code B01 (**2, Figure 1**) **20 Nm**
 - Ground point of terminal 41, with engine 654 and with code B01 (**1, Figure 1**) **16 Nm**
2. Assemble in reverse order.

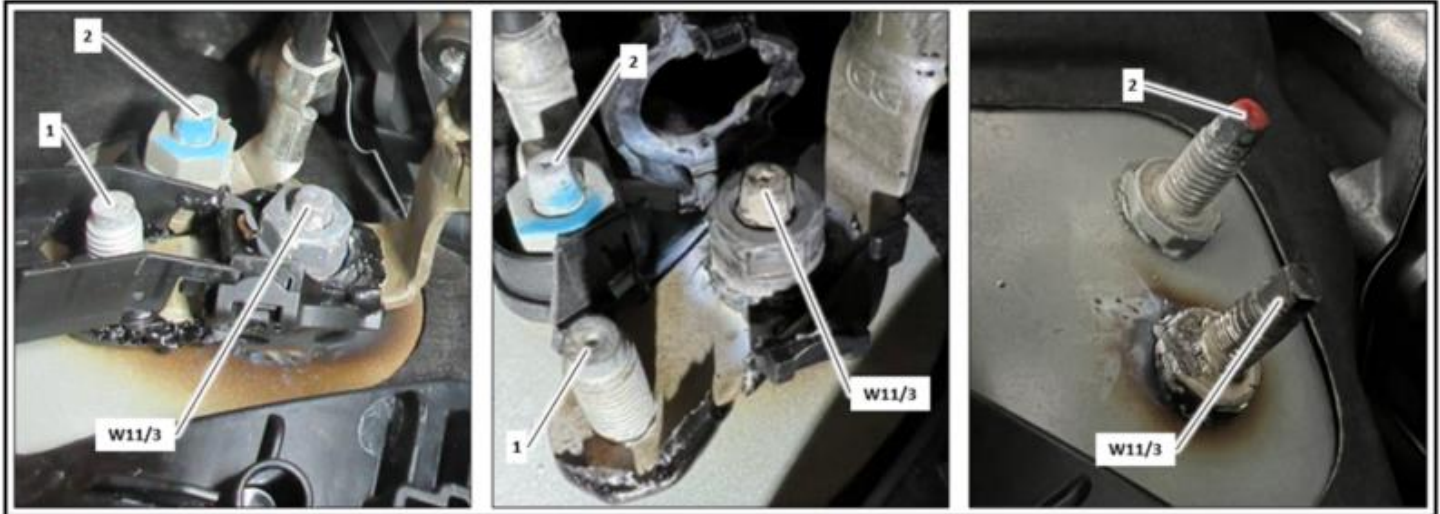
1. Remove respective affected nut at ground point (**1, 2, or W11/3, Figure 1**) and perform a visual check of the affected electric line, contact area, and weld stud.

Figure 2, examples of the types of damage to ground points (1, 2, W11/3)

1. Replace damaged weld stud if necessary.

2. If necessary, replace damaged electric line and nut and tighten to the specified tightening torque.
 - Ground point on left of combustion engine (**W11/3, Figure 1**) **20 Nm**
 - Ground point of terminal 31, with code B01 (**2, Figure 1**) **20 Nm**
 - Ground point of terminal 41, with engine 654 and with code B01 (**1, Figure 1**) **16 Nm**
3. Assemble in reverse order.
