Recall Campaign Bulletin

Campaign No. 2023070018, August 2023

SUBJECT: **Model C-Class (206 platform)**
Model Year 2022-2023

Inspect 12V and 48V Ground Connections

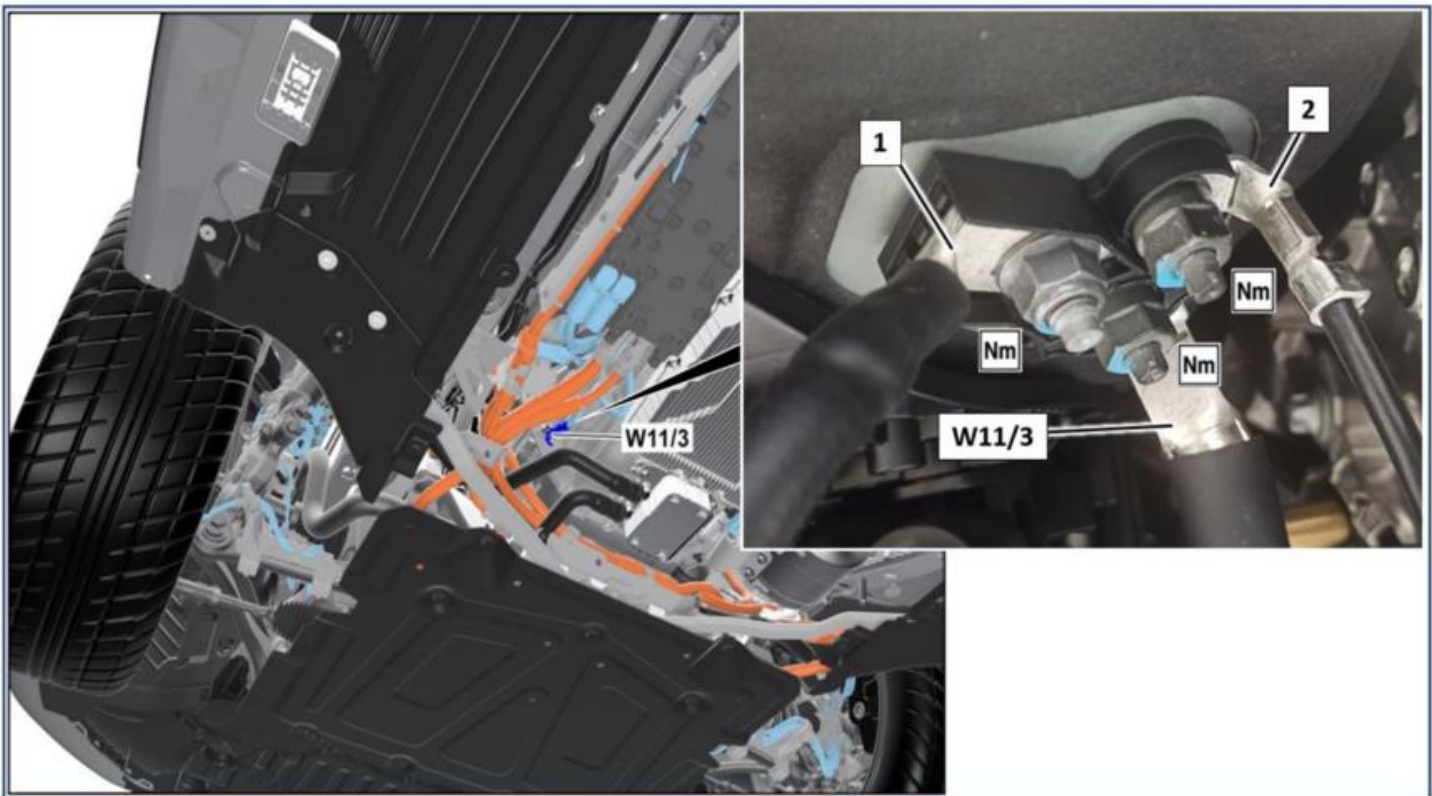
Figure 1

1. Remove rear engine compartment lining.
 - i** For basic information, see AR61.20-P-1105WT.
2. Check whether tightening torque of screw connections on ground points (1, 2, W11/3, Figure 1) is correct.
 - Ground point on left of combustion engine (W11/3, Figure 1) 20 Nm
 - Ground point of terminal 31, with code B01 (2, Figure 1) 20 Nm
 - Ground point of terminal 41, with engine 654 and with code B01 (1, Figure 1) 16 Nm

- a. Torque is **correct**. End measure.
- b. Torque is **not** correct: Carry out **check/Test Procedure 2**.

1. Replace respective nut at ground point (1, 2, or W11/3, Figure 1) and tighten to the specified tightening torque.
 - Ground point on left of combustion engine (W11/3, Figure 1) 20 Nm
 - Ground point of terminal 31, with code B01 (2, Figure 1) 20 Nm
 - Ground point of terminal 41, with engine 654 and with code B01 (1, Figure 1) 16 Nm
2. Assemble in reverse order.

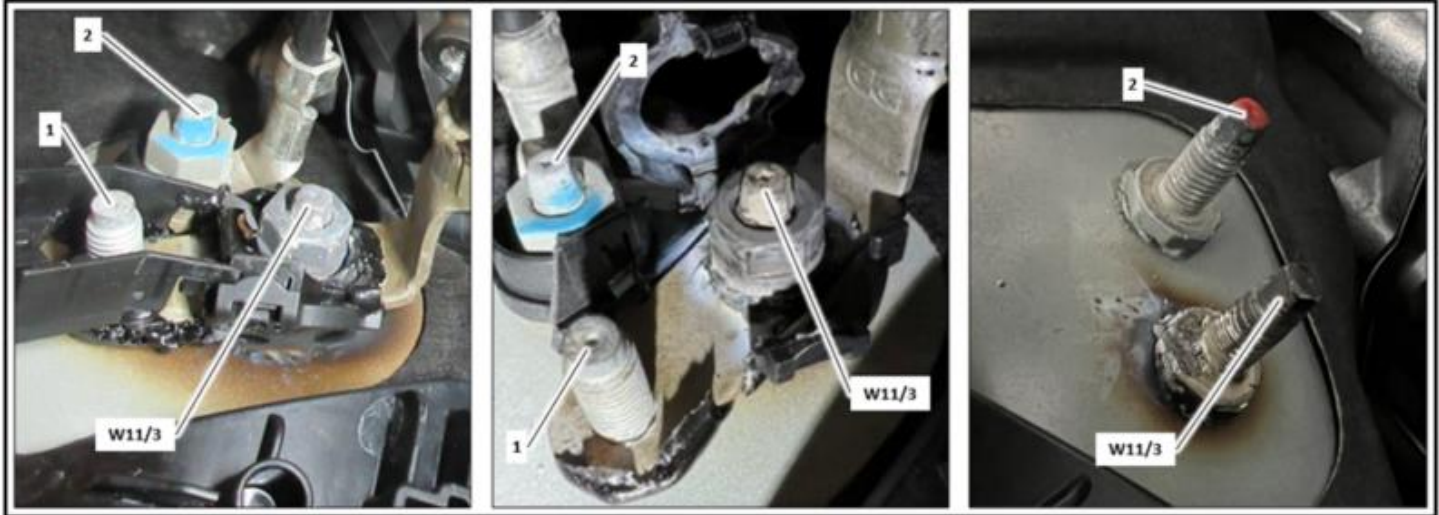
1. Remove respective affected nut at ground point (1, 2, or W11/3, Figure 1) and perform a visual check of the affected electric line, contact area, and weld stud.
 - i** See examples of the types of damage (Figure 2).
 - a. Contact area, weld stud, and electric line **not** damaged: Carry out **Work Procedure 1**.
 - b. Contact area, weld stud, and/or electric line **damaged**: Carry out **Work Procedure 2**.

Figure 2, examples of the types of damage to ground points (1, 2, W11/3)

1. Replace damaged weld stud if necessary.
 - i** For basic information, see AR60.00-P-0100A (part number of weld stud can be found here).
2. If necessary, replace damaged electric line and nut and tighten to the specified tightening torque.
 - Ground point on left of combustion engine (W11/3, Figure 1) 20 Nm
 - Ground point of terminal 31, with code B01 (2, Figure 1) 20 Nm
 - Ground point of terminal 41, with engine 654 and with code B01 (1, Figure 1) 16 Nm
3. Assemble in reverse order.
