# SAFETY RECALL

Communication #: T-23-03

Model Year(s): 2020-2023

## **SUBJECT: REVERSE CAMERA**

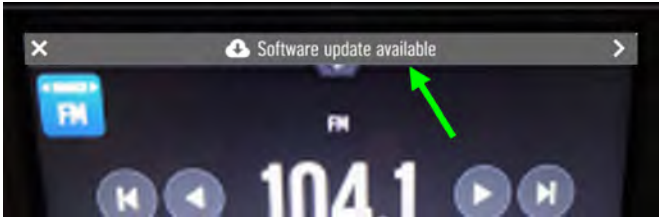
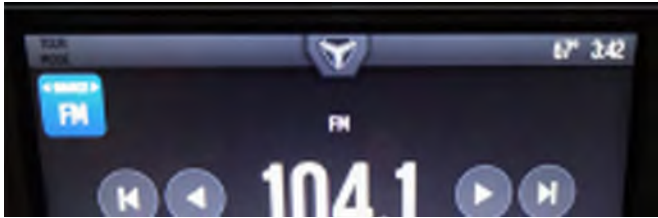
DOES THE FOLLOWING BANNER “SOFTWARE UPDATE AVAILABLE” APPEAR ON THE RIDE COMMAND SCREEN?	
<b>Yes.</b> The banner “Software update available” appears on screen. Over the Air Update required. <b>Proceed to page 7.</b>	<b>No.</b> The banner “Software update available” does not appear on screen. <b>Proceed to Step 2.</b>

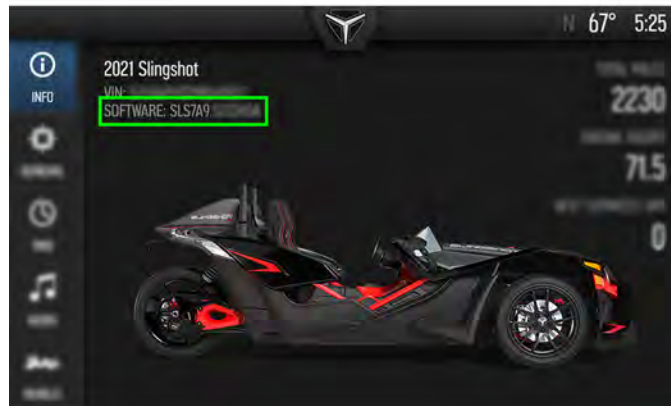
- On the display screen, press the Slingshot logo at the top of the screen.
- Press ALL SETTINGS.
- The software version is displayed below the VIN on the Info tab.

<b>STOP!</b>
Vehicles with software <b>SLS7AB.M32304A (APR 2023)</b> require an update.
