SAFETY RECALL

Communication #: T-23-03

Model Year(s): 2020-2023

SUBJECT: REVERSE CAMERA

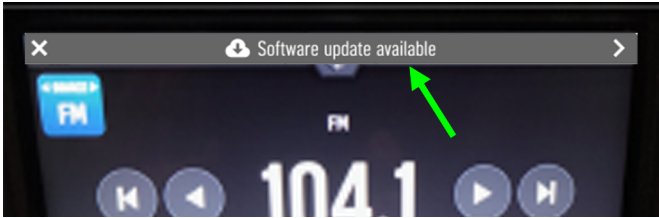
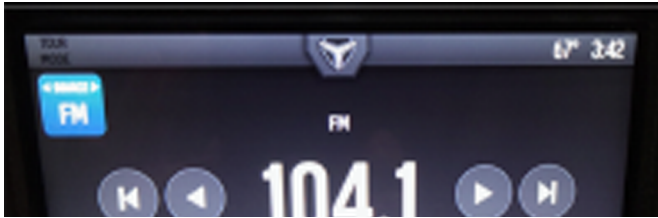
DOES THE FOLLOWING BANNER “SOFTWARE UPDATE AVAILABLE” APPEAR ON THE RIDE COMMAND SCREEN?	
Yes. The banner “Software update available” appears on screen. Over the Air Update required. Proceed to page 8.	No. The banner “Software update available” does not appear on screen. Proceed to Step 2.

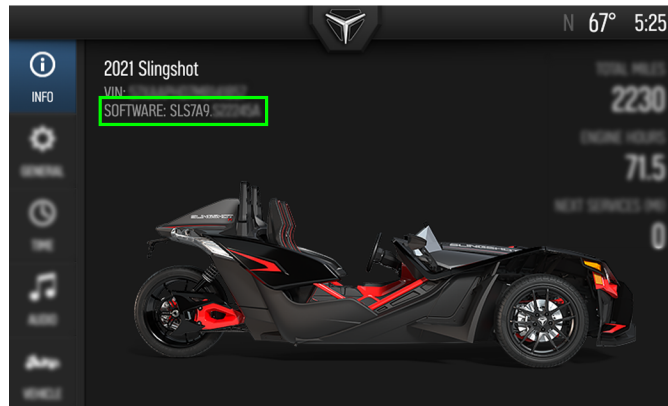
2. On the display screen, press the Slingshot logo at the top of the screen.
3. Press ALL SETTINGS.
4. The software version is displayed below the VIN on the Info tab.

STOP!
Vehicles with software SLS7AB.M32304A (APR 2023) require an update.
