TECHNICAL INSTRUCTIONS

SAFETY RECALL 23LA02

DRIVER AIRBAG MAY NOT DEPLOY

CERTAIN MODEL YEAR 2023-2024 NX AND 2023 RX

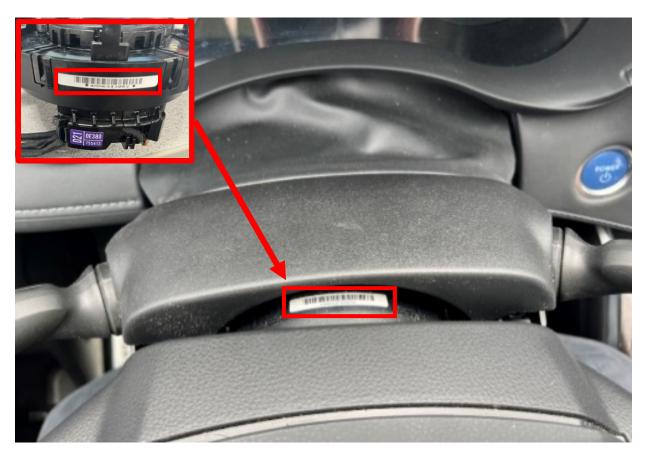
1. Remove upper steering column cover to access spiral cable serial number.

Follow steps 5 and 6 in the Repair Manual to remove the upper steering column cover. **DO NOT REMOVE THE LOWER STEERING COLUMN COVER TO ACCESS THE SERIAL NUMBER.**
