VOLUNTARY RECALL CAMPAIGN

Classification: EL23-017A	Reference: NTB23-057A	Date: August 1, 2023
------------------------------	--------------------------	-------------------------

VOLUNTARY SAFETY RECALL CAMPAIGN 2018-2023 LEAF; VCM REPROGRAM

CAMPAIGN ID #: R23A6
APPLIED VEHICLES: 2018-2023 LEAF (ZE1)

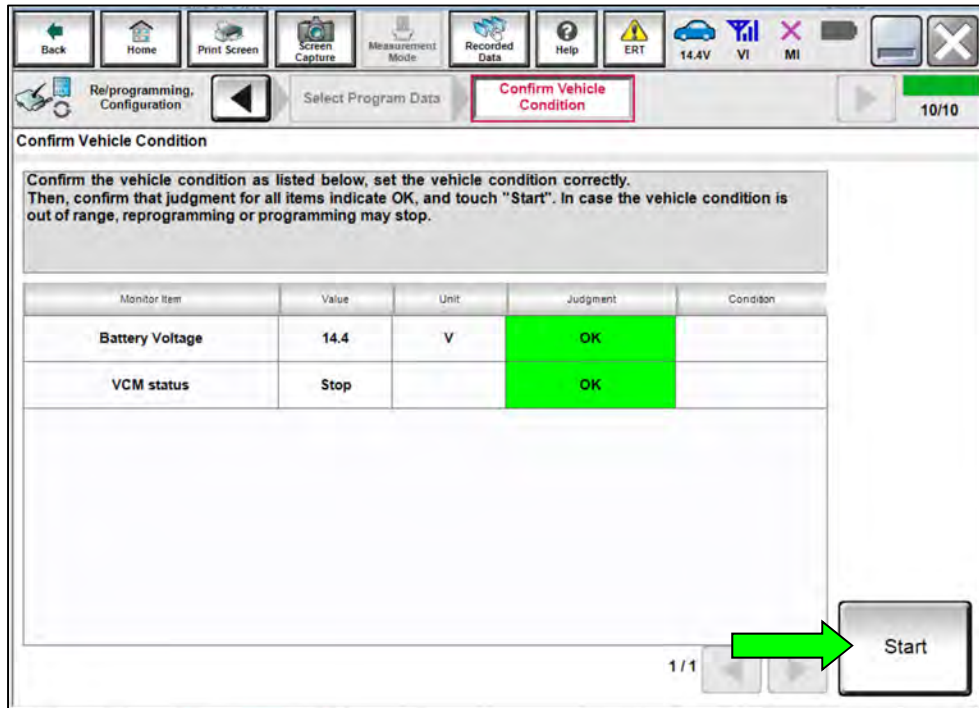
22. Confirm all items listed have a judgement of **OK**, and then select **Start**.
- The reprogramming process will take approximately 15 minutes.
 - If any of the items shown in Figure 15 display a status of NG, verify the battery maintainer/smart charger is turned ON and is securely connected to the 12V battery, and ensure the vehicle is NOT in Ready mode.

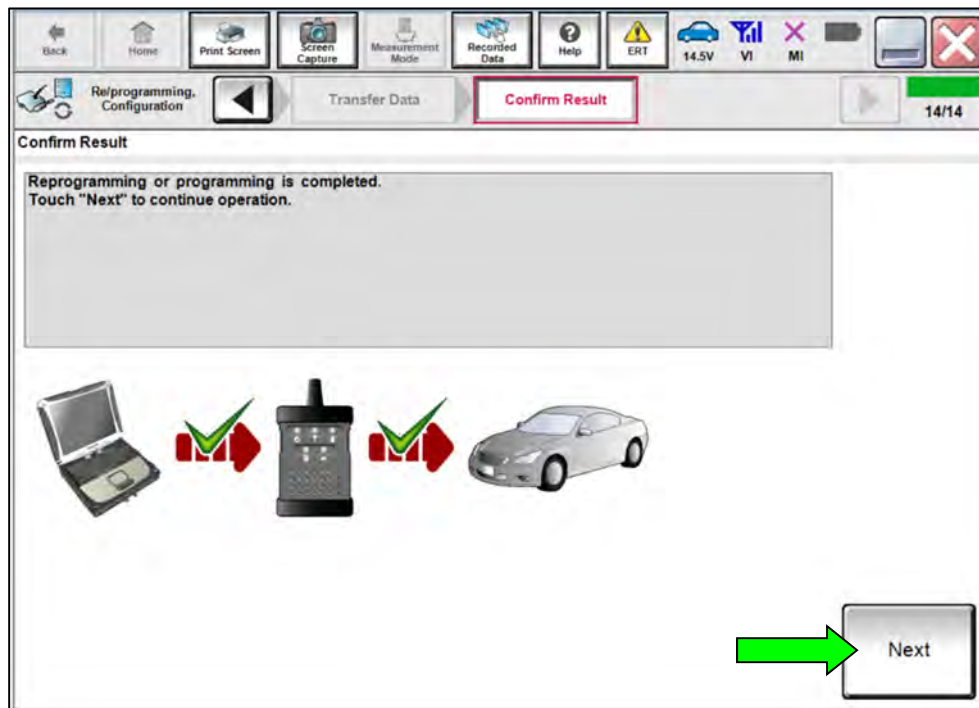
23. Once the screen in Figure 16 displays, the reprogramming is complete. Select **Next**.
- If the screen in Figure 16 does NOT display, indicating that reprogramming did not complete, refer to **VCM Recovery** on page 15.

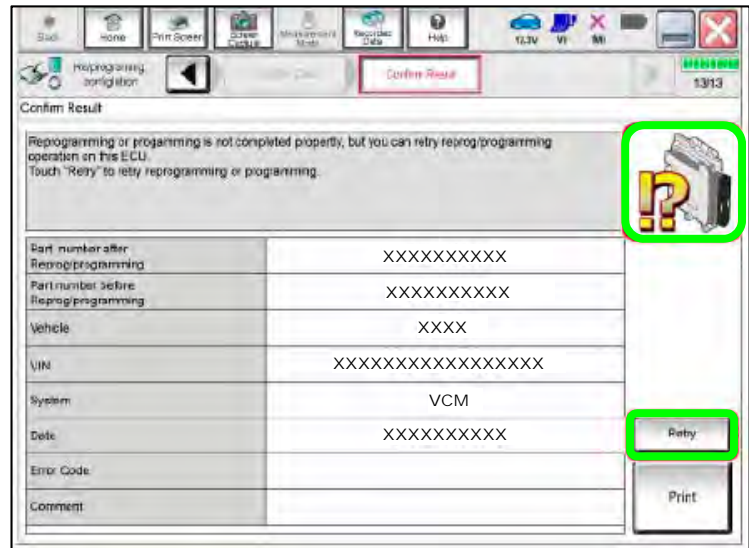
Figure 22

If reprogramming does not complete and the “!?” icon displays, as shown in Figure 22:

- Check battery voltage (12.0 V – 15.5 V).
- EV system is ON (Not Ready).
- External Bluetooth® devices are OFF.
- All electrical loads are OFF.
- Select **Retry** and follow the on screen instructions.
- Retry may not go through on first attempt and can be selected more than once.

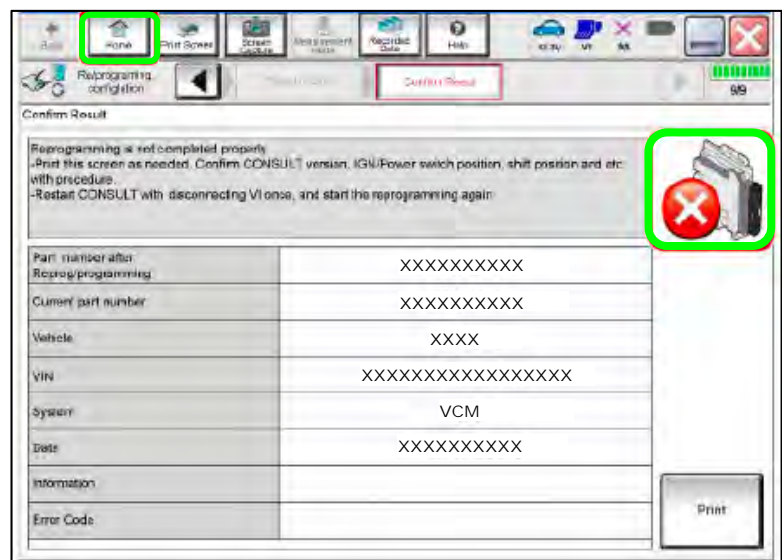
Figure 23

If reprogramming does not complete and the “X” icon displays, as shown in Figure 23:

- Check battery voltage (12.0 V – 15.5 V).
- CONSULT A/C adapter is plugged in.
- EV system is ON (Not Ready).
- Transmission is in Park.
- All C-III plus / VI cables are securely connected.
- All C-III plus updates are installed.
- Select **Home**, and restart the reprogram procedure from the beginning.
