SAFETY RELATED RECALL

Global Recall Action
Number: H445

Subject: Rear View Camera Image Display	Publication No.: H445
	Model: XE (X760)
	Model Year: 2019
	Date of Issue: 21 September 2023

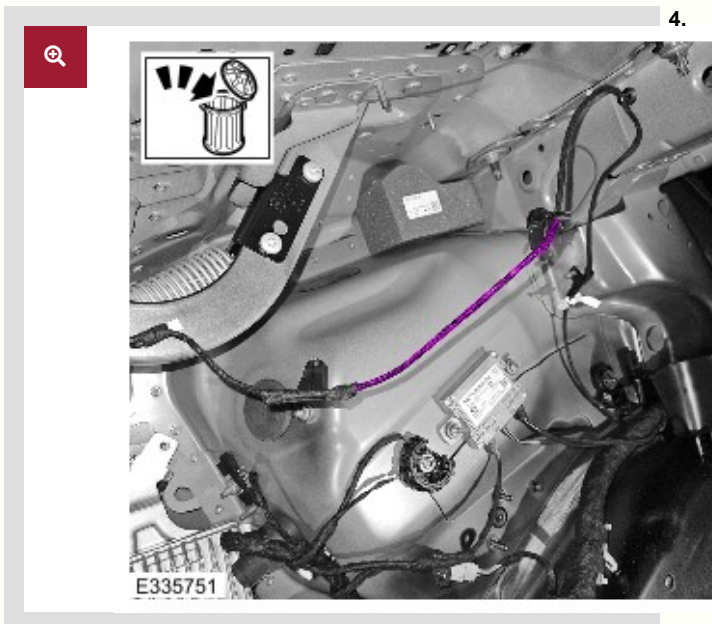
If the Touchscreen displayed a blue screen during step 1, the rear view camera wiring harness, located on the left tailgate hinge, may have become damaged.

The length of the harness between 2 fixing points in the trunk is insufficient leading to excessive force applied to the harness and subsequently progressive damage to the wires when the tailgate is open and closed.

- If the wiring harness has become damaged the repair must be claimed as part of the 'Related Damage Process'.
- If no damage to the wiring harness can be found, continue to diagnose possible rear view camera related concerns as part of a separate repair before continuing with this Service Instruction.

- Remove and discard the adhesive tape from the harness and locate the damaged wires.
- Repair any wires that have become damaged (see TOPIx Workshop Manual section 418-02: Wiring Harnesses - Description and Operation - Wiring Harness - Wiring Harness Repair).
