SAFETY RECALL

Date	Number	Release	Page
09.2023	SC0446	01	1(14)

Mack LR Passenger Seat Pedestal LR

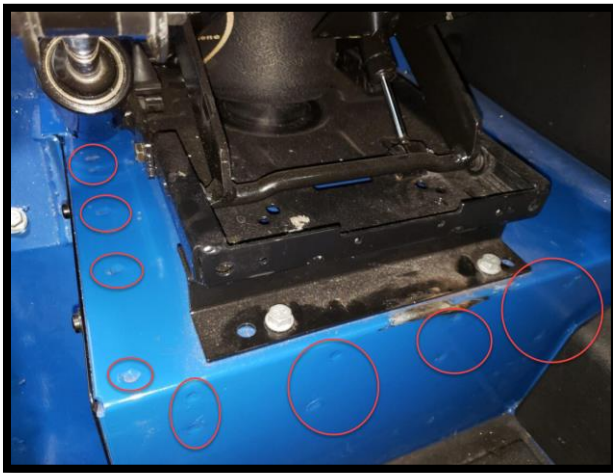
6. Inspect the passenger side seat pedestal for reinforcement welds. You should see indentations where the sheet metal has been spot welded together. (See image below)
 - a. If spot welds are visible, then no action is needed. (Continue to step 29)
 - b. If no spot welds are visible, then continue to step 7.
