HYUNDAI Technical Service Bulletin	GROUP RECALL	NUMBER 23-01-071H-3
	DATE OCTOBER 2023	MODEL(S) PALISADE (LX2) SONATA (DN8) TUCSON (NX4) ELANTRA (CN7) KONA (OS)
SUBJECT: ELECTRIC OIL PUMP CONTROLLER INSPECTION AND REPLACEMENT (RECALL 246)

This TSB supersedes TSB # 23-01-071H-2 to add Elantra (CN7) and Kona (OS).

This bulletin provides the procedure to check the ISG Electric Oil Pump (EOP) controller specification and replace it if necessary.

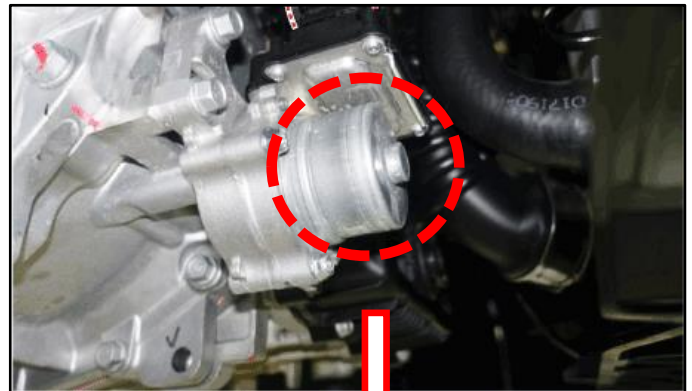
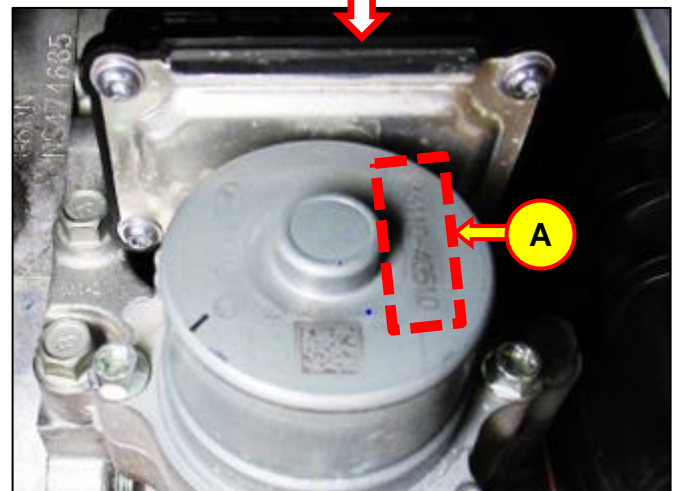
2. Check the EOP part number (A).

Use the part number on the part surface (A) as shown.

- If the part number is as follows, take a STUI picture as directed in step 3 below. Then reinstall the undercover and return the vehicle to the customer.
 - **46110-4G500**
 - **46110-4G510**
- If the part number is as follows, take a STUI picture as directed in step 3 below. Then continue to the Replacement Procedure to replace the EOP controller.
 - **46110-4G530**
