HYUNDAI
Technical Service Bulletin

GROUP RECALL	NUMBER 23-01-071H-1
DATE SEPTEMBER 2023	MODEL(S) PALISADE (LX2) SONATA (DN8) TUCSON (NX4)

SUBJECT: ELECTRIC OIL PUMP CONTROLLER INSPECTION AND REPLACEMENT (RECALL 246)

This TSB supersedes TSB # 23-01-071H to add Sonata (DN8) and Tucson (NX4).

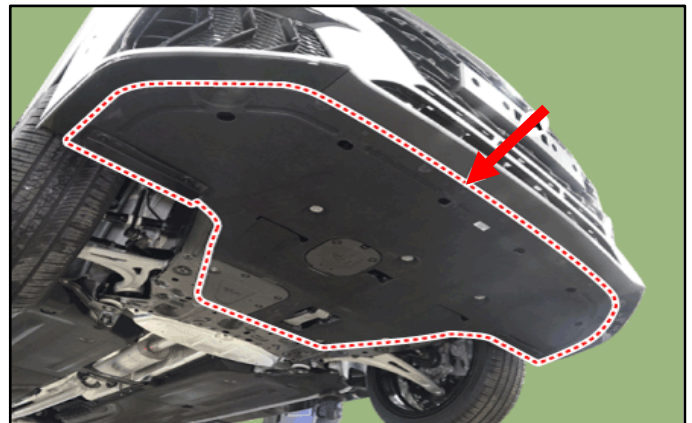
1. Record the preset radio stations.
Disconnect the negative (–) battery cable.
Lift the vehicle on a hoist and remove the undercover.

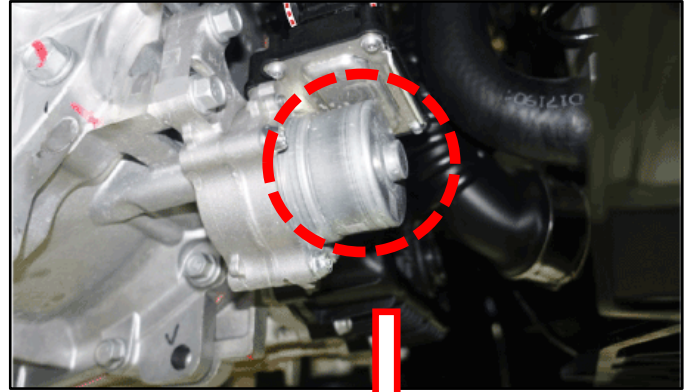
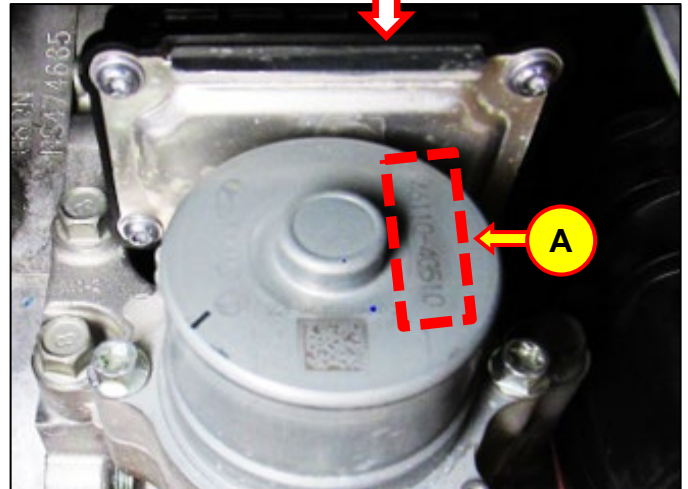
2. Check the EOP part number.

Use the part number on the part surface (A) as shown.

- If the part number is as follows, take a STUI picture as directed in step 3 below. Then reinstall the undercover and return the vehicle to the customer.
 - **46110-4G500**
 - **46110-4G510**
- If the part number is as follows, take a STUI picture as directed in step 3 below. Then continue to the Replacement Procedure to replace the EOP controller.
 - **46110-4G530**

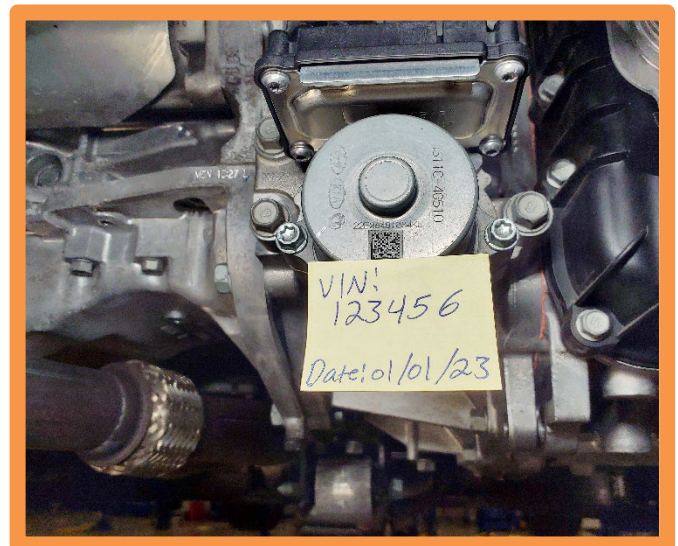
Using STUI, take a photo of the existing EOP with the part number visible, including the last 6 digits of the VIN and date of the inspection on a piece of paper.
