<b>HYUNDAI</b> <b>Technical Service Bulletin</b>	<b>GROUP</b> <b>RECALL</b>	<b>NUMBER</b> <b>24-01-015H</b>
	<b>DATE</b> <b>FEBRUARY 2024</b>	<b>MODEL(S)</b> <b>PALISADE (LX2)</b> <b>SONATA (DN8)</b> <b>TUCSON (NX4)</b> <b>ELANTRA (CN7)</b> <b>KONA (OS)</b>
<b>SUBJECT:</b> ELECTRIC OIL PUMP CONTROLLER INSPECTION AND REPLACEMENT (RECALL 246)

*This TSB supersedes TSB # 23-01-071H-3 to add a 'NOTICE' box on page 11, step 3 to remove the electric oil pump and housing as a single unit.*

**Description:** The transmission electric oil pump for the Idle Stop & Go System ("ISG") in certain vehicles listed below may have been assembled with printed circuit boards ("PCB") that were damaged during manufacturing by the oil pump controller supplier. A damaged capacitor on the pump controller PCB could impact electrical operation leading to heat damage to the electric oil pump circuit board, connector, and wiring harness. The heat damage at the pump increases the risk of a vehicle fire in addition to a potential Controller Area Network ("CAN") communication disruption for multiple onboard controllers.

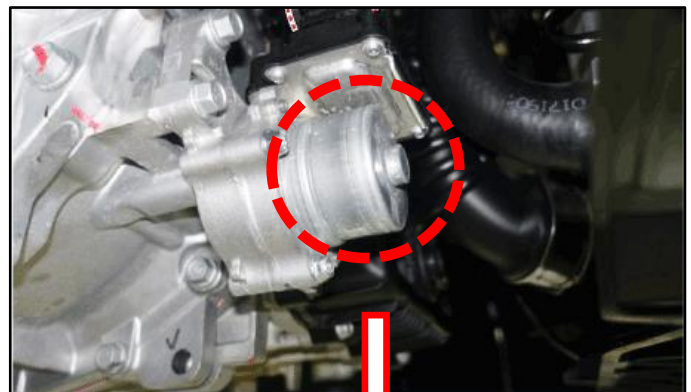
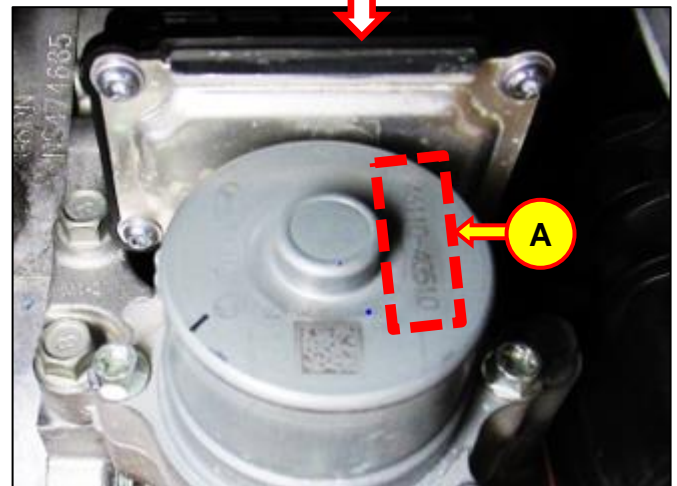
2. Check the EOP part number (A).

Use the part number on the part surface (A) as shown.

- If the part number is as follows, take a STUI picture as directed in step 3 below. Then reinstall the undercover and return the vehicle to the customer.
  - **46110-4G500**
  - **46110-4G510**
- If the part number is as follows, take a STUI picture as directed in step 3 below. Then continue to the Replacement Procedure to replace the EOP controller.
  - **46110-4G530**
