HYUNDAI
Technical Service Bulletin

GROUP RECALL	NUMBER 23-01-071H-2
DATE SEPTEMBER 2023	MODEL(S) PALISADE (LX2) SONATA (DN8) TUCSON (NX4)

SUBJECT: ELECTRIC OIL PUMP CONTROLLER INSPECTION AND REPLACEMENT (RECALL 246)

This TSB supersedes TSB # 23-01-071H-1 to add 2024MY for the Tucson (NX4) & revise the applicable production dates for the Palisade (LX2) & Tucson.

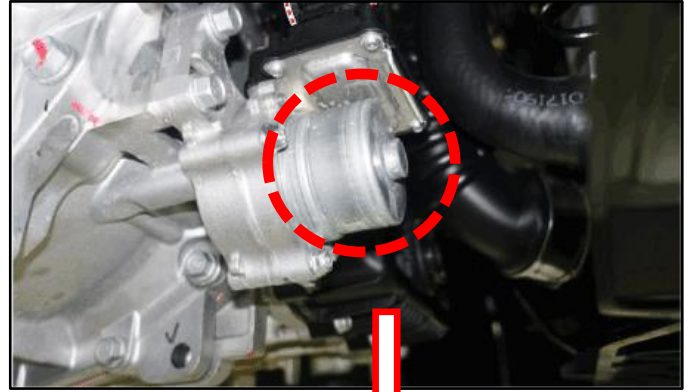
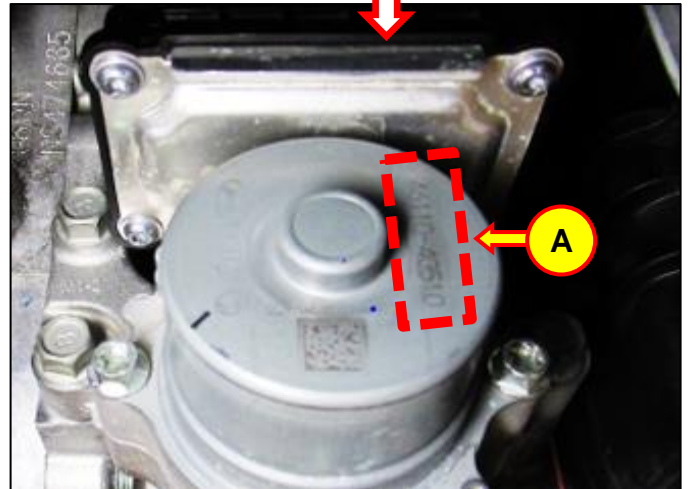
2. Check the EOP part number.

Use the part number on the part surface (A) as shown.

- If the part number is as follows, take a STUI picture as directed in step 3 below. Then reinstall the undercover and return the vehicle to the customer.
 - 46110-4G500
 - 46110-4G510
- If the part number is as follows, take a STUI picture as directed in step 3 below. Then continue to the Replacement Procedure to replace the EOP controller.
 - 46110-4G530

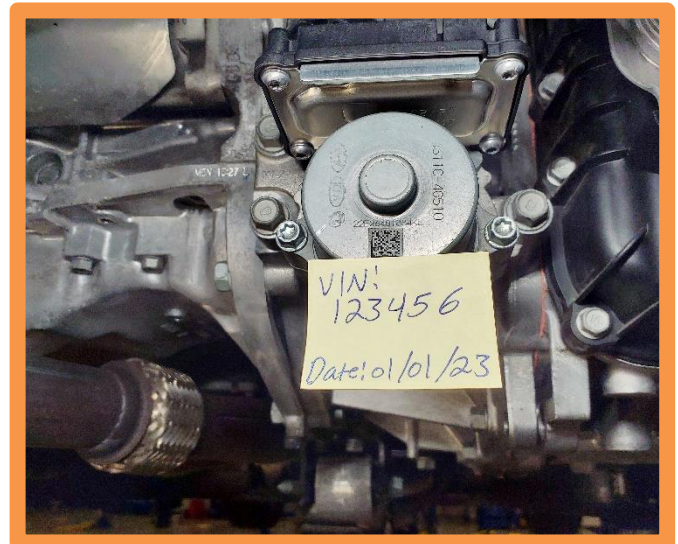
Using STUI, take a photo of the existing EOP with the part number visible, including the last 6 digits of the VIN and date of the inspection on a piece of paper.
