Recall Campaign Bulletin

Campaign No.2023080008, September 2023
Revision A 9/12/2023

SUBJECT: **Model S-Class (223 platform)**
Model Year 2022-2023

Inspect 12V Ground Connection

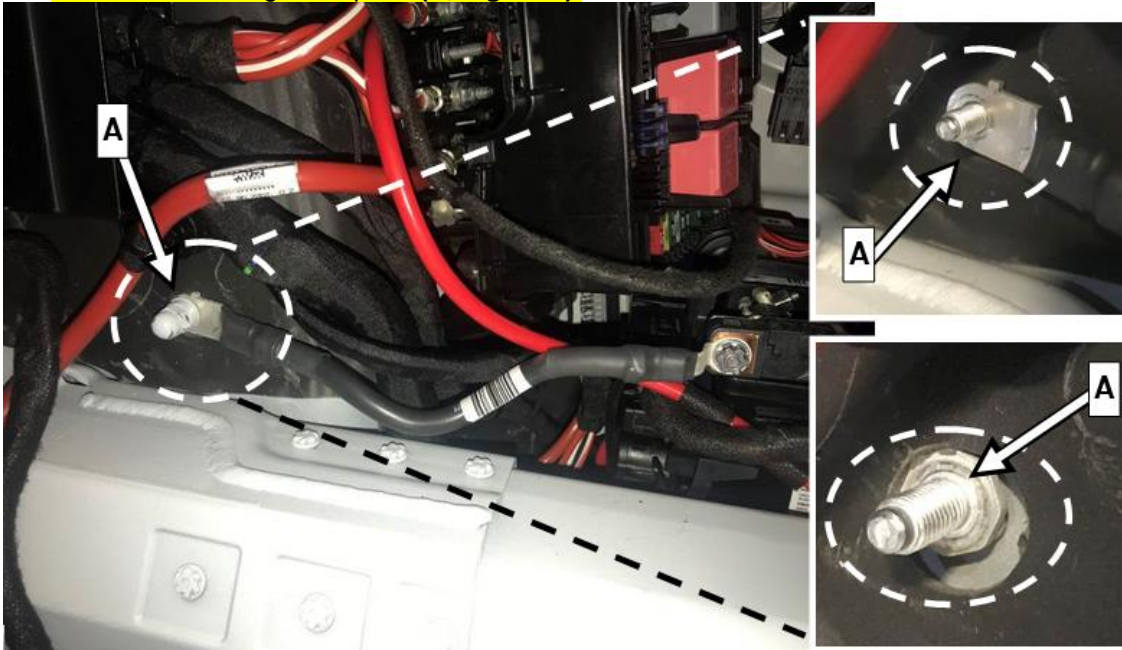
Figure 2, shown on vehicles without code ME 10 (Hybrid vehicle (plug-in, PHEV))

3. Remove ground line (A, Figure 2) of battery sensor (B95/3) of auxiliary battery from body.

i For vehicles **without** code ME 10 (Hybrid vehicle (plug-in, PHEV)), the ground line runs from the secondary 12 V on-board electrical system battery to the ground point (A, Figure 2).
