Recall Campaign Bulletin

Campaign No.2023080008, September 2023

SUBJECT: **Model S-Class (223 platform)**
Model Year 2022-2023

Inspect 12V Ground Connection

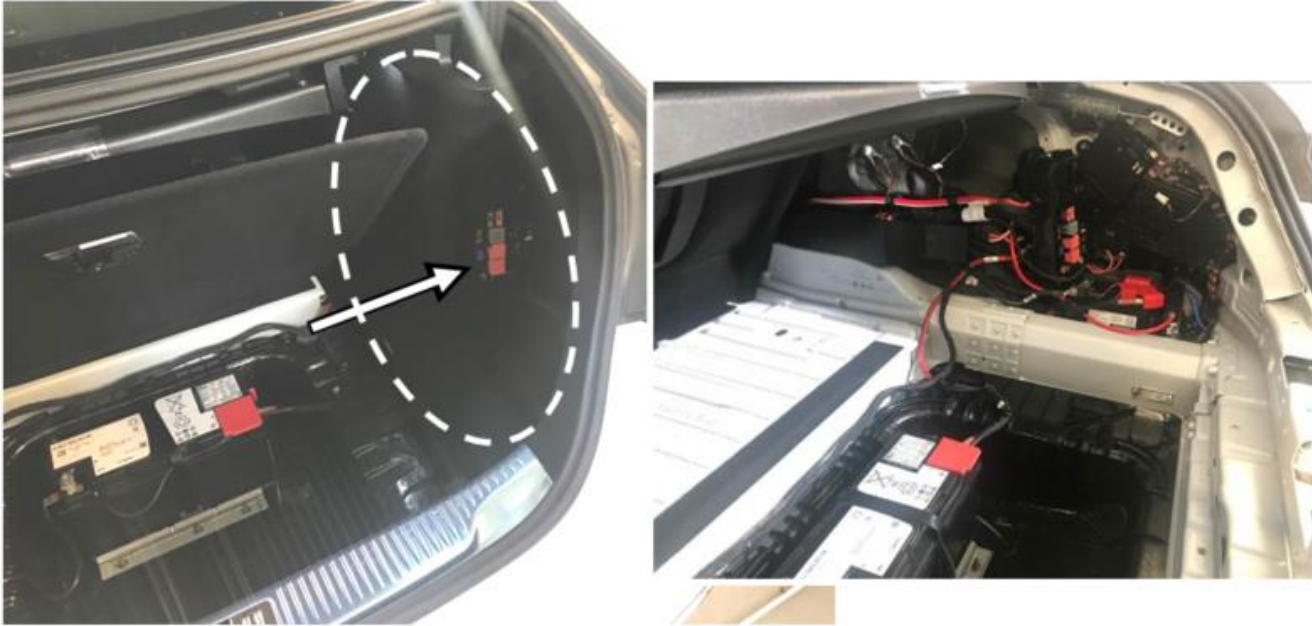
Figure 1

1. Switch off ignition and keep transmitter keys outside of transmitting range (at least 6 m).
2. Remove right side trim in trunk (**Figure 1**).
i For basic data, see AR68.30-P-4800S.

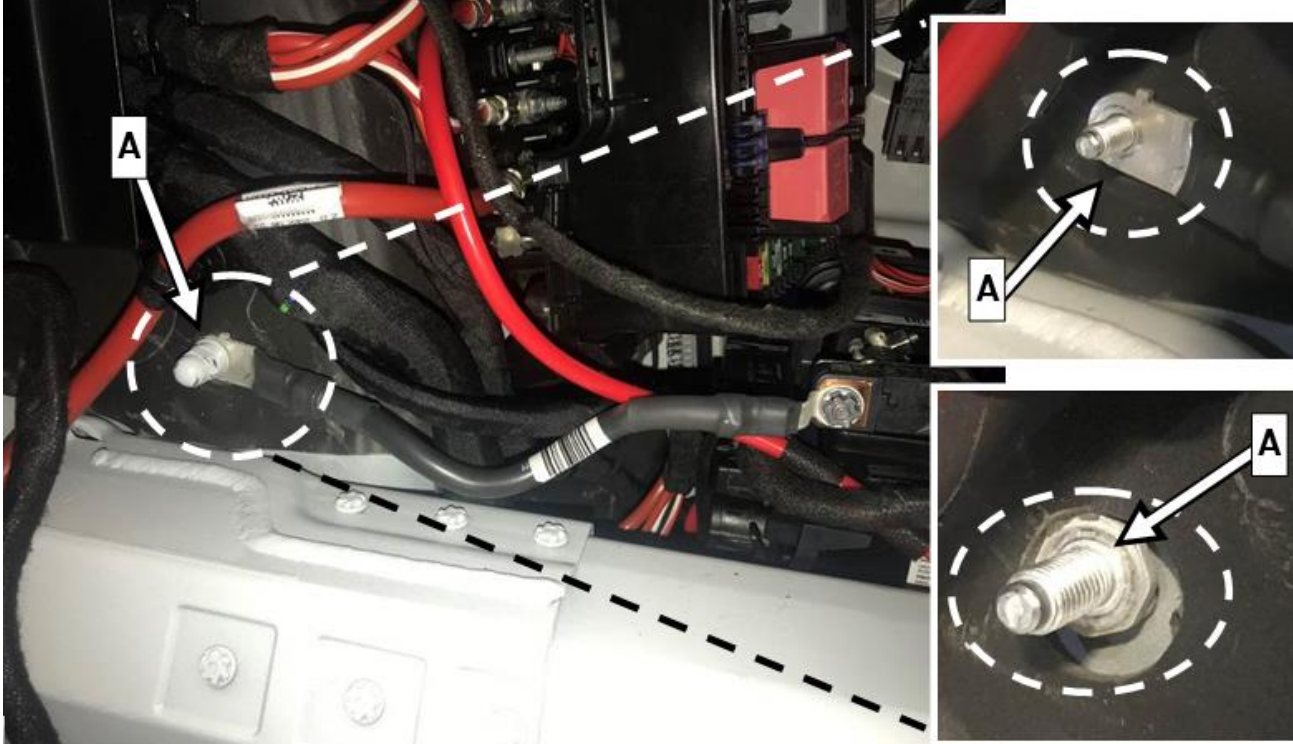
Figure 2

3. Remove ground line (**A, Figure 2**) of battery sensor (B95/3) of auxiliary battery from body.

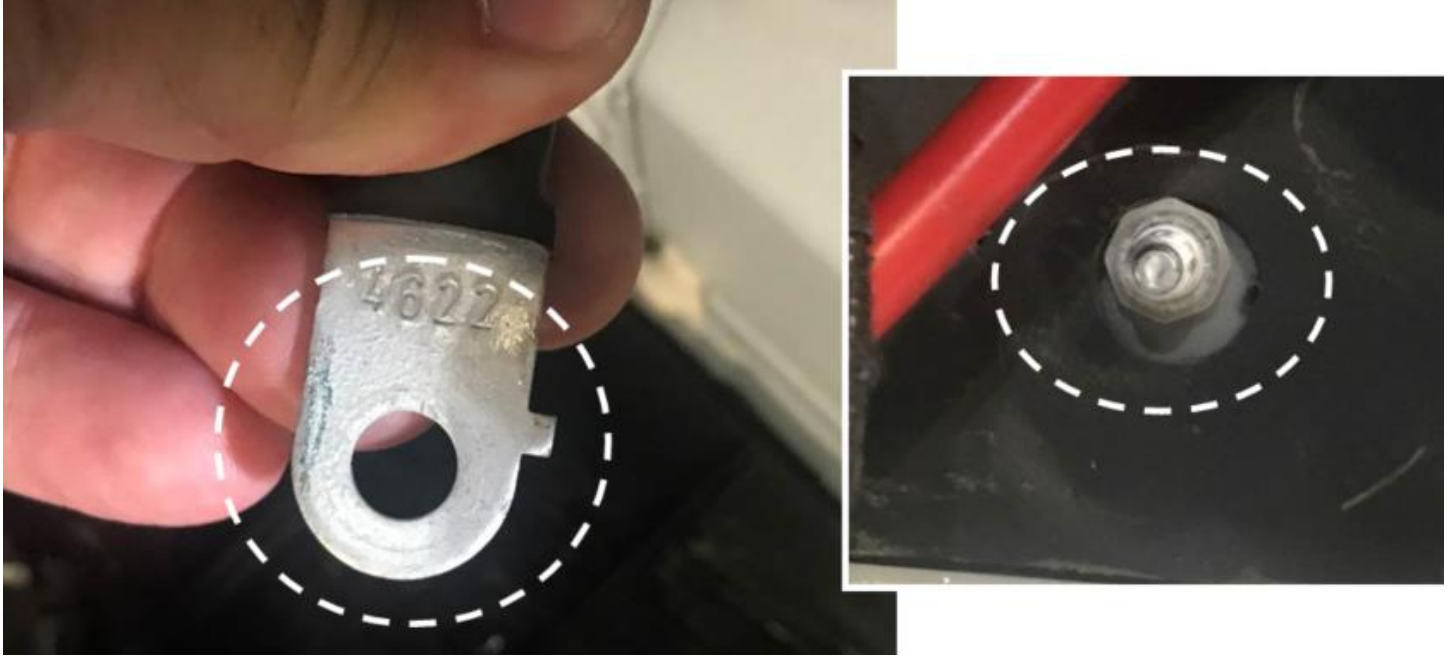
Figure 3

4. Check contact surfaces at lug of ground line and weld stud for damage (**Figure 3**).

i The possibility exists that the insulation mat at the wheel arch was slightly jammed under the ground line.

- a. Lug of ground line and ground bolt **not** damaged: Carry out **Work Procedure A**.
- b. Lug of ground line or weld stud damaged: Carry out **Work Procedure B**.

1. Slide the lug of ground line onto the weld stud and tighten it.

i **Ensure that the insulation mat is not jammed between the lug and contact surface of the weld stud!**

i **Attention: Weld stud is made from aluminum, observe tightening torque!**

Nm Ground line to body weld stud 7 Nm

1. Replace damaged ground line with battery sensor and/or weld stud.
-
