Recall Campaign Bulletin

Campaign No. 2023080004, August 2023

SUBJECT: **Model EQE (295 platform)**
Model Year 2023

Replace the Absorbers in the Roof Frame

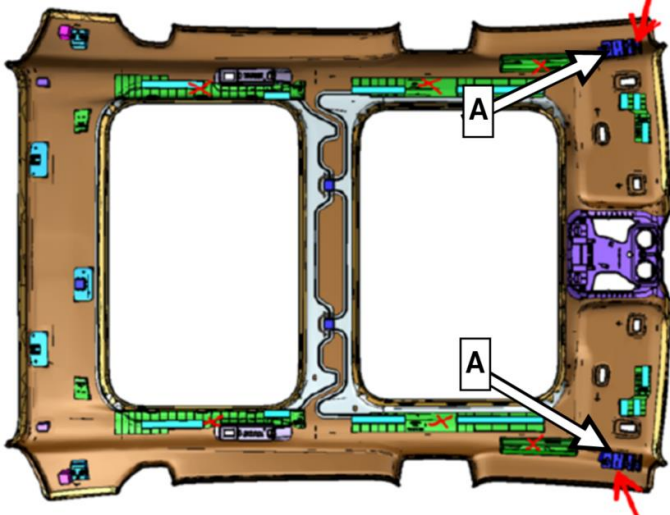
Figure 1

Mercedes-Benz AG (“MBAG”), the manufacturer of Mercedes-Benz vehicles, has determined that on certain Model Year (“MY”) 2023 EQE (295 platform) vehicles, the mounting of the absorbers in the roof frame might not meet current production specifications. In the event of a crash with window airbag deployment, the absorbers might separate into the interior of the vehicle. In this case, the risk of injury for vehicle occupants could be increased. An authorized Mercedes-Benz dealer will replace the absorbers on the affected vehicles.

- Replace front absorbers on the left and right sides (**A**, **Figure 1**).

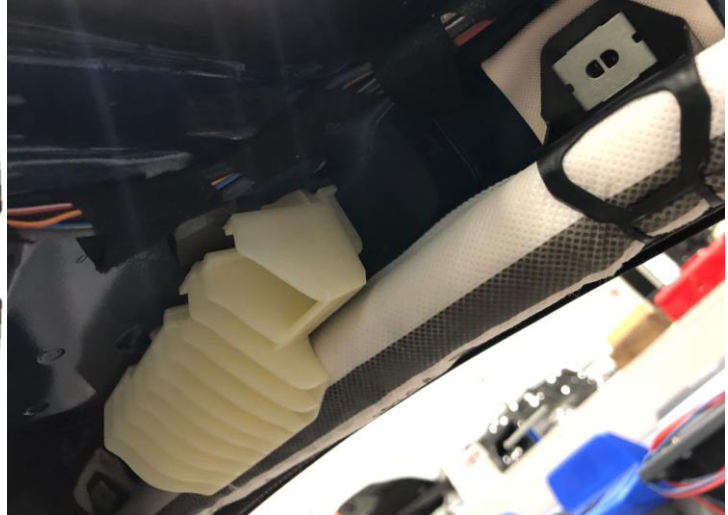
i The absorbers are clipped into the body-in-white under the headliner (**Figure 2**).

Figure 2 (Installed absorber on the left side)
