BULLETIN NUMBER:
CB23-N-002B

IMPORTANT SAFETY RECALL

IGNITION COIL PACK FUSE (Customer Vehicles Only) – 23V-564 (Transport Canada 2023-444)

- 2023 – 2024MY Isuzu N-Series Vehicles Equipped with 6.6L (L8T) Gasoline Engines

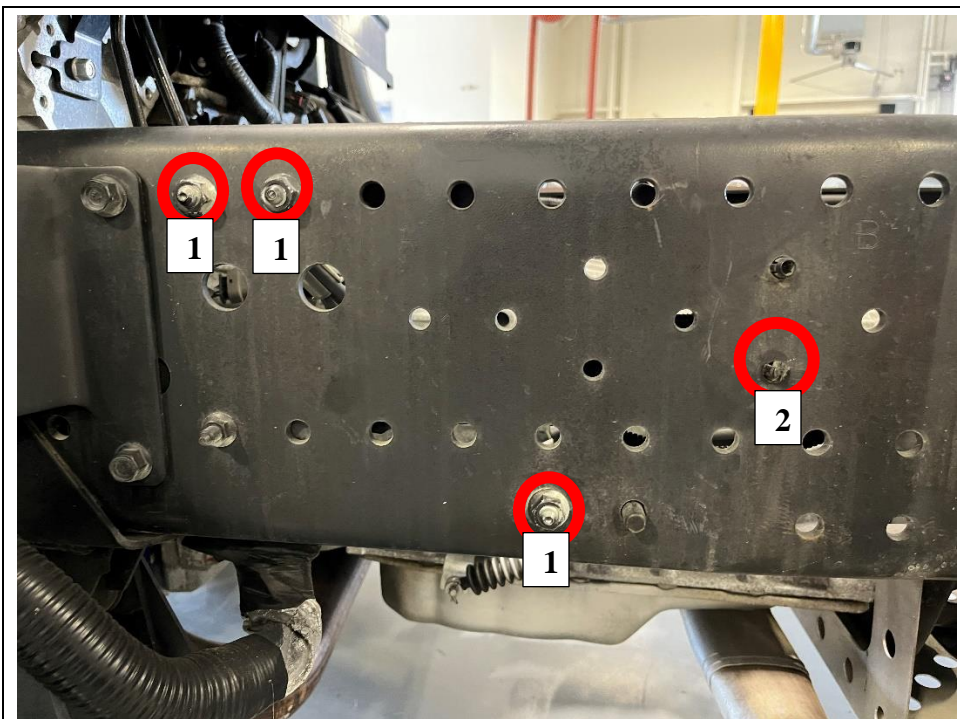
Figure 1

1. Transmission Cooler Line Bracket Nut/Bolt Locations
2. Harness Clip

1. Disconnect the negative battery cable.
2. **For NPR/NPRHD ONLY** - Remove three (3) nuts and bolts (14mm) securing the transmission cooler lines and release one (1) chassis harness clip. (See Figure 1.) **(For NQR/NRR proceed to Step 3.)**
