CB23-N-001A

IMPORTANT SAFETY RECALL

IGNITION COIL PACK FUSE (New Dealer Inventory Only) – 23V-564 (Transport Canada 2023-444)

- 2023 – 2024MY Isuzu N-Series Vehicles Equipped with 6.6L (L8T) Gasoline Engines

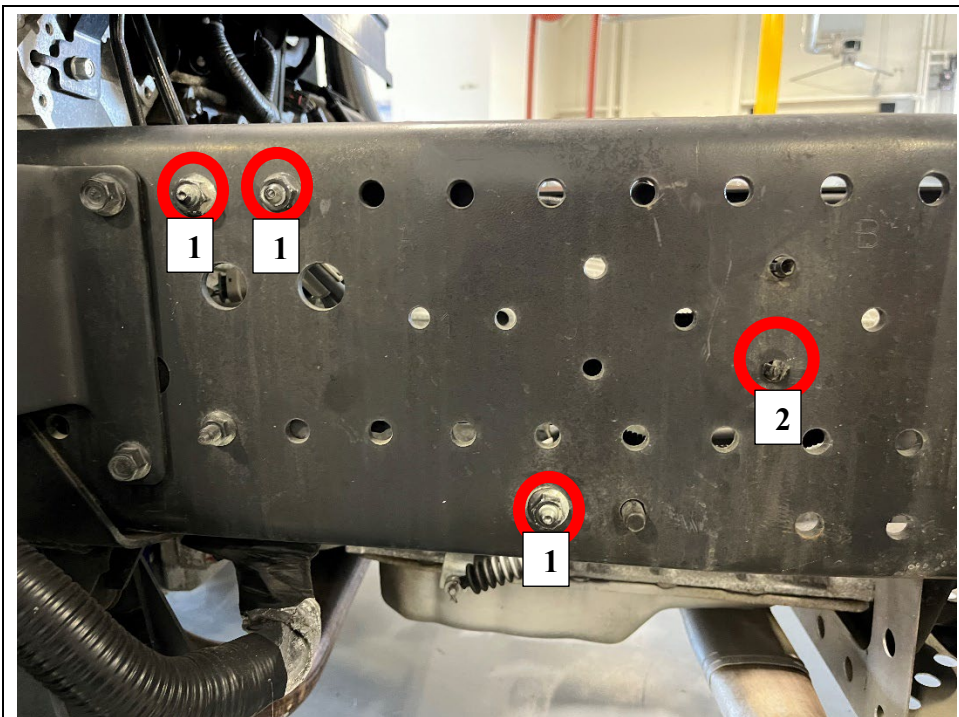
Figure 1

1. Transmission Cooler Line Bracket Nut/Bolt Locations
2. Harness Clip

1. Disconnect the negative battery cable.
2. **For NPR/NPRHD ONLY** - Remove three (3) nuts and bolts (14mm) securing the transmission cooler lines and release one (1) chassis harness clip. (See Figure 1.) **(For NQR/NRR proceed to Step 3.)**
