BULLETIN

CB23-N-002A

IGNITION COIL PACK FUSE (Customer Vehicles Only) – 23V-564 (Transport Canada 2023-444)

- 2023 – 2024MY Isuzu N-Series Vehicles Equipped with 6.6L (L8T) Gasoline Engines

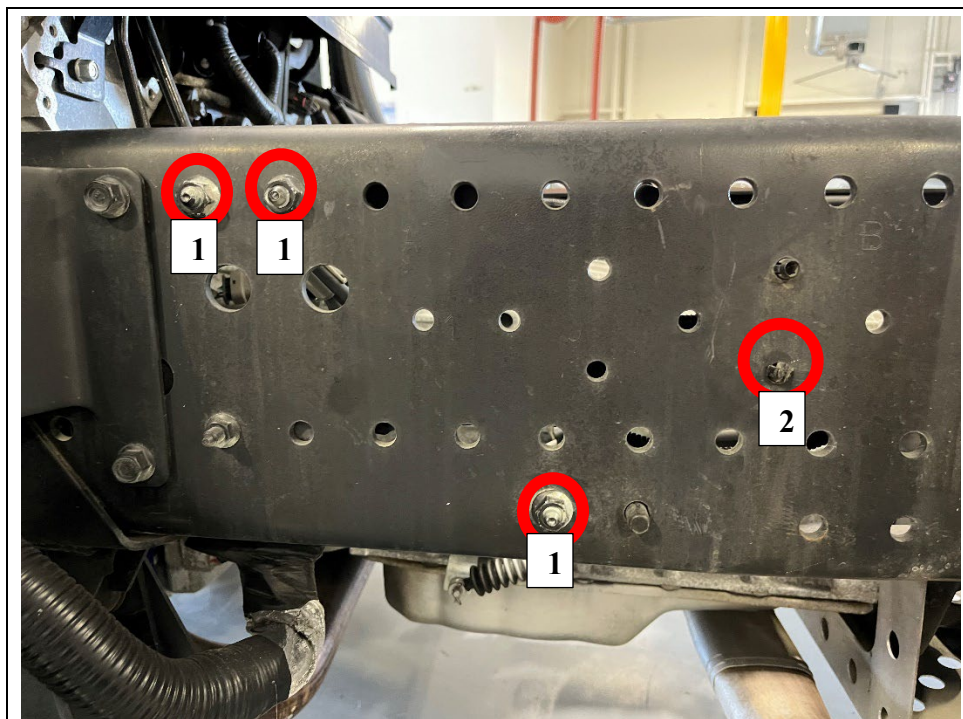
Figure 1

1. Transmission Cooler Line Bracket Nut/Bolt Locations
2. Harness Clip

1. Disconnect the negative battery cable.
2. **For NPR/NPRHD ONLY** - Remove three (3) nuts and bolts (14mm) securing the transmission cooler lines and release one (1) chassis harness clip. (See Figure 1.) (**For NQR/NRR proceed to Step 3.**)
