SAFETY RECALL

Spare Tire Carrier Assembly

Reference: 84A / NHTSA 23V-565

Remedy available for
2023 (JL) Jeep Wrangler

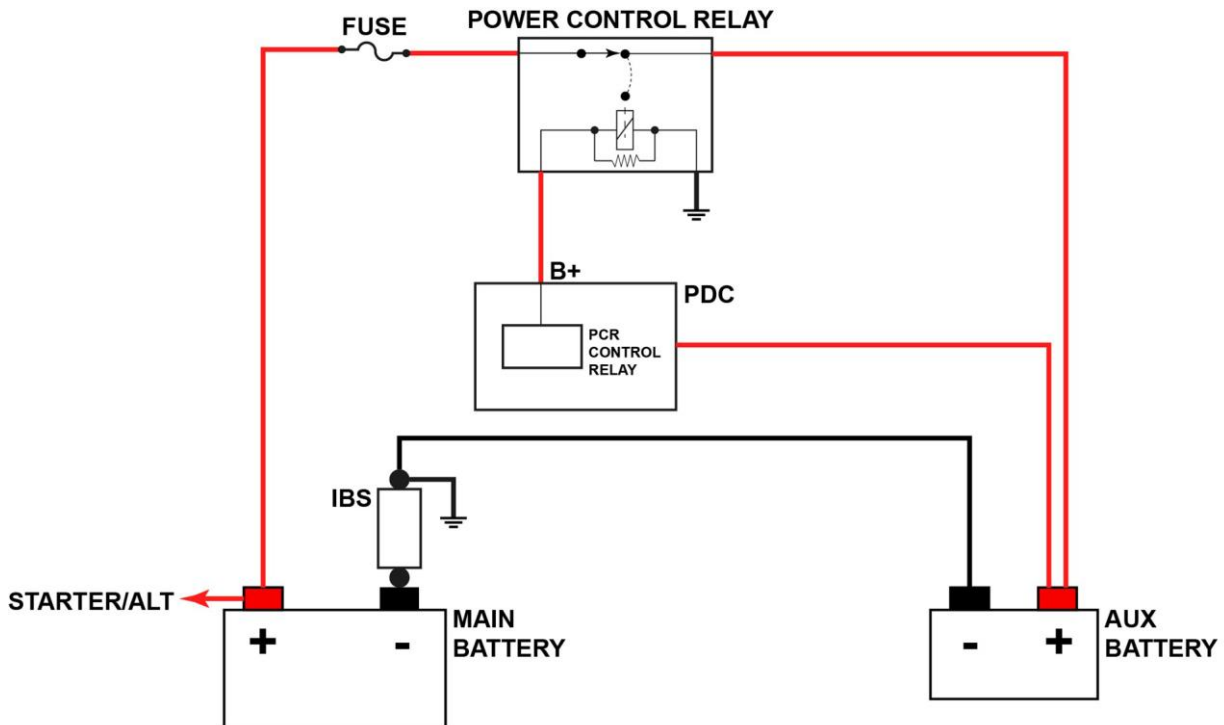
Figure 1 – Battery System

NOTE: On this dual battery system the auxiliary battery ground cable connects to the main battery cable end (shown in generic graphic above) and grounds through the main battery ground cable connection to the body, chassis, or engine (depending on vehicle). Therefore, simply disconnecting and isolating the main battery negative cable clamp from the main battery post will not isolate the auxiliary from the vehicle's electrical system. The auxiliary battery will still be grounded through its connection to the main battery negative cable end. If both battery negative cables are not isolated, it will result in the vehicle electrical system and Power Distribution Center (PDC) still having battery connection which can cause vehicle wiring damage or deployment of air bags on re-connection. (Figure 1).

1. Open the hood and turn the ignition off. Wait five minutes to allow the main modules to go to sleep.
2. Disconnect and isolate the supplemental (auxiliary) battery negative cable from the main battery negative cable end. This will disconnect and isolate the auxiliary battery ground.
3. The main battery ground can be disconnected by removing the main battery negative cable from the negative battery cable end, or by disconnecting the IBS connector, loosening the negative battery clamp nut and removing the negative battery cable end from the battery post. Either method will disconnect the main battery. Both batteries should be disconnected from the vehicle electrical system.

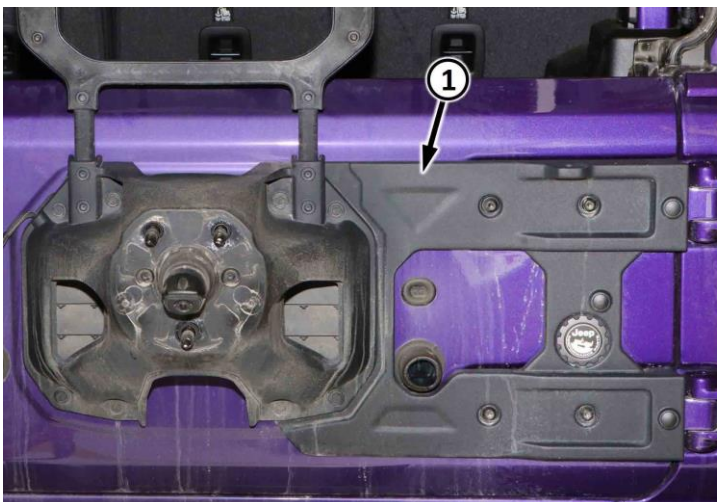
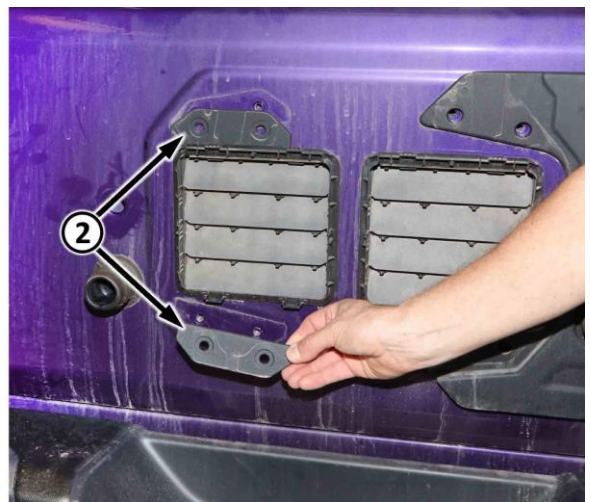
Figure 10 – Tire Carrier Mopar Hinge Reinforcement Bracket Spacers

16. If the vehicle is equipped with a swing gate tire carrier Mopar hinge reinforcement bracket (1), the spacers (2) might fall during tire carrier fastener removal (Figure 10).

17. Remove the spare tire carrier assembly from the vehicle (Figure 11).
18. **DISCARD** the old spare tire carrier assembly and obtain the correct **NEW** spare tire carrier assembly (Figure 11).
19. If the vehicle is equipped with a swing gate tire carrier Mopar hinge reinforcement bracket (1), ensure the spacers (2) are reinstalled during tire carrier installation (Figure 10).

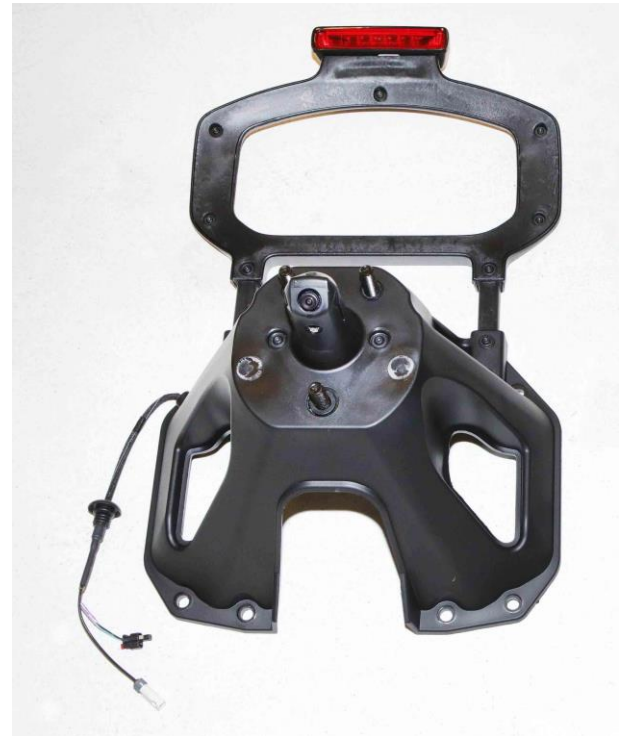
Figure 11 – Tire Carrier Assembly

The spare tire carrier on about 16 of the above vehicles may have been built with an incorrect Center High Mount Stop Lamp (CHMSL) bracket assembly. A CHMSL that is partially obstructed may not have adequate conspicuity to other drivers to indicate the intention to slow or stop, which can cause a crash without prior warning.

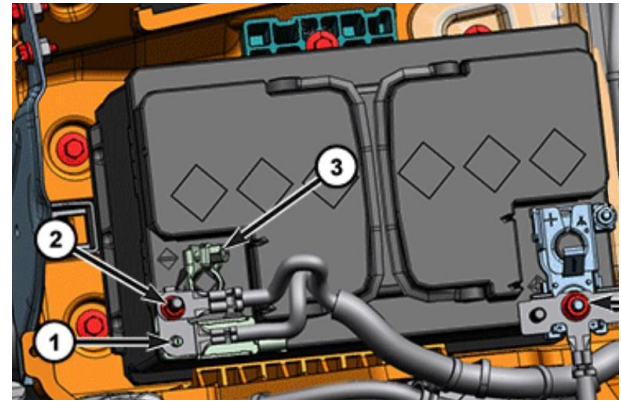
Figure 13 – Battery

NOTE: Overtightening of the nuts connecting the negative cables to the IBS may cause damage to the IBS or break the stud.

31. Connect the Intelligent Battery Sensor (IBS) clamp to the main battery negative post (3) and tighten to the proper torque specification or connect the main battery negative cable (2) to the negative cable clamp. If the main battery negative cable is connected with a nut, install the nut and tighten to the proper torque specification (Figure 13).

- (1) Auxiliary Battery Negative Cable 5 N·m (44 in. Lbs.).
- (2) Main Battery Negative Cable to IBS 12 N·m (9 Ft. Lbs.)
- (3) IBS to Main Battery Negative Post 7 N·m (62 In. Lbs.).

32. Connect the IBS harness connector if disconnected.
33. Connect the auxiliary battery negative cable (11) to the main battery negative cable clamp. If connected by a nut, install the nut and tighten to 5 N·m (44 In. Lbs.) (Figure 13).
