# Safety Recall

## N232414710 Instrument Panel Airbag Tear Seam

Release Date: December 2023

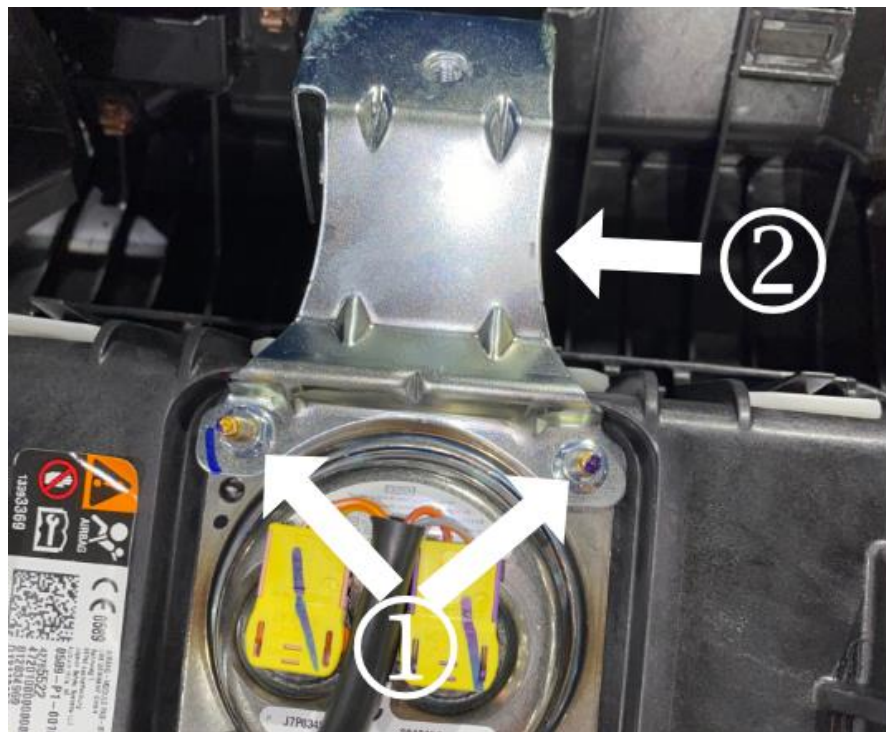
6440516

**Caution: The nuts MUST be removed using ONLY hand tools, any other method risks breaking the mounting studs resulting in a total airbag replacement.**

2. Remove the Nuts (1).
3. Remove the Mounting Plate (2).

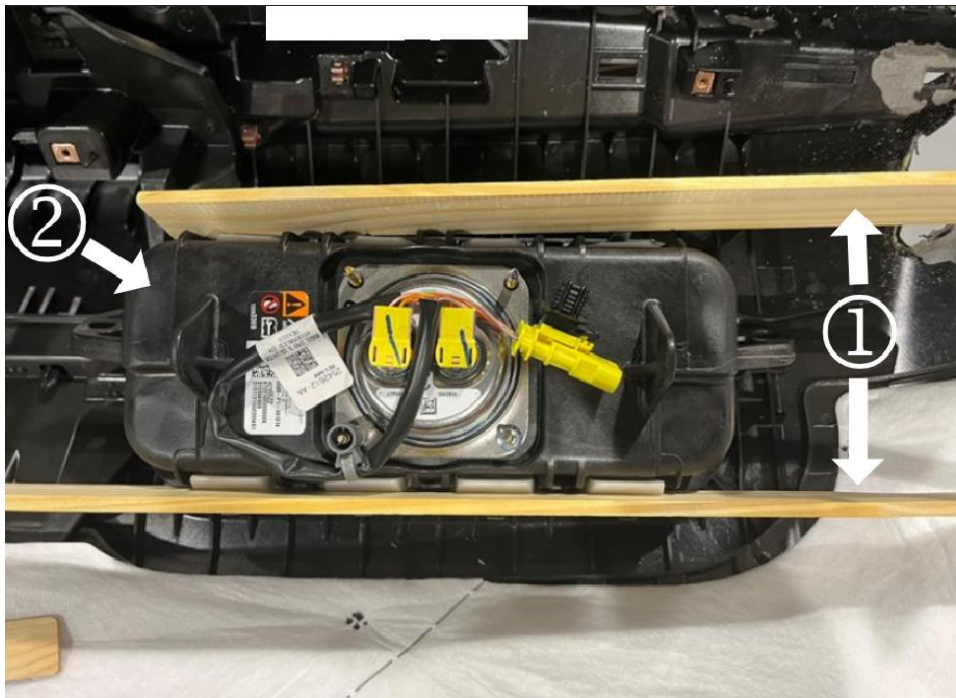
6444157

**Caution:** If any of the tabs or part of the Instrument Panel Airbag Assembly is damaged during removal it **MUST** be replaced. Refer to *Inflatable Restraint Module Handling and Scrapping* in SI.

4. Insert a wood straight edge (1), one per side behind all locking tabs, to simultaneously release the instrument panel airbag housing from the instrument panel chute without overextending the airbag locking tabs. Use a wood straight edge that is approximately 50.8 cm (20 in) long and 5 mm (0.20 in) thick with a rounded edge.
5. Remove the Instrument Panel Airbag Assembly (2).
6. Transfer remaining components as necessary from the old Instrument Panel Assembly to the NEW Instrument Panel Assembly.

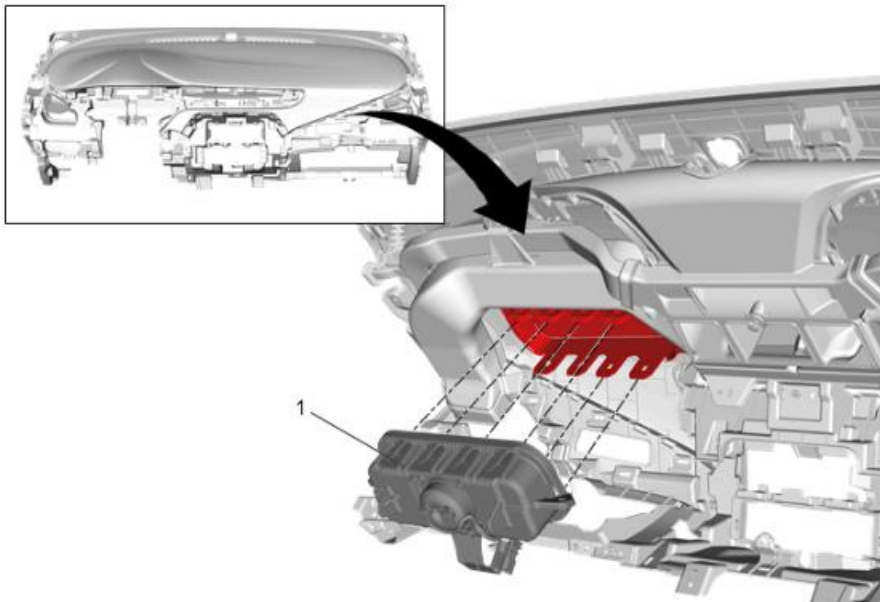
4518414

**Note:** When installing the Instrument Panel Airbag (2), ensure that it is fully seated into the Instrument Panel Assembly which may require some extra force to fully seat it.

7. Install the old Instrument Panel Airbag (2) into the NEW Instrument Panel Assembly.

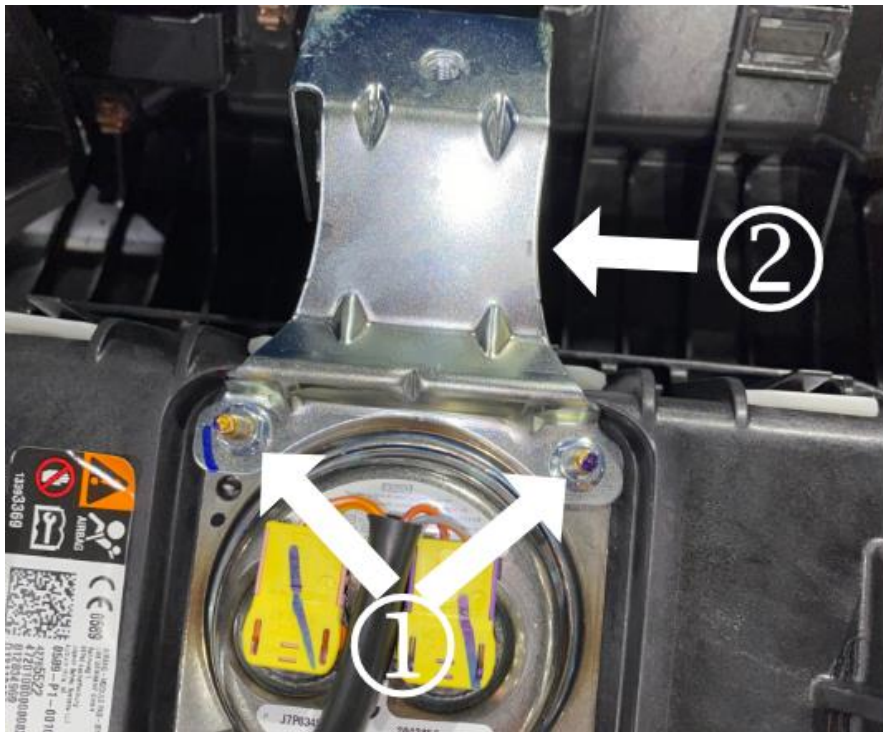
6440516

**Note:** Use **ONLY** hand tools to install, tighten, and torque the Nuts. Any other method risks breaking the mounting studs resulting in a total airbag replacement.

8. Install the Mounting Plate (2).
9. Install and tighten the Nuts (1) to 6.5 nm (57.5 lb in).
10. Install the NEW Instrument Panel Assembly. Refer to *Instrument Panel Assembly Replacement* in SI.
