RECALL COMMUNICATION G_230741_RC_EN

Model: 2023 Moto Guzzi V100 Mandello (Standard & Aviazione Navale version)

Subject: Rear Shock Absorber Check and/or Replacement

NHTSA SAFETY RECALL 23V-572

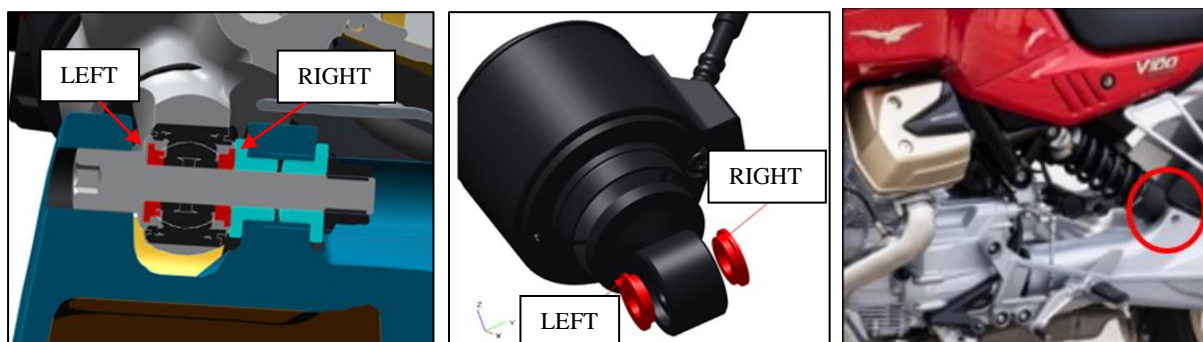
Lower connection

Check the presence and correct installation of the two bushings at each mounting point highlighted in red in the drawing below. These ensure the correct operation of the rear shock absorber.

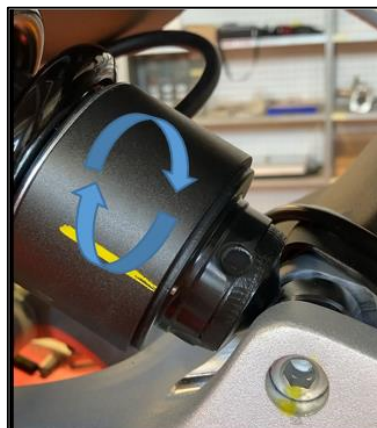
Act on the shock absorber spring by rotating it right/left and check that it has free play and movement in both directions; the shock absorber must be able to rotate and rock freely back and forth with little force.

If the shock absorber is blocked/rigid (has no rotational free play), enter Coupon 2 to replace the complete shock absorber. This indicates that an inner bushing/ right side bushing is missing (either at the top or bottom of the shock), which prevents rotational free play.

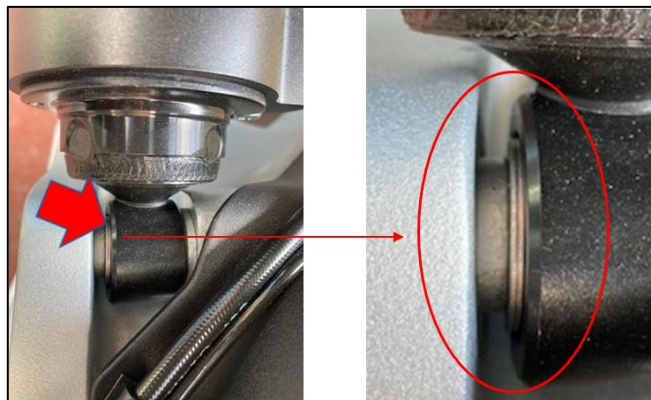
Lower connection Visual check: if the functional check does not indicate a problem, carry out a visual check from the outer left side (facing forward) to check that the lower left bushing is present (see photo below). You should see a bright metallic bushing up against the head of the bolt.

If the lower left bushing is missing, enter 2nd coupon to replace the complete shock absorber.

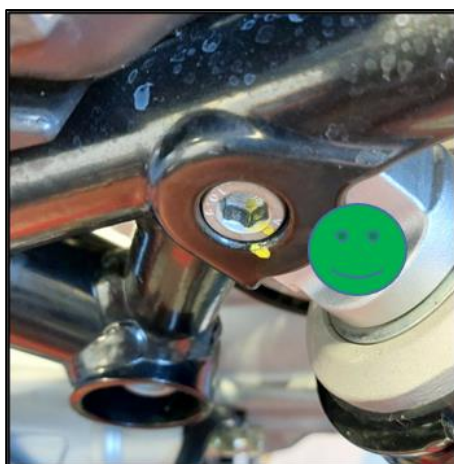
OK - 1 mm recess

Upper connection visual check: if the functional check does not indicate a problem, measure the recess of the upper screw head in relation to the frame on the external left side to certify the presence of the upper left bushing (see photos below).
