VOLUNTARY RECALL CAMPAIGN

Classification: ST23-004A	Reference: NTB23-078A	Date: December 18, 2023
------------------------------	--------------------------	----------------------------

VOLUNTARY SAFETY RECALL CAMPAIGN 2020-2022 SENTRA; INNER TIE ROD

CAMPAIGN ID #: R23B3
APPLIED VEHICLES: 2020-2022 Sentra (B18)

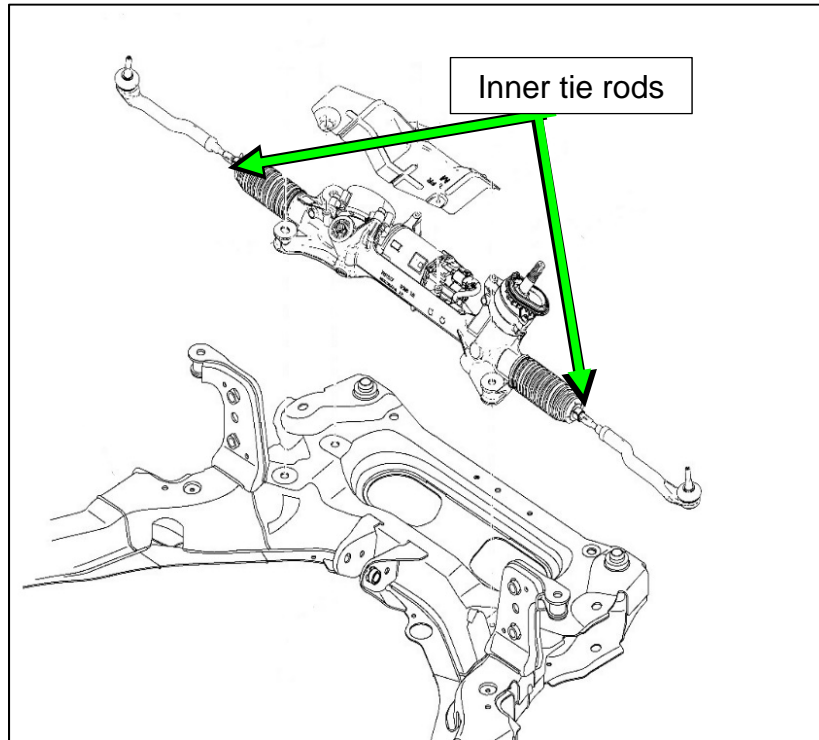
Figure 1

1. Place the vehicle on a lift and raise to a suitable height.
2. Locate the Driver (LH) and Passenger (RH) inner sockets (inner tie rods).

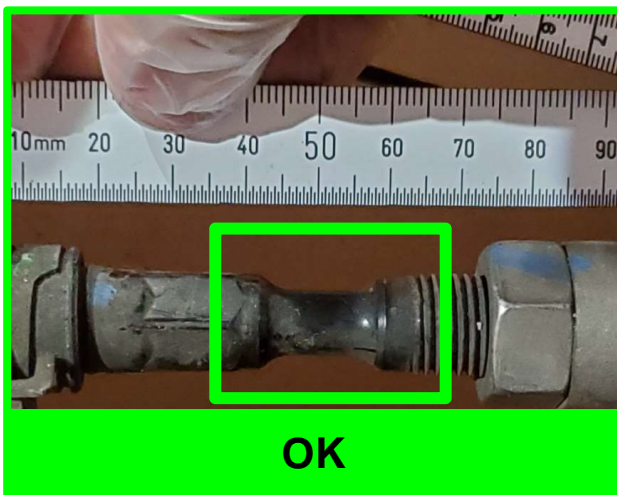
Figure 2

3. Inspect each inner tie rod for a bent condition by placing a straight edge on each inner tie rod (Figure 2 and Figure 3).

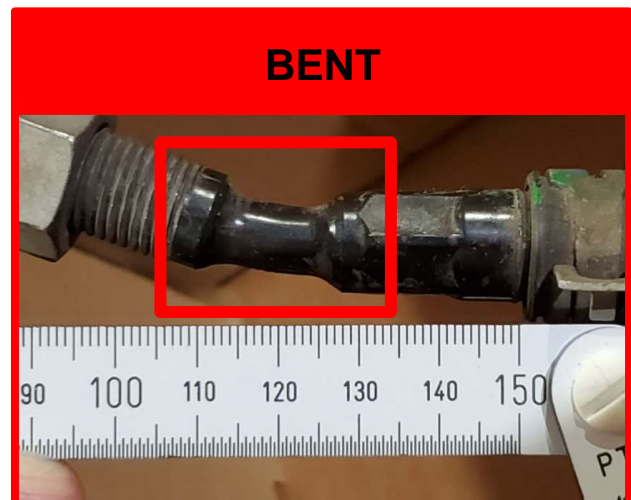
HINT: The inner tie rod in Figure 3 has an exaggerated bend. Any inner tie rod(s) that is found to be bent may not be as extreme. Any inner tie rod(s) found with any bent condition should be replaced.

4. Replace both inner tie rods.
 - Obtain pre-approval for inner tie rod replacement.
 - For inner tie rod replacement, refer to the ESM: **STEERING > STEERING SYSTEM > REMOVAL AND INSTALLATION > STEERING GEAR AND LINKAGE > Removal and Installation – Inner socket**
 - During reassembly, replace the outer tie rod to knuckle nuts and torque to specification.
 - Outer tie rod to knuckle nut torque: 34.4 N•m (3.5 kg-m, **25 ft-lb.**)
5. Perform a 4-wheel alignment.
