**HYUNDAI**
Technical Service Bulletin

| GROUP RECALL | NUMBER 23-01-070H |
| DATE AUGUST 2023 | MODEL(S) ELANTRA HYBRID (CN7 HEV) |

SUBJECT: MOTOR CONTROL UNIT (MCU) SOFTWARE UPDATE (RECALL CAMPAIGN 248)

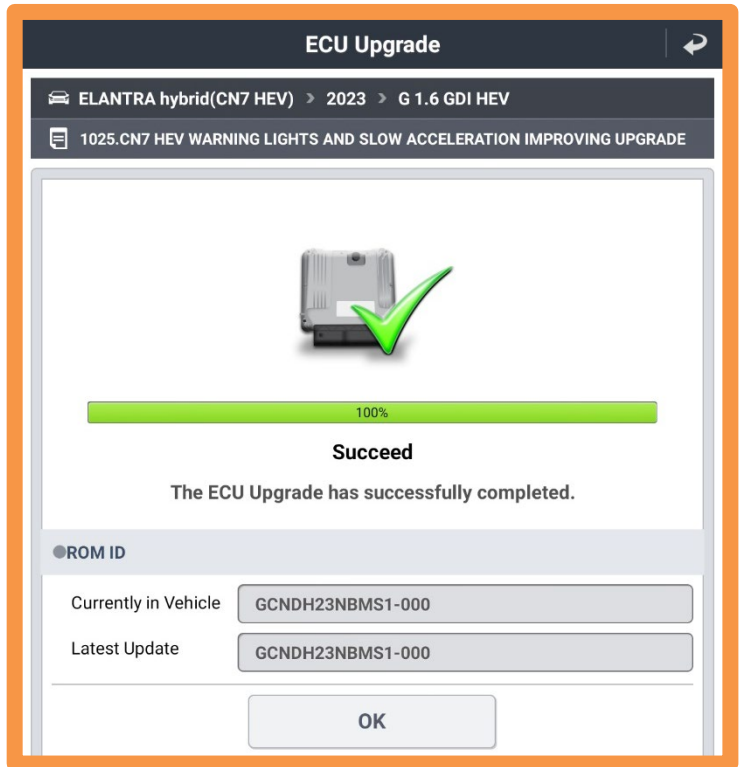
Take a screenshot of the MCU Update Complete screen using your particular tablet’s screenshot save method and upload to STUI.
