# Safety Recall Code: 13i6

#### **Engine Connecting Rod**

Date	Summary			
09/29/2023	Added engine parts, claiming, and repair information.			
08/25/2023	Original publication

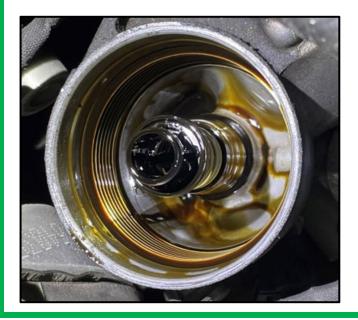
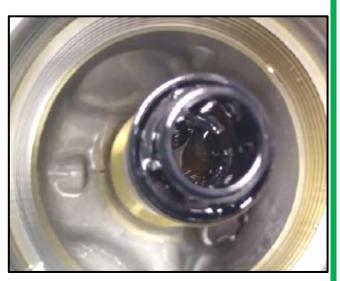
# **Examples of OK Oil Filters and Oil Filter Housing**

- Remove oil filter.
- See examples of OK and NOT OK oil filter and housing on the following pages.
- If no excessive metal particles are found:
  - Engine does not require replacement.

- Replace oil filter and seal again.
  - o Torque housing to 25 Nm.
  - Proceed to Section D.
- If excessive metal particles are found:
  - o The engine requires replacement.
