# SAFETY RECALL

Mack Trucks Inc.  
Greensboro, NC USA

| Date | Number | Release | Page |
|---|---|---|---|
| 09.2024 | SC0448 | 04 | 1(19) |

## Mack GR, GU Turn Signal Visibility GR, GU

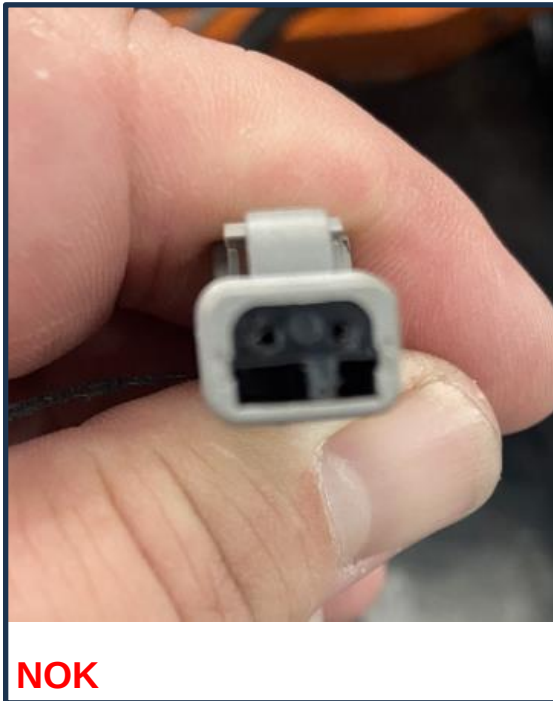
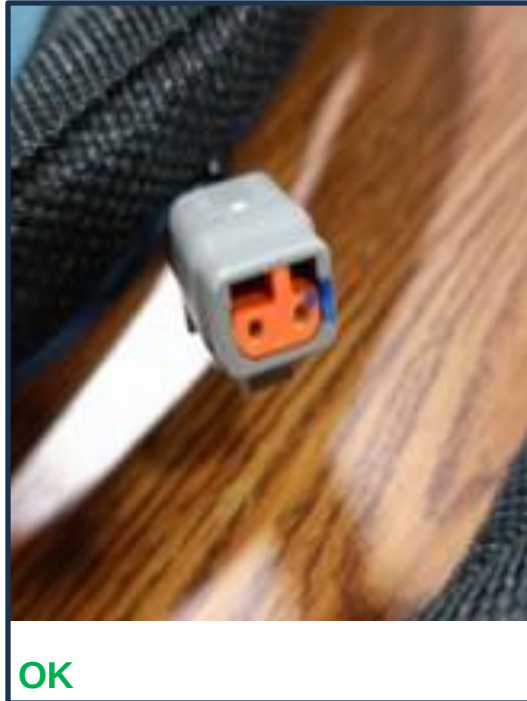
**ATTENTION: HARNESSSES ORDERED BEFORE 9/29/2024 MAY HAVE BEEN BUILT WITH THE INCORRECT CONNECTOR WEDGE LOCK NOT ALLOWING THE HARNESS TO CONNECT PROPERLY.**

**REPLACE WEDGE LOCK WITH CORRECT WEDGE LOCK (PN: 85130765) TO REPAIR. FOLLOW CLAIMING INSTRUCTIONS IN THE REIMBURSEMENT TAB.**
