SAFETY RECALL

Date	Number	Release	Page
10.2024	SC0448	06	1(21)

Mack GR, GU Turn Signal Visibility GR, GU

Mack Trucks has determined that on certain 2015 to 2023 model year GR and GU trucks, the turn signal visibility may not alert other drivers to a turning vehicle, increasing the risk of a crash.

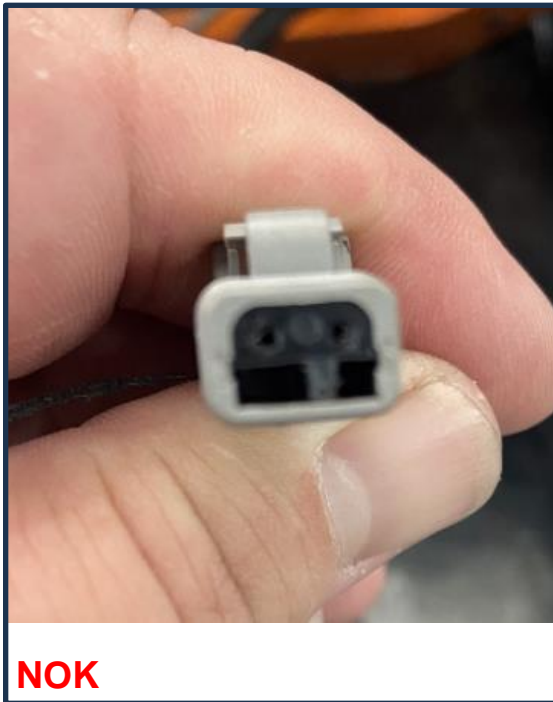
NOK

ATTENTION: HARNESSES ORDERED BEFORE 9/29/2024 MAY HAVE BEEN BUILT WITH THE INCORRECT CONNECTOR WEDGE LOCK NOT ALLOWING THE HARNESS TO CONNECT PROPERLY.

REPLACE WEDGE LOCK WITH CORRECT WEDGE LOCK (PN: 85130765) TO REPAIR. FOLLOW CLAIMING INSTRUCTIONS IN THE REIMBURSEMENT TAB.
